June 8, 2007

RE: Preliminary Subsurface Utility Engineering Study for the Proposed Carolina Tranvía Stations, Carolina, Puerto Rico

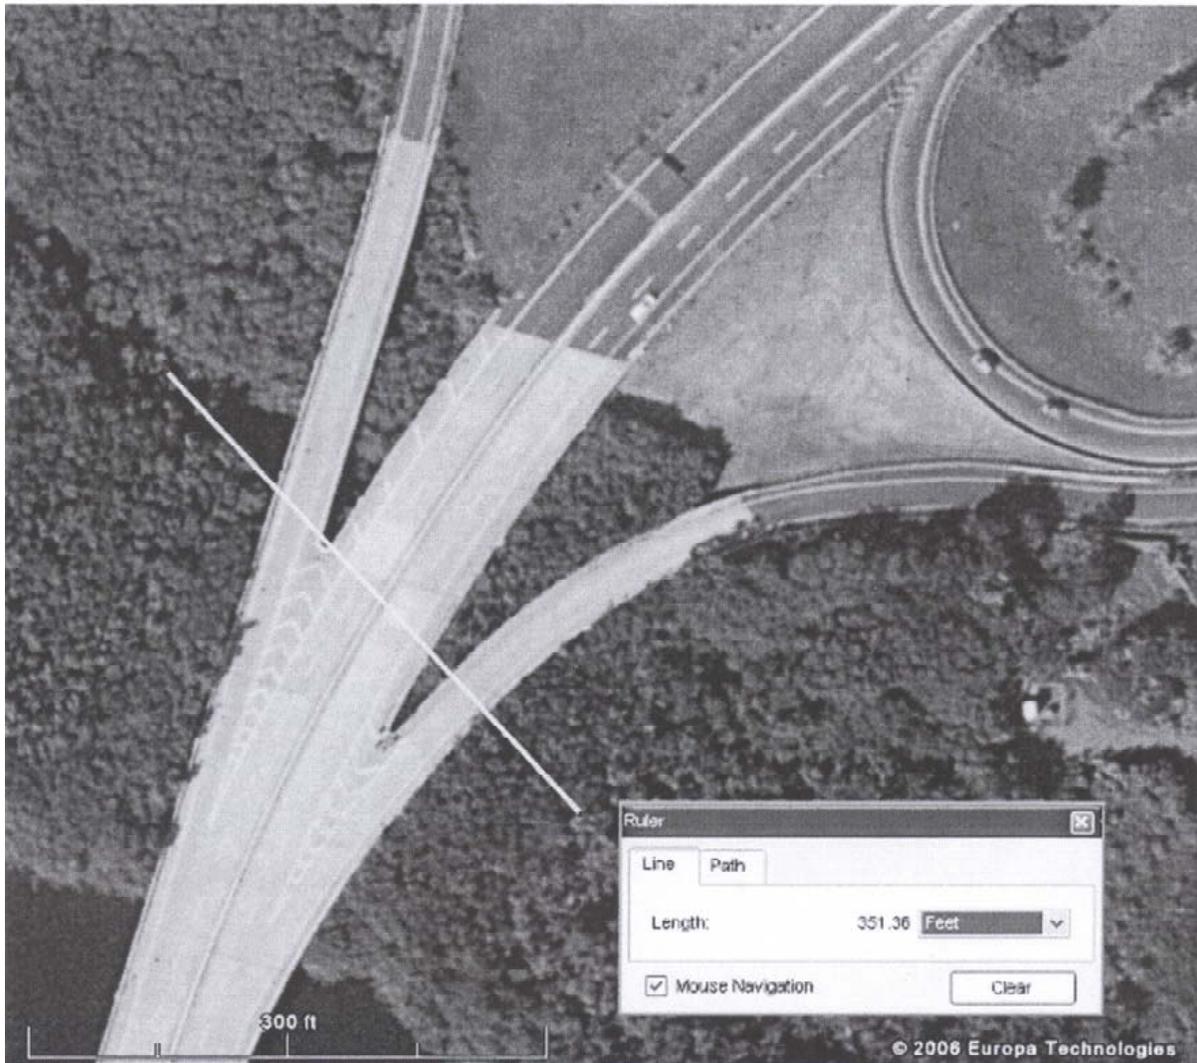
Location 11: Under N span of Moscoso
 Bridge. Water and Sewer Main Pipe
 Subsurface Utility Survey, Tranvía, Carolina
 Puerto Rico
 Figure 10

At Location 2: Under N span of Moscoso Bridge (Figure 10) due to the fact that the terrain conditions at this location did not allow using the GPR or the PL, a visual inspection was performed. Two manholes more that ten feet deep were found. These manholes appear to be inlets of waters that come from two stormwater channels that run at both sides of the north span of the bridge. Although the manholes appear to be connected, this could not be affirmed because at the time of the inspection they were full of water.

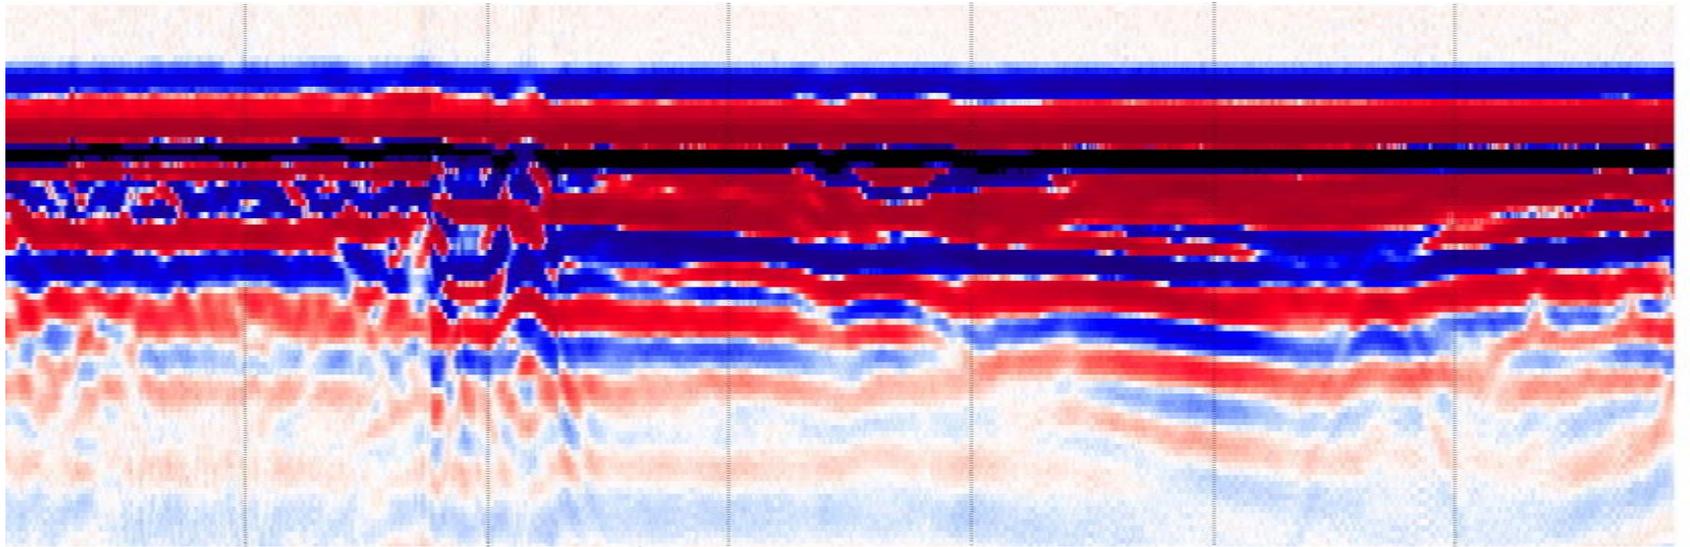
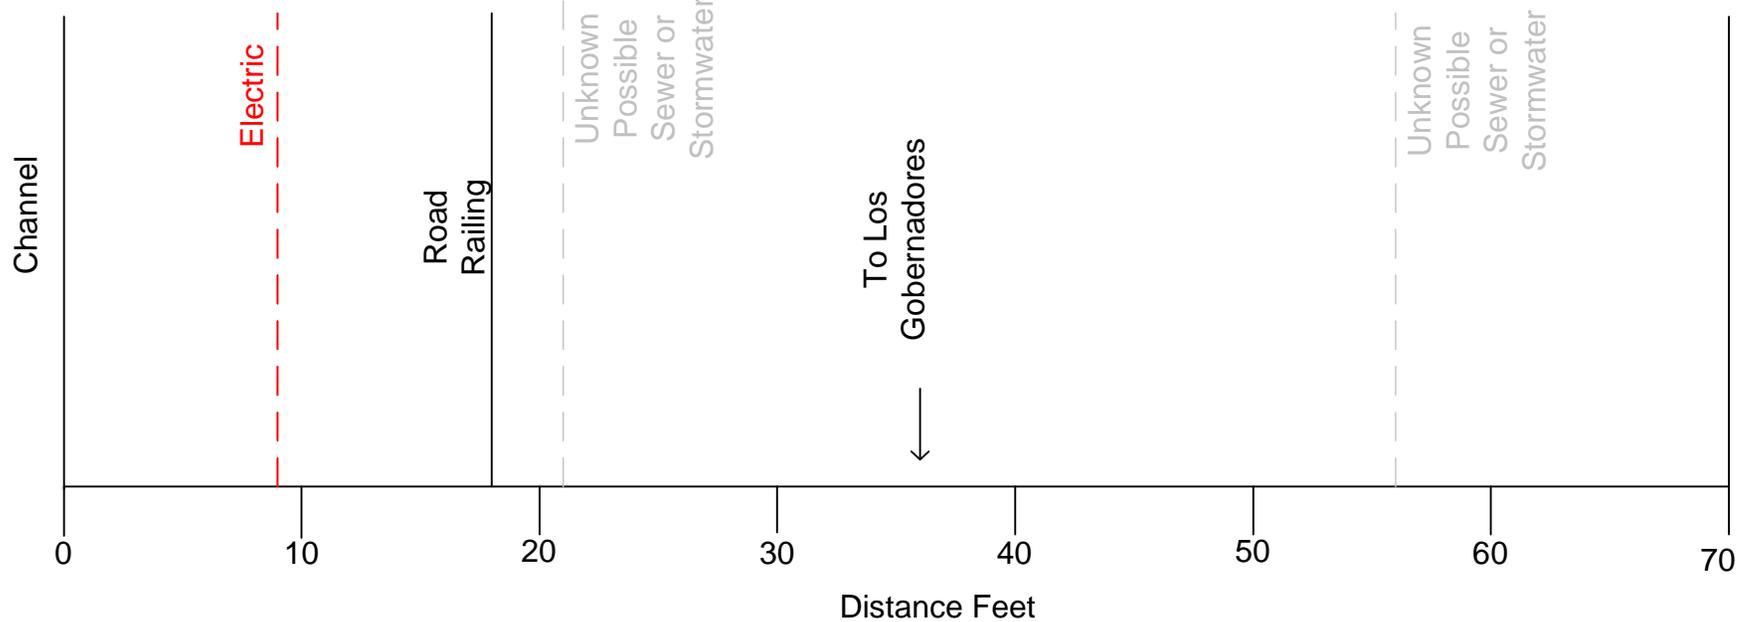
Location 1: PR-26 West of Embassy Suites
 Subsurface Utility Survey, Tranvía Carolina
 Puerto Rico
 Figure 11

At **Location 1: PR-26 West of Embassy Suites (Figure 11)** the following utilities were identified:

1. Using the channel as reference point, at nine feet from the eastern side of the channel, approximately at two feet deep, an electric line that probably powers the light poles.
2. At three feet from the channel, about three feet deep from the road railing an unknown pipe.*
3. At fifty-six feet, about three to four feet deep an unknown pipe.*

* Either of these two unknown pipes possibly can be sewer, stormwater, or a pressurize fuel line.

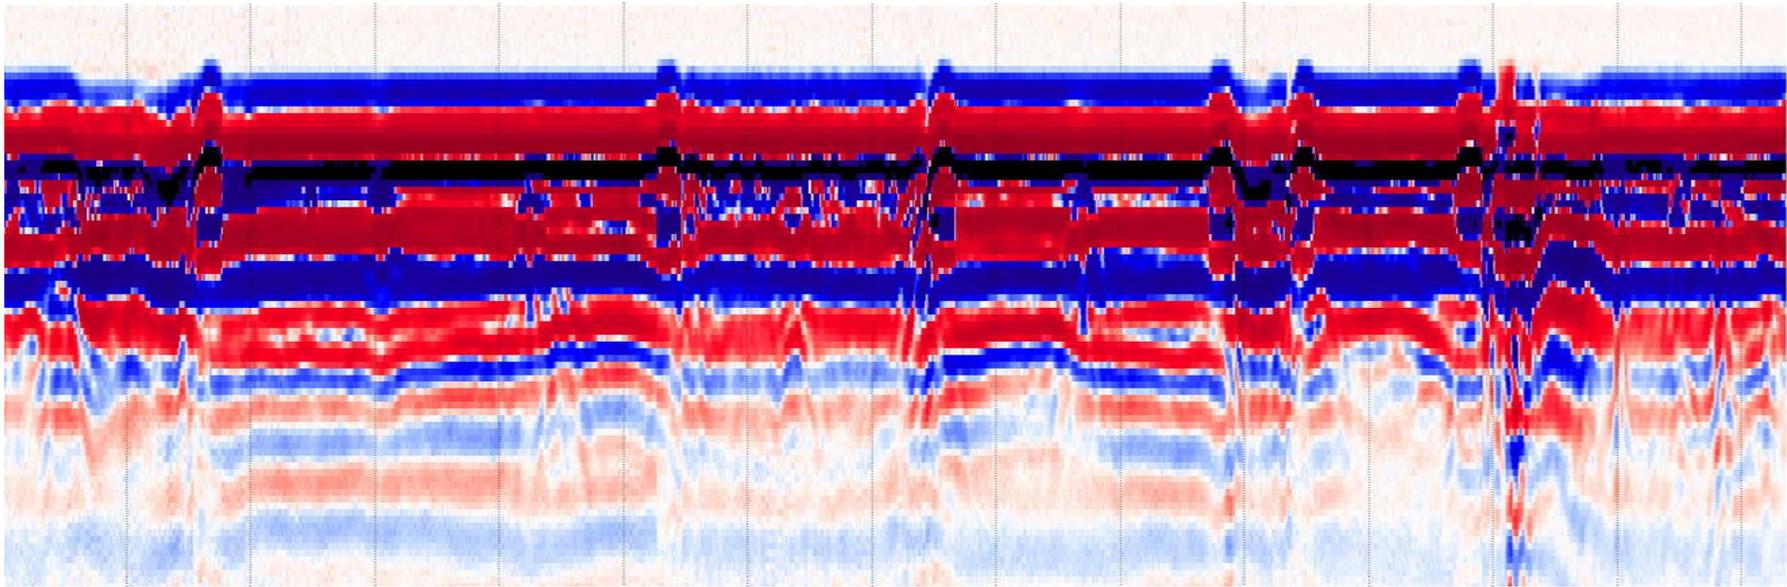
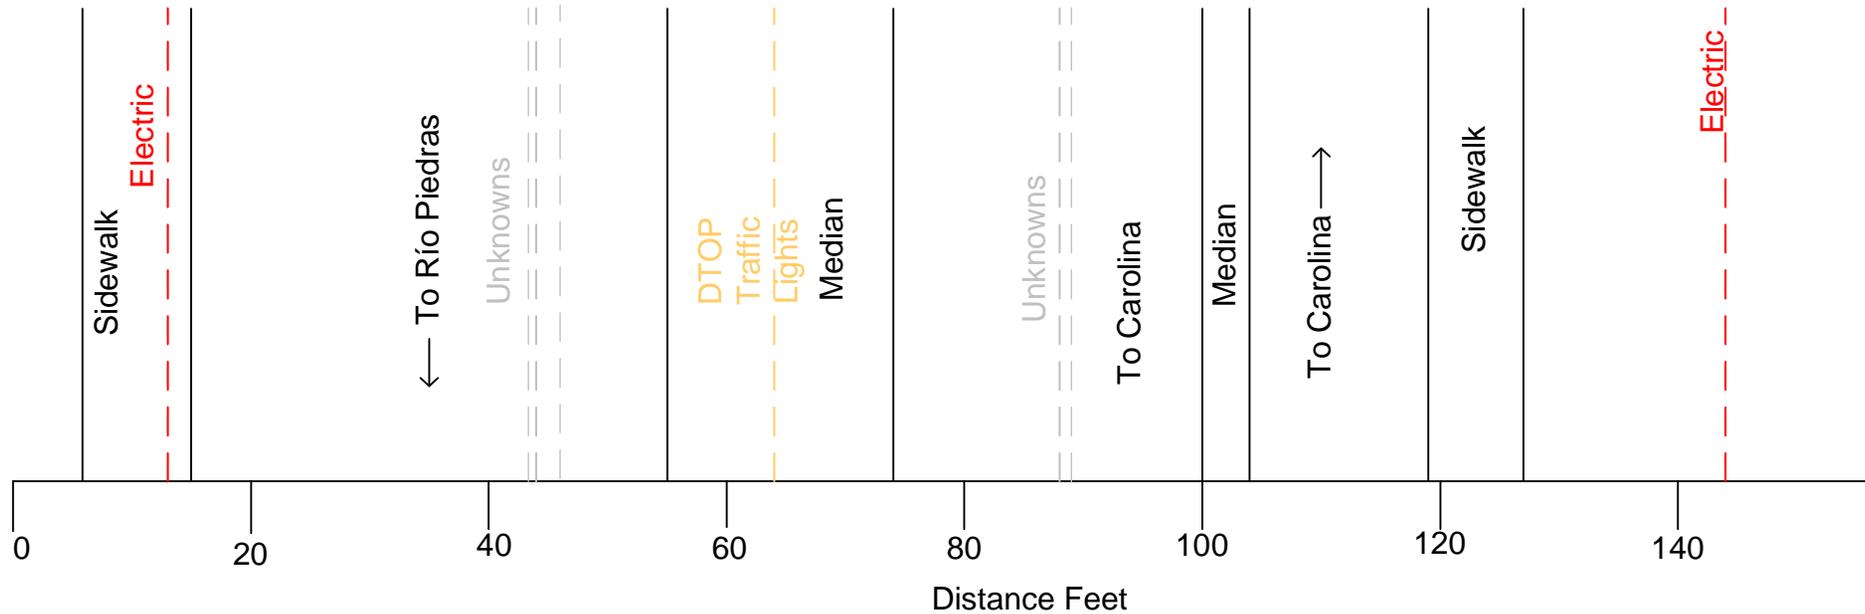
Location 3: PR-26 and Monserrate Ave.
 Subsurface Utility Survey, Tranvía Carolina
 Puerto Rico
 Figure 12

At Location 3: **PR-26 and Monserrate Ave. (Figure 12)** the following utilities were identified:

1. Approximately five feet from the northern sidewalk, approximately at three feet deep an electric line that powers the light poles.
2. Approximately forty feet from the curb, at two feet deep, three unknown pipes.
3. At the center of the median, at approximately two feet deep, the lines that control and power the traffic lights.
4. At approximately fifteen feet from the median curb, two feet deep, two unknown pipes.
5. At twenty feet from the south sidewalk, two feet deep, an electric line.

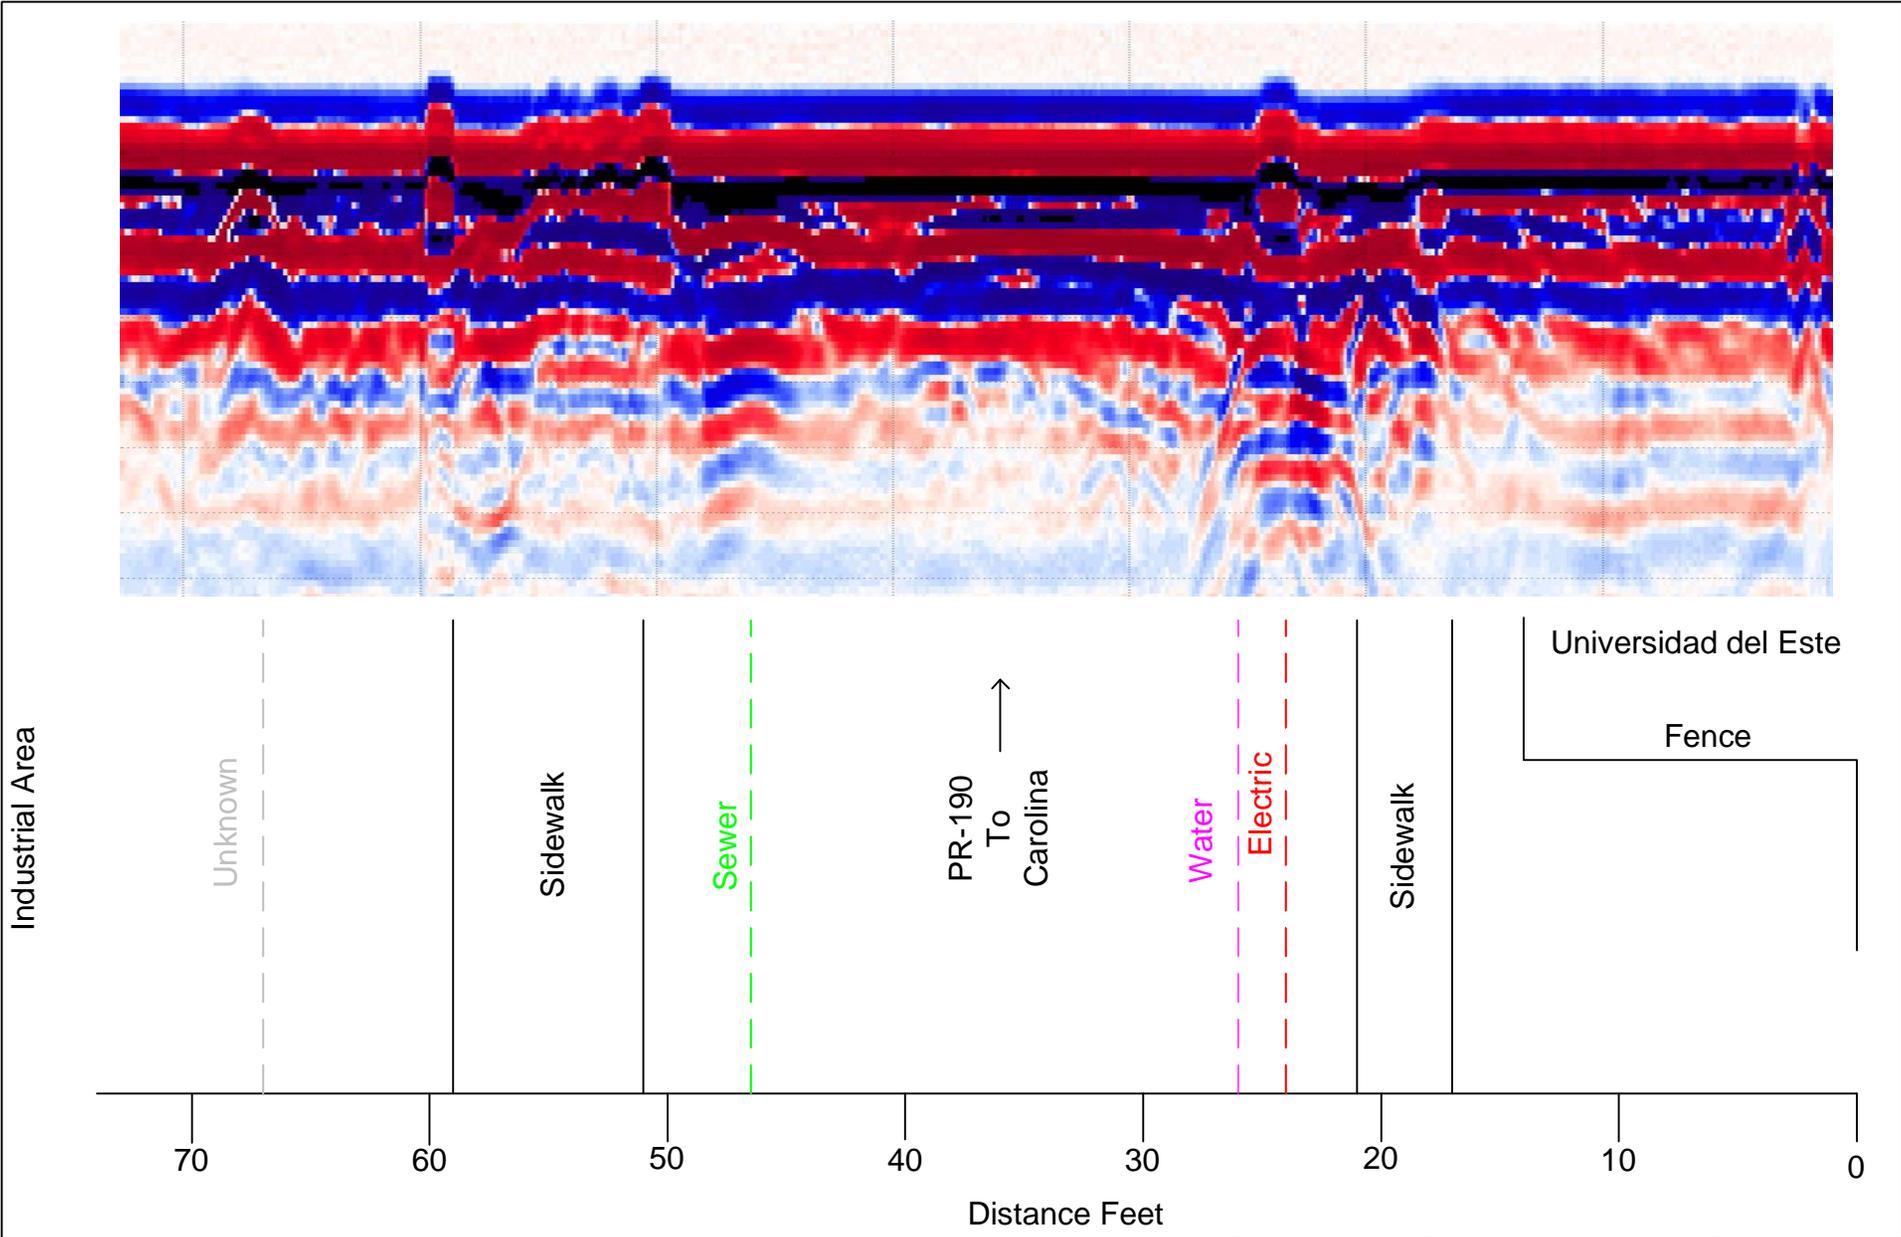
Location 4: PR-190 and Entrance to Universal del Este.
 Subsurface Utility Survey, Tranvía Carolina
 Puerto Rico
 Figure 13

At Location 4: **PR-190 and Entrance to Universidad del Este (Figure 13)** the following utilities were found:

1. At twenty-four feet from the University fence, one foot deep and electric line.
2. At twenty six feet from the University fence, two feet deep a potable water pipe.
3. At five feet before the eastern sidewalk, two feet deep, a sewer line.
4. At eight feet after the eastern sidewalk, at a foot deep, an unknown pipe.

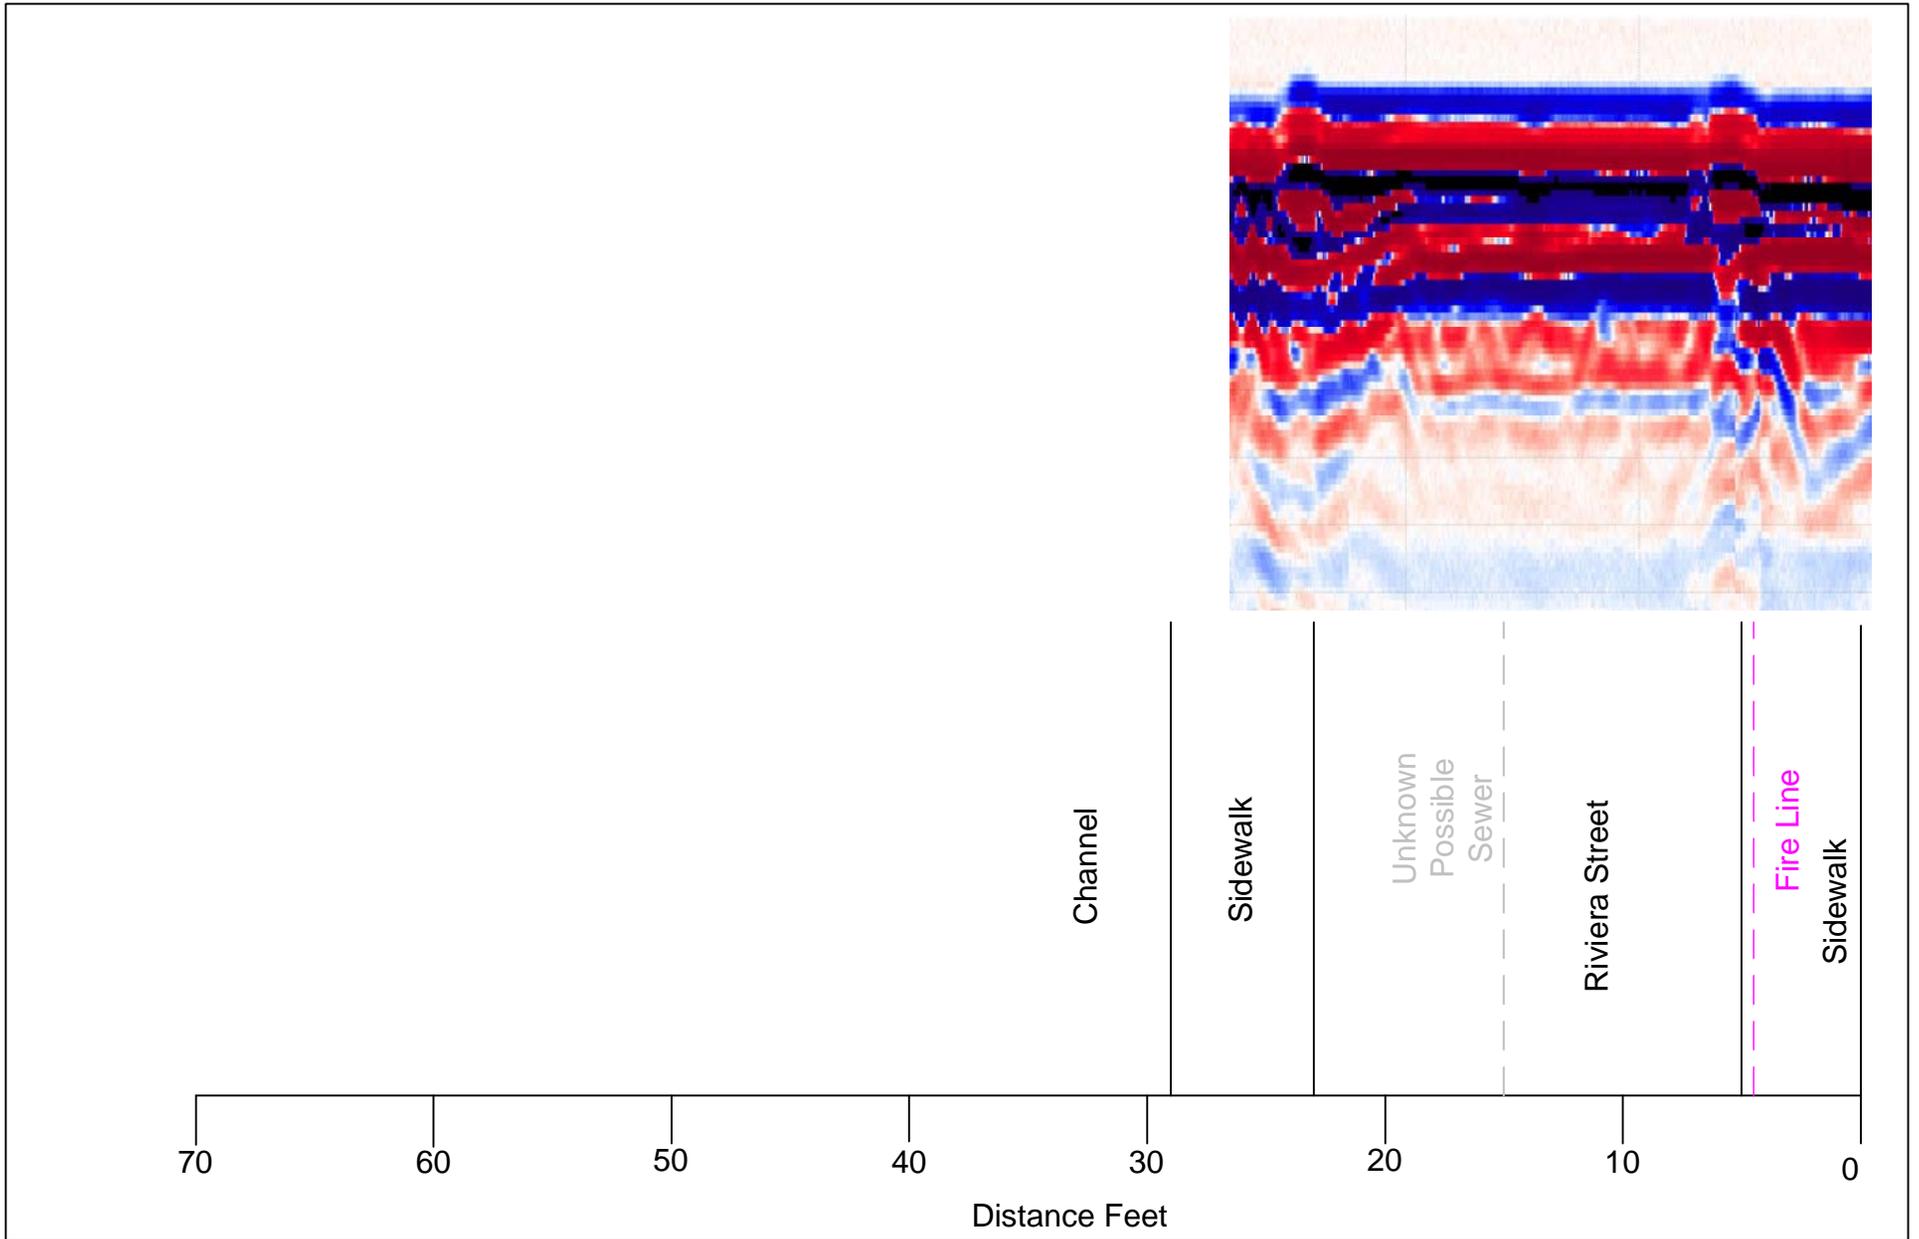
Location 5: Garcilaso and Riviera St. Crossing San Fernando, thru Channel
 Subsurface Utility Survey, Tranvía Carolina
 Puerto Rico
 Figure 14

At Location 5: **Garcilaso and Riviera St. Crossing San Fernando**, just east of Channel (Figure 14) the following utilities were found:

1. At four feet from the eastern sidewalk, two feet deep, a fire line.
2. At ten feet from the eastern sidewalk, two feet deep, an unknown pipe.

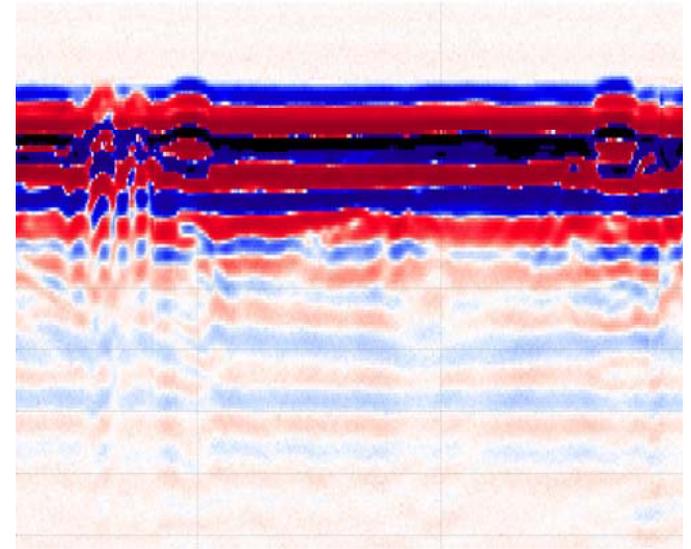
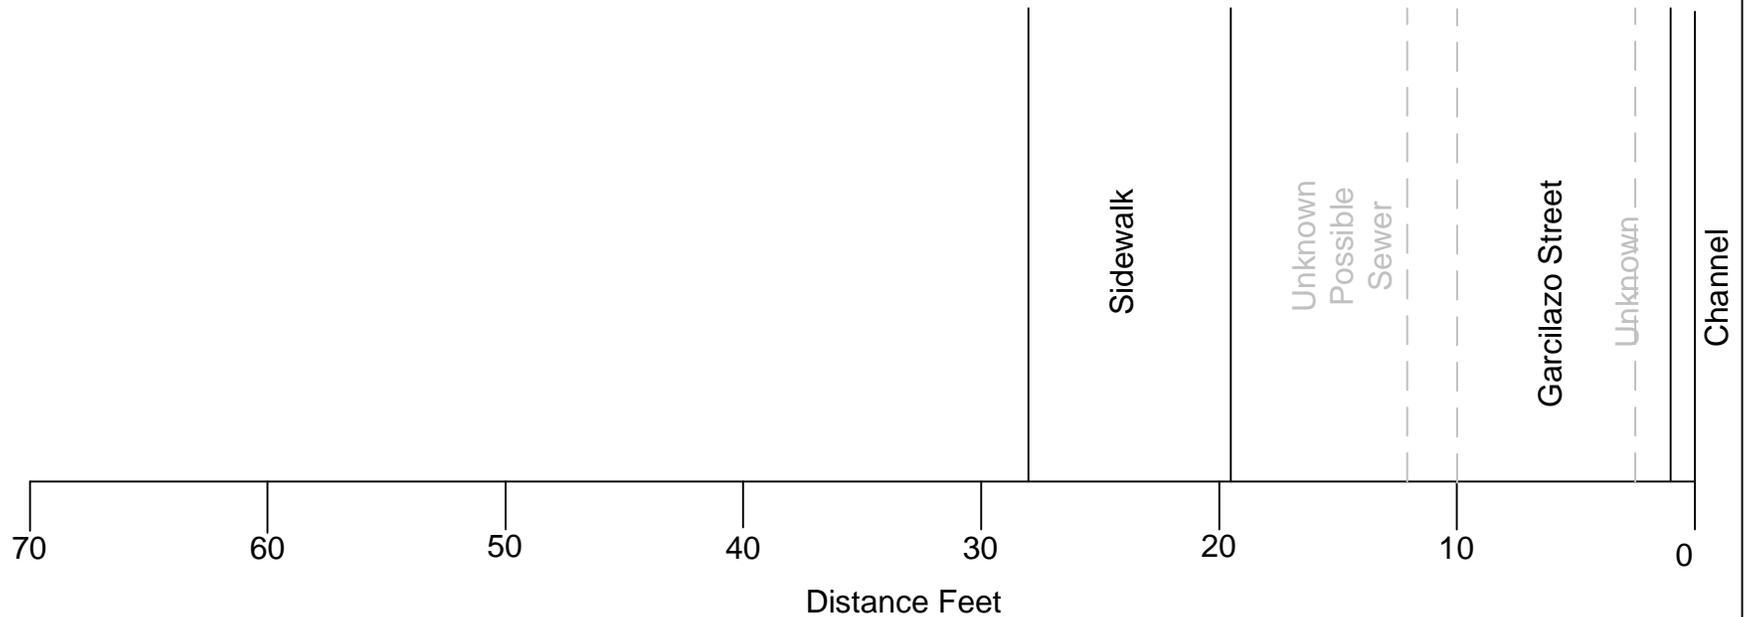
Location 5: Garcilazo and Riviera St. Crossing San Fernando, thru Channel
 Subsurface Utility Survey, Tranvía Carolina
 Puerto Rico
 Figure 15

At Location 5: **Garcilaso and Riviera St. Crossing San Fernando**, west of the Channel (Figure 15) the following utilities were found:

1. At three feet west of the channel, two feet deep, an unknown line.
2. At ten feet from the channel, three feet deep, one unknown line.
3. At twelve feet from the channel, three feet deep, one unknown line.

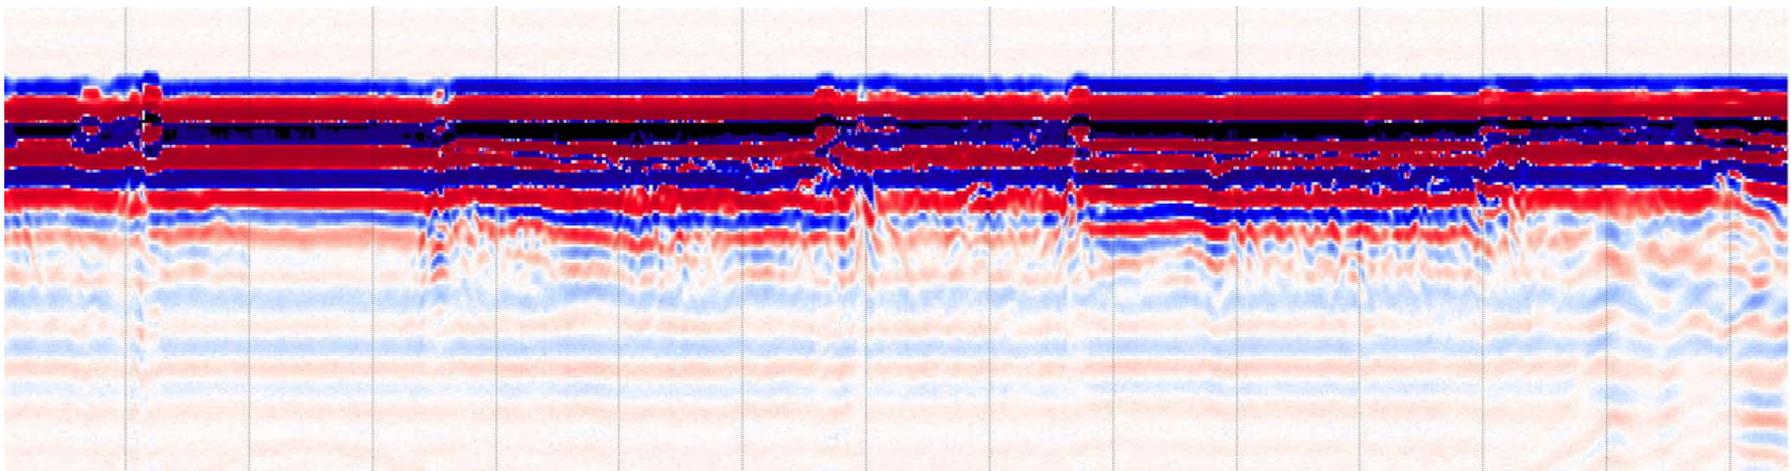
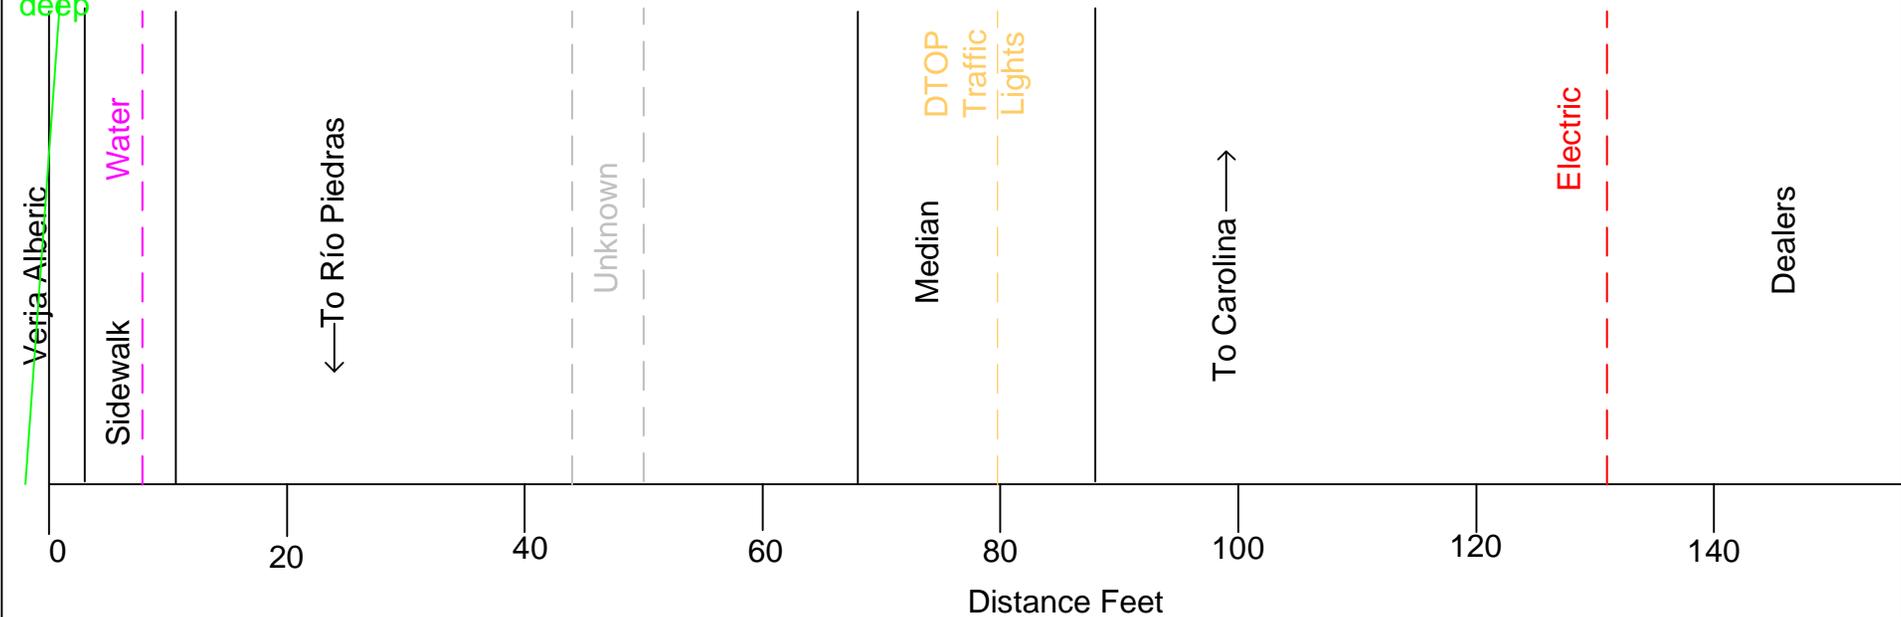
Location 6: PR-3 and De Diego Ave.
Subsurface Utility Survey, Tranvía Carolina
Puerto Rico
Figure 16

At Location 6: **PR-3 and De Diego Ave. (Figure 16)**, the following utilities were found:

1. About two feet before where our cross-section line starts (adjacent to Alberic Ford) there is a Sewer line more than seven feet deep.
2. At five feet from the beginning of the northern side walk, one foot deep, a potable water pipe.
3. At forty-five feet from the Alberic fence, two feet deep, one unknown pipe.
4. At fifty feet from the Alberic fence, two feet deep, one unknown pipe.
5. At the center of the median, at one foot deep, the line that controls the traffic lights.
6. Three feet from the southern road border, two feet deep, an electric line.

Sewer
more
than 7'
deep

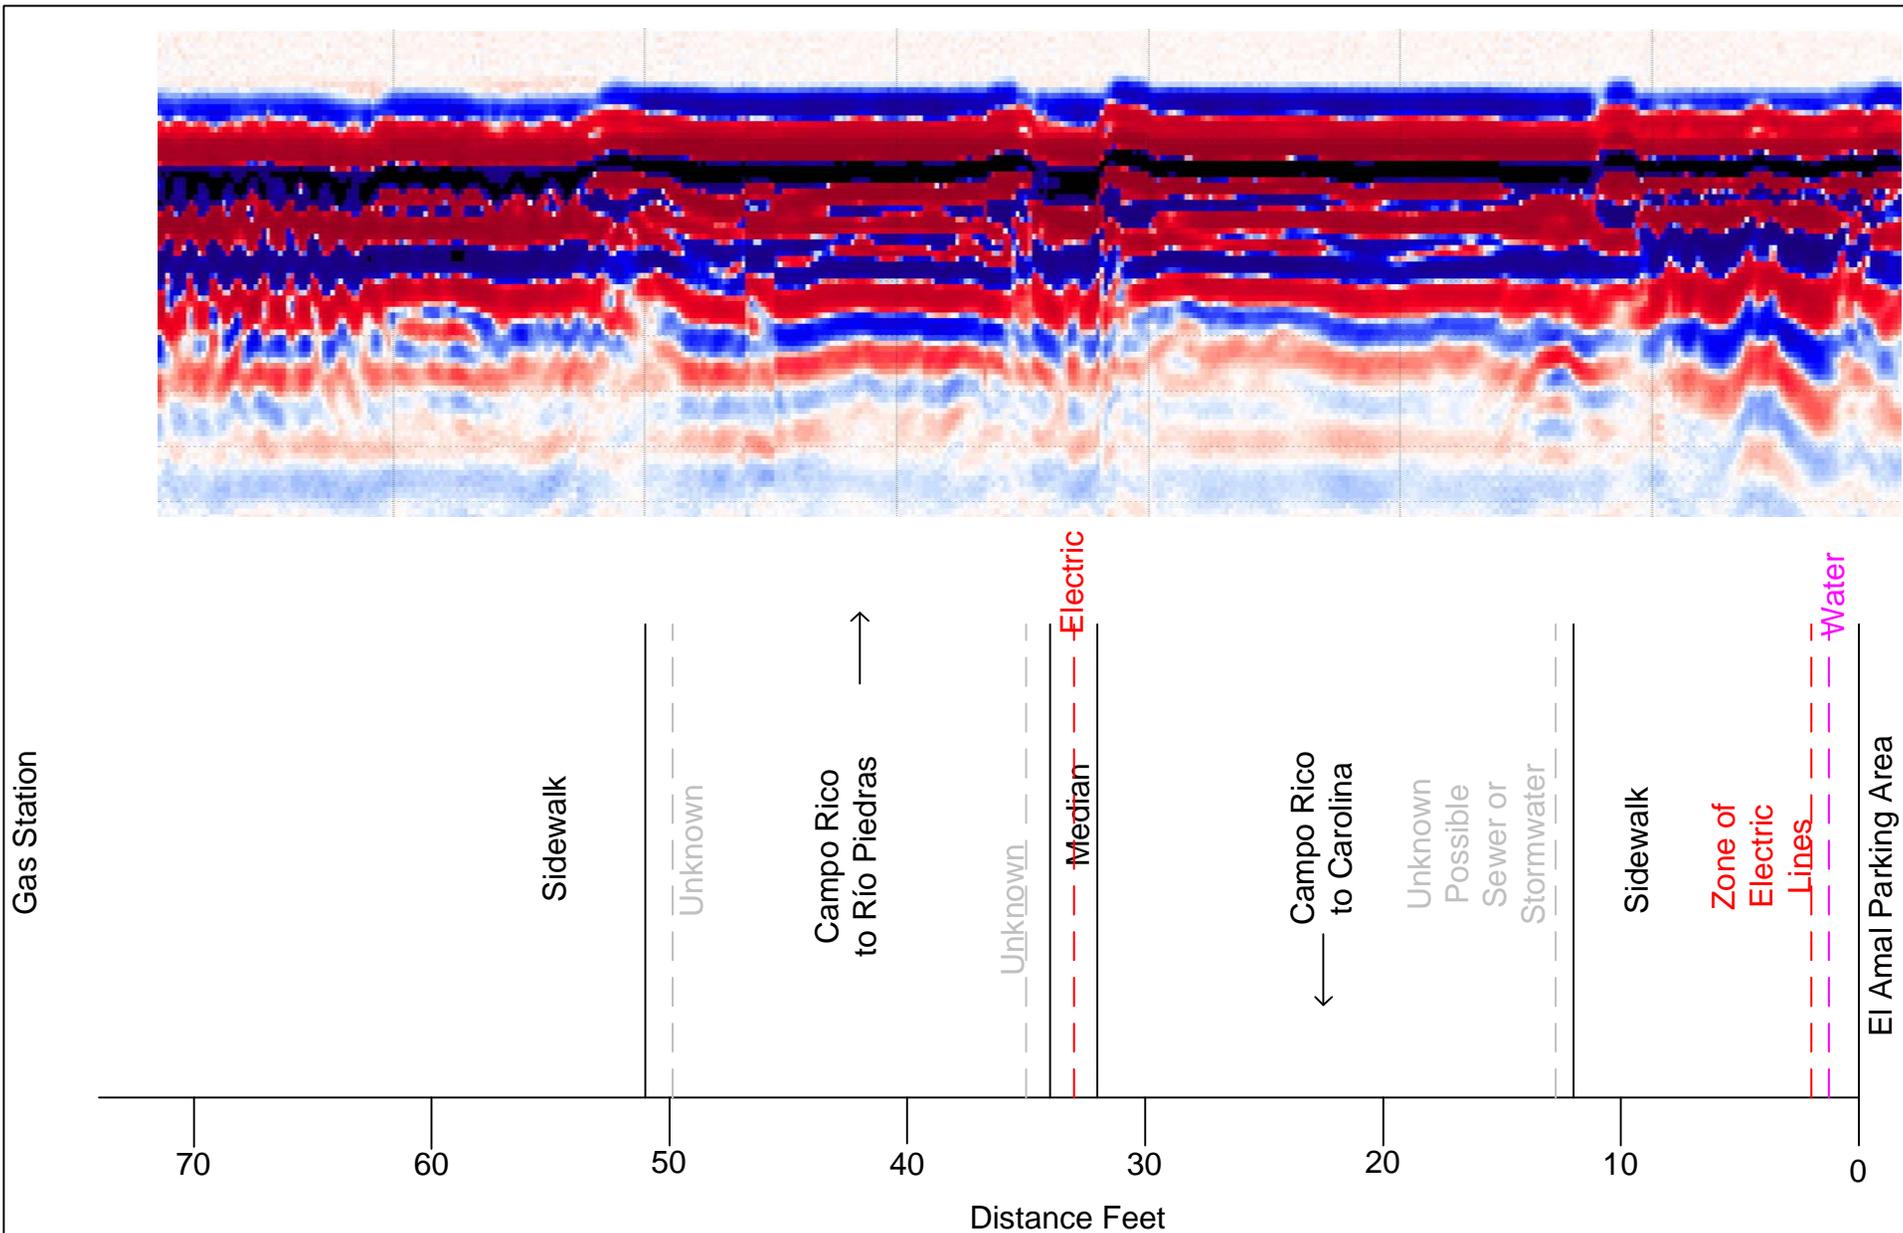
Location 7: Campo Rico Ave. and B St.
 Subsurface Utility Survey, Tranvía Carolina
 Puerto Rico
 Figure 17

At Location 7: Campo Rico Ave. and B ST. (Figure 17), the following utilities were found:

1. One foot from the El Amal parking lot, one foot deep, various pipes including electricity and potable water.
2. One foot from the sidewalk curb, one foot deep an unknown pipe probably sewer or storm water.
3. At the center of the median, at a foot deep, an electric line.
4. One foot before the south sidewalk, two feet deep, an unknown pipe, probably sewer or storm water.
5. There is a 24 inch diameter pipe that crosses the bridge at its south side (adjacent to the gas station) with a 90 degree bend that apparently turns to the south, did not show in the GPR nor the PL.

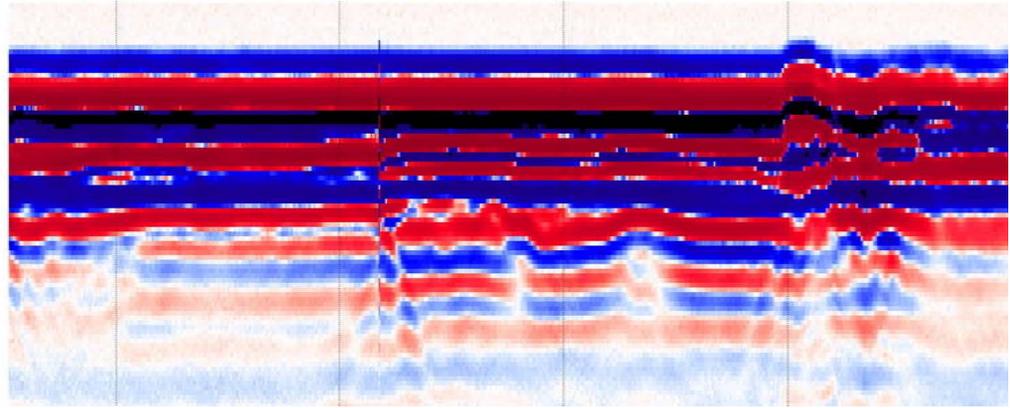
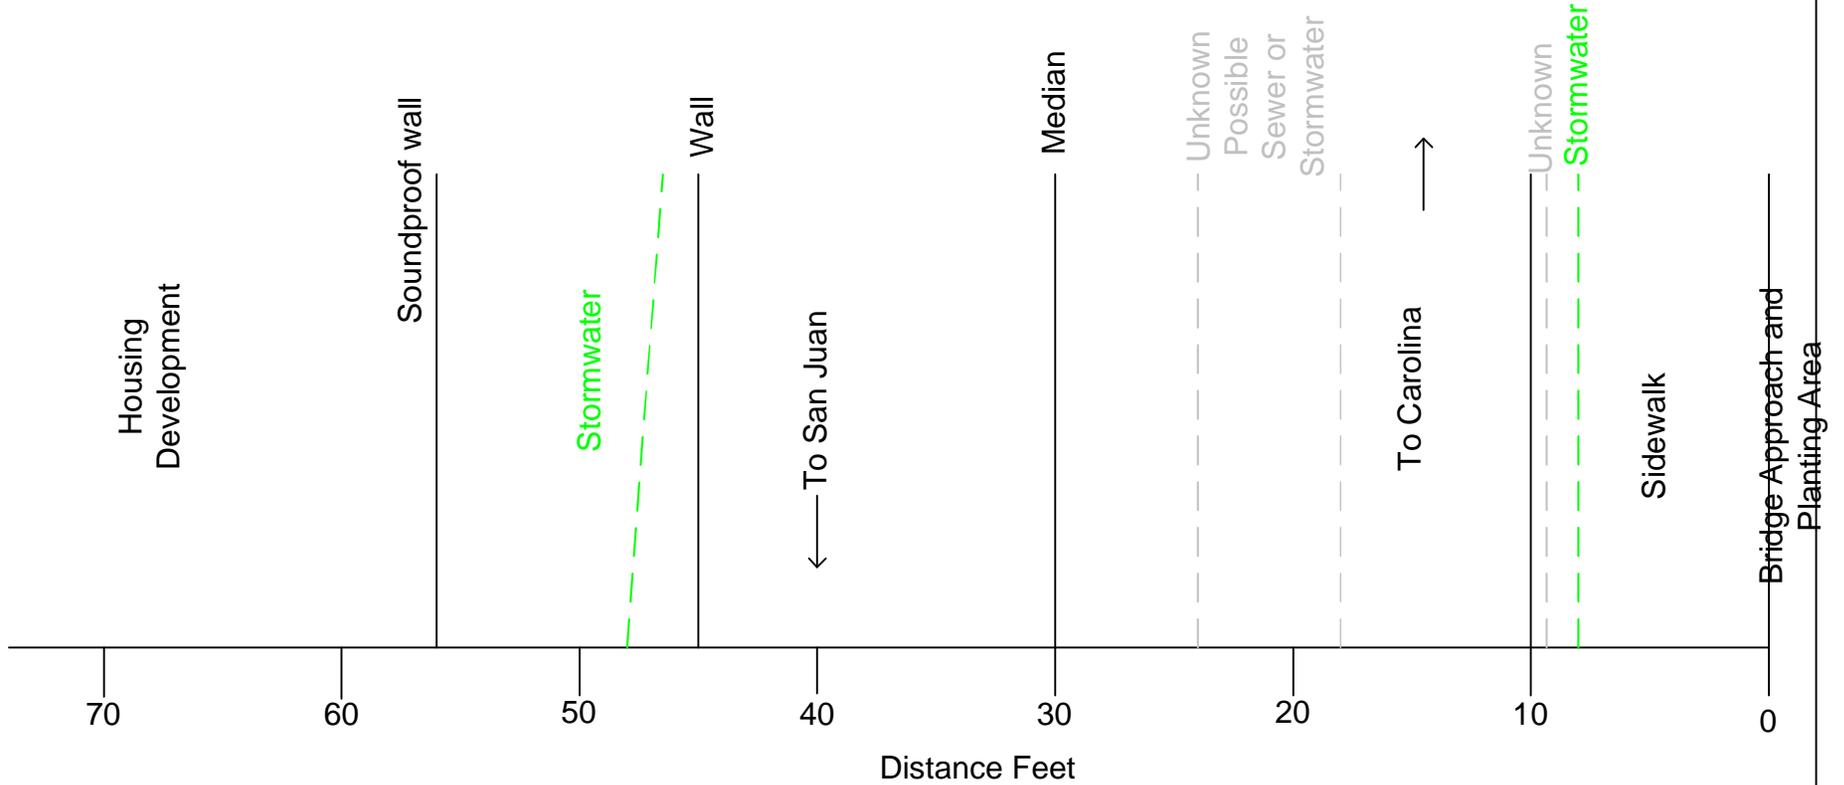
Location 8: PR-26 and Fragoso Ave.
 Subsurface Utility Survey, Tranvía Carolina
 Puerto Rico
 Figure 18

At Location 8: PR-26 and Fragoso Ave. (Figure 18), the following utilities were found:

1. Eight feet from where the eastern sidewalk, two feet deep, a storm water pipe.
2. One foot before the eastern road border, one foot deep, an unknown pipe.
3. Eight feet from where the eastern road border, two feet deep, possible sewer or storm water pipe.
4. Eight feet after the retaining wall, two feet deep, a storm water pipe.

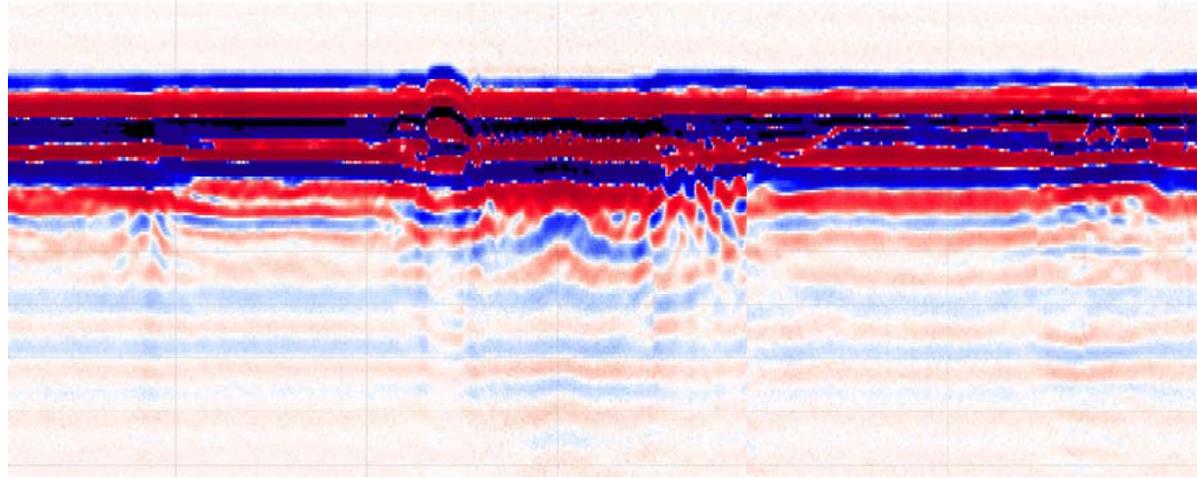
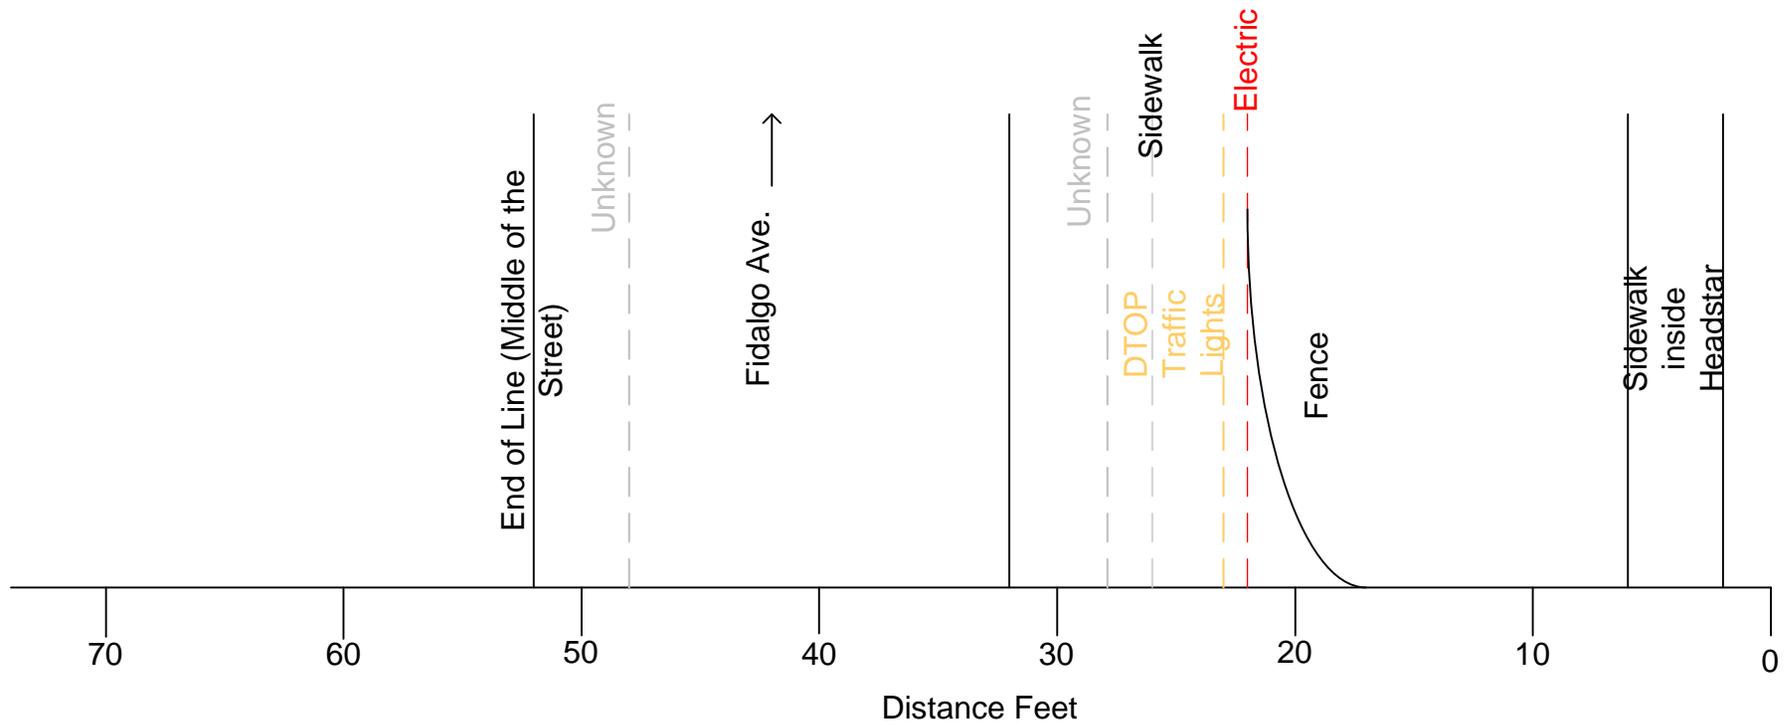
Location 9: Monserrate and Fidalgo Ave.
 Subsurface Utility Survey, Tranvía Carolina
 Puerto Rico
 Figure 19

At Location 9: Monserrate and Fidalgo Ave. (Figure 19), the following utilities were found:

1. Three feet from the fence, two feet deep, an electric line.
2. Four feet from the fence, one foot deep, traffic light control lines.
3. Eight feet from the fence, two feet deep, an unknown pipe.
4. Ten feet from the fence, three feet deep, an unknown pipe.
5. Seventeen feet from the curb, two feet deep, an unknown pipe.
