June 8, 2007

RE: Preliminary Subsurface Utility Engineering Study for the Proposed Carolina Tranvía Stations, Carolina, Puerto Rico

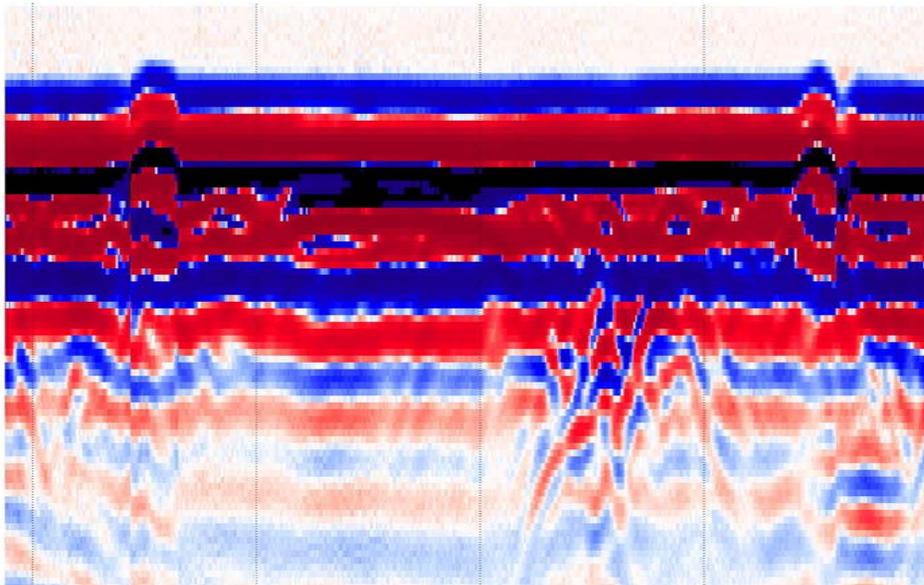
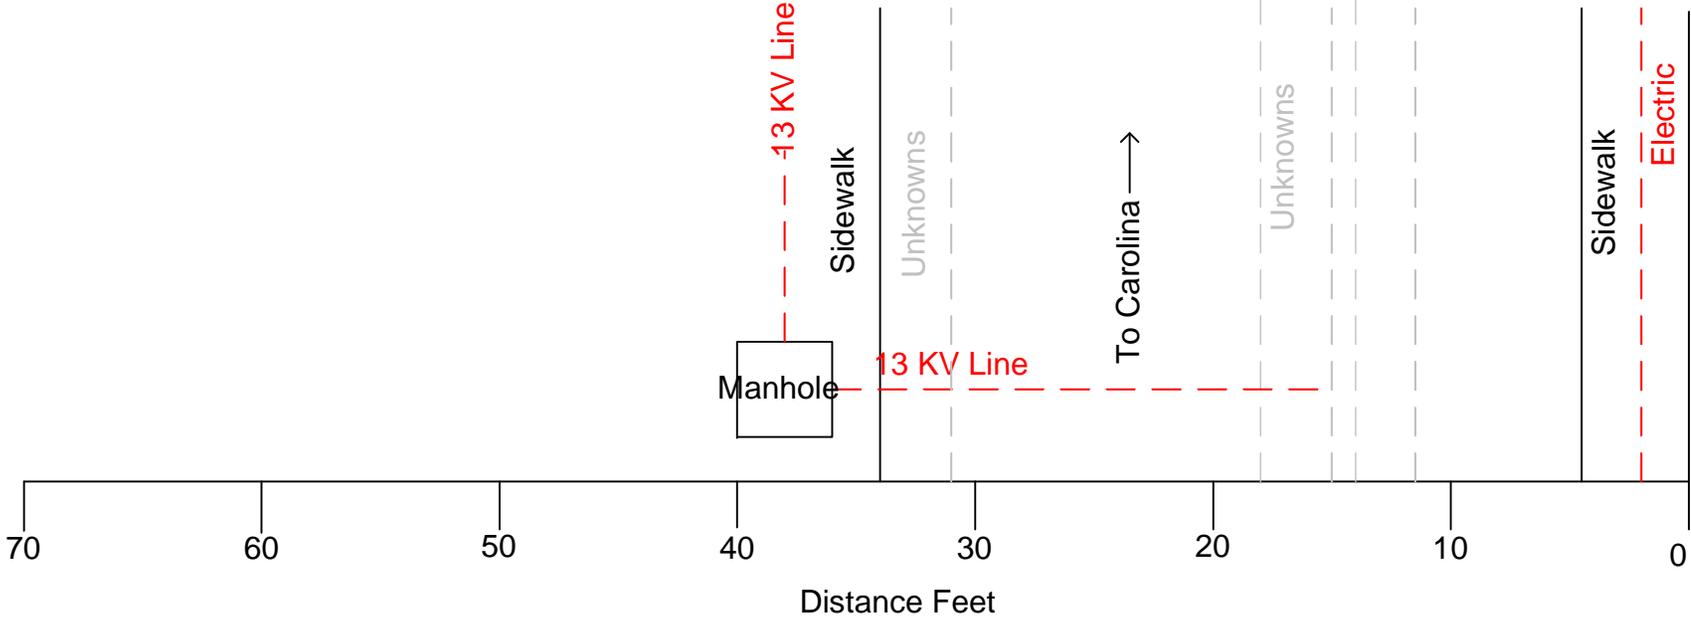
Location 10: Ignazio Arzuaga and Antonio Jimenez Landrau St.
 Subsurface Utility Survey, Tranvía Carolina
 Puerto Rico
 Figure 20

At Location 10: Ignazio Arzuaga and Antonio Jimenez Landrau St. (Figure 20), the following utilities were found:

1. One foot inside the southern sidewalk, three feet deep, an electric line that powers light poles.
2. Eight feet from the curb, three feet deep, an unknown pipe.
3. Ten feet from the curb, three feet deep, two unknown pipes.
4. Fourteen feet from the curb, three feet deep, an unknown pipe.
5. Two feet before the north sidewalk, an unknown pipe.
6. Four feet after the north sidewalk curb, seven feet deep, a thirteen KV, electric line.
7. The electric line comes from the electric manhole perpendicular to the road, and seems to merge with item number three (see above).
