Results of Geologic Mapping and Reconnaissance at Flamenco, Culebra Island, P.R.
June 4, 2012

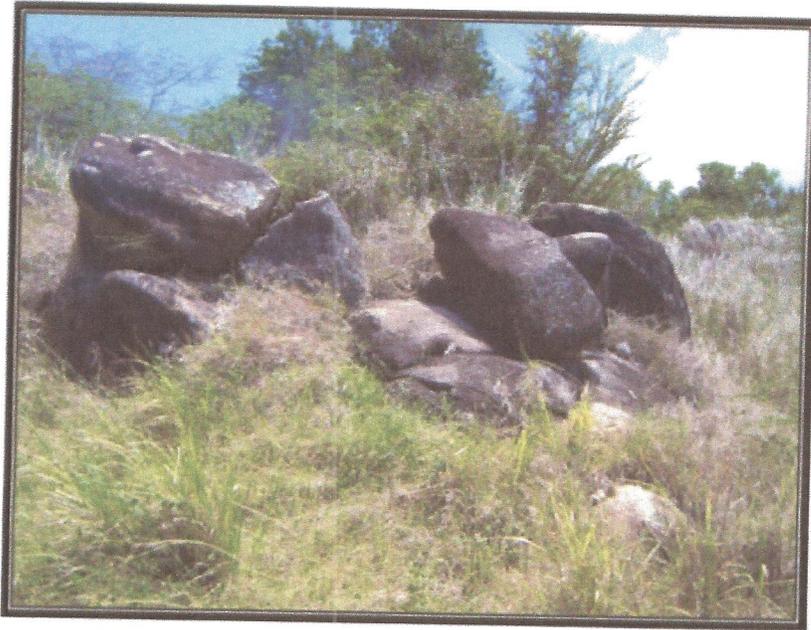
FIGURE 6. Loose diorite boulders are common throughout the site.

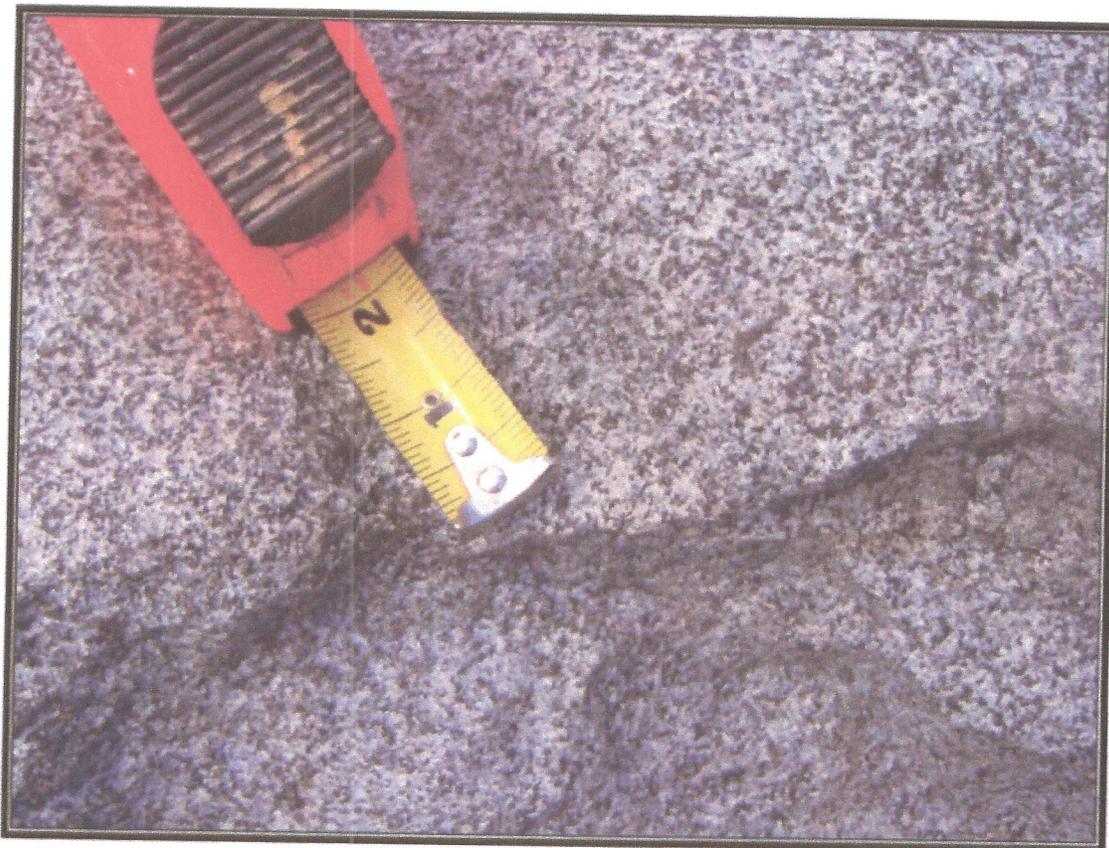
FIGURE 7. Picture showing composition of diorite.

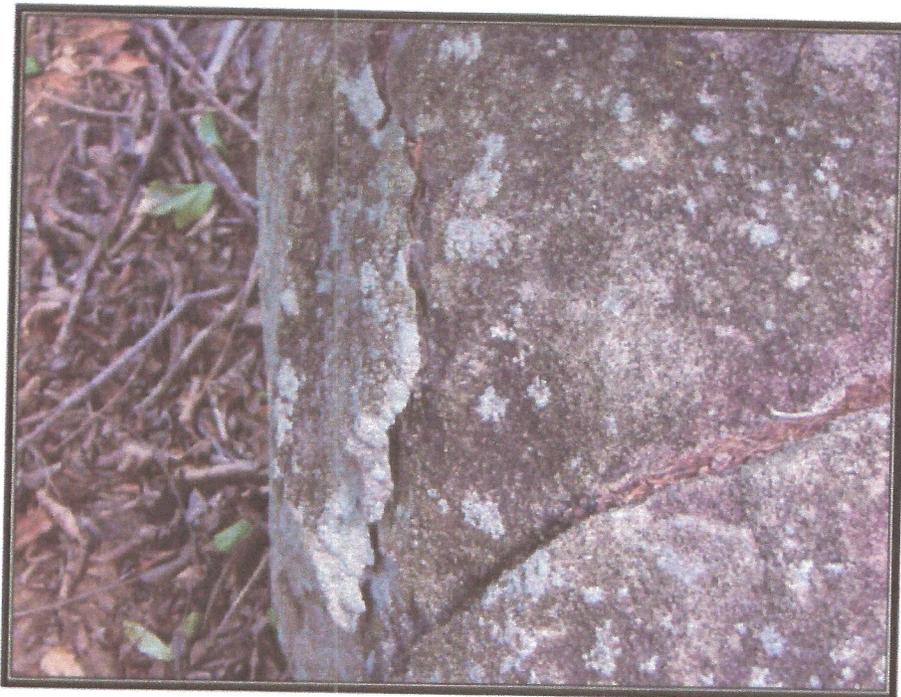
FIGURE 8. Spheroidal weathering

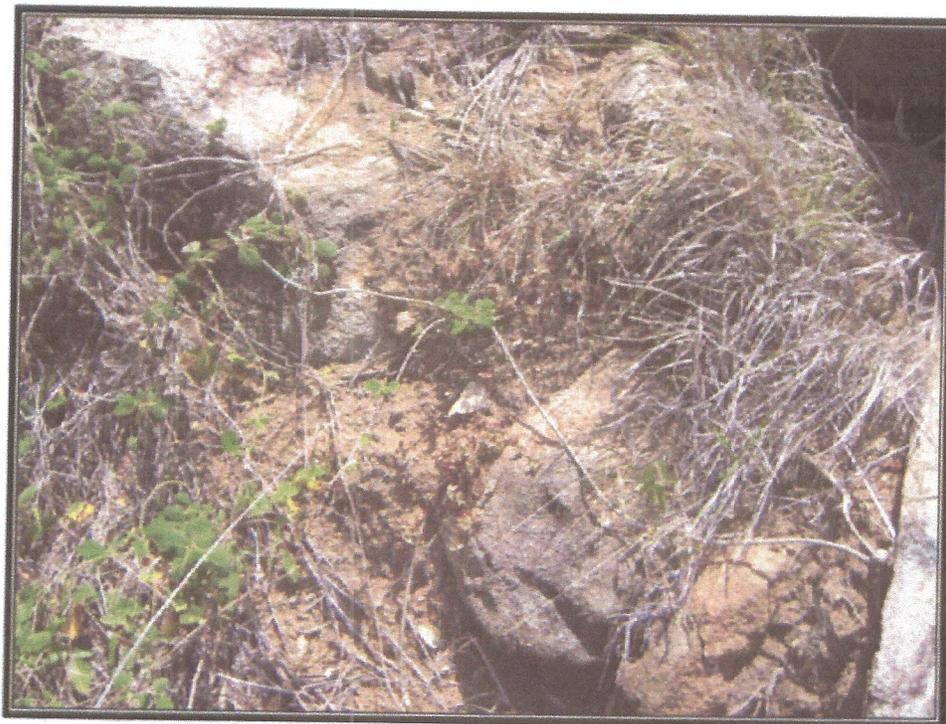
FIGURE 9. Weathered rock with resulting residual soils.

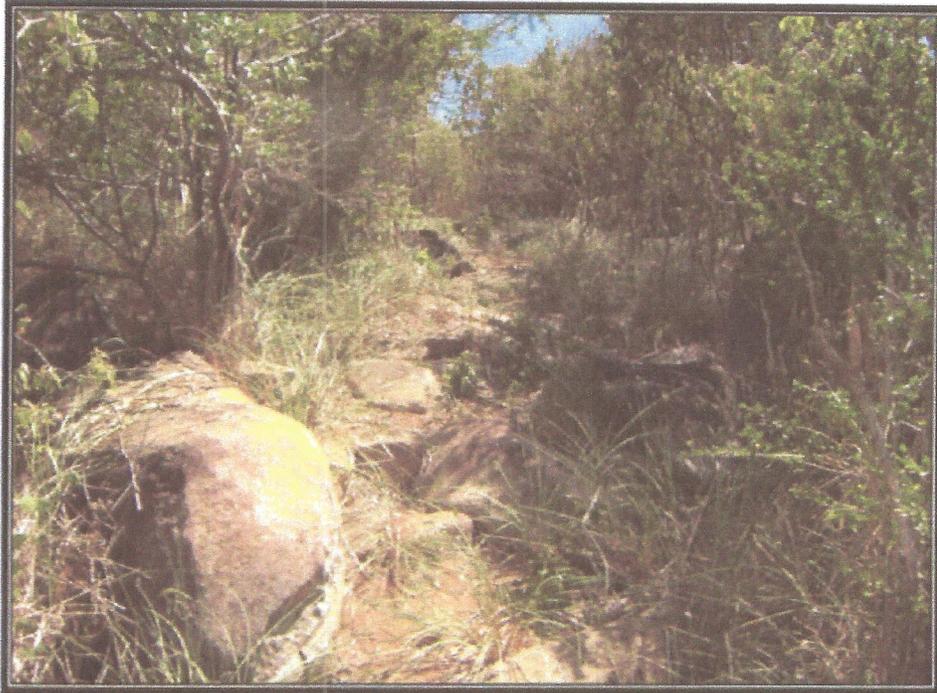
FIGURE 10. Colluvium deposits on the eastern side of the hill.

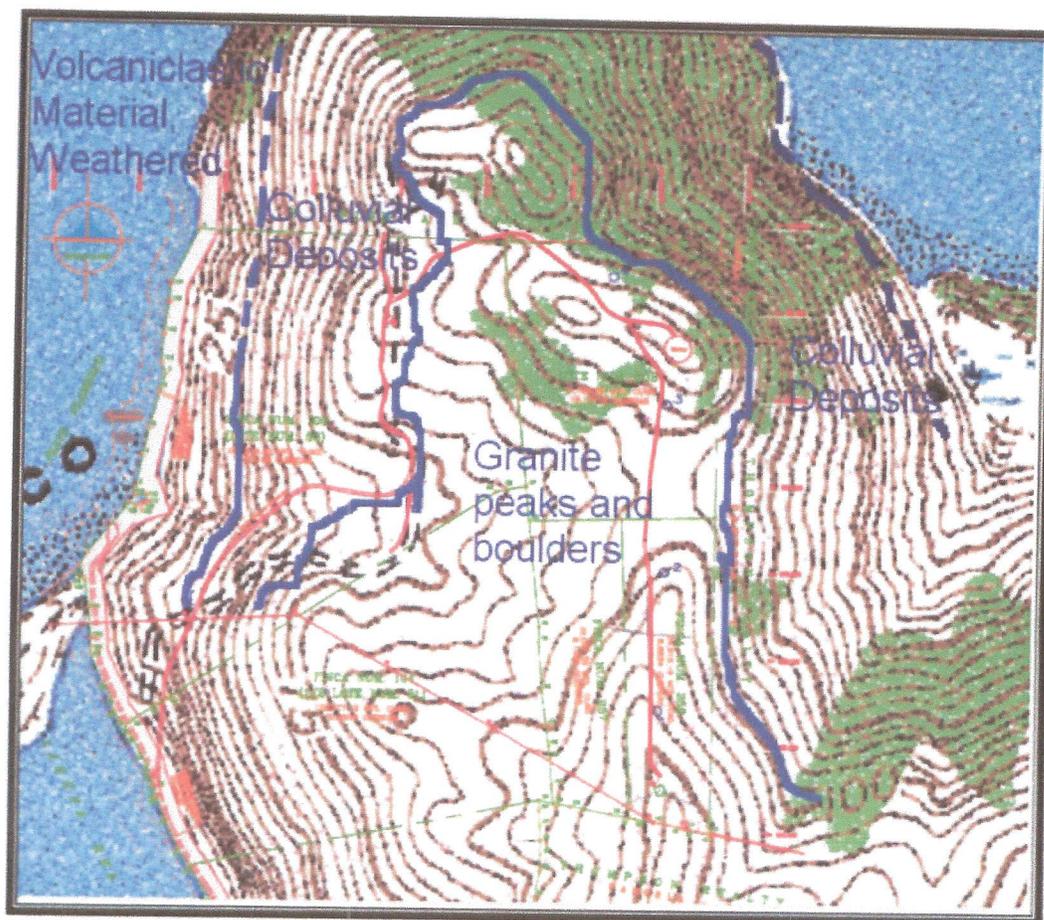
FIGURE 11. General geologic map of the site.
