**RIO VALENCIANO DAM PROJECT: SITE
GEOLOGY AND GEOLOGIC STRUCTURE ANALYSIS
-DR. JAMES JOYCE-**

Rio Valenciano Dam Project Site Geology and Geologic Structure Analysis

Prepared for the CSA Group
on behalf of
The Puerto Rico Aqueduct and Sewer Authority

Prepared by James Joyce PhD, PG
Professor of Geology - Department of Geology
Mayagüez Campus - University of Puerto Rico

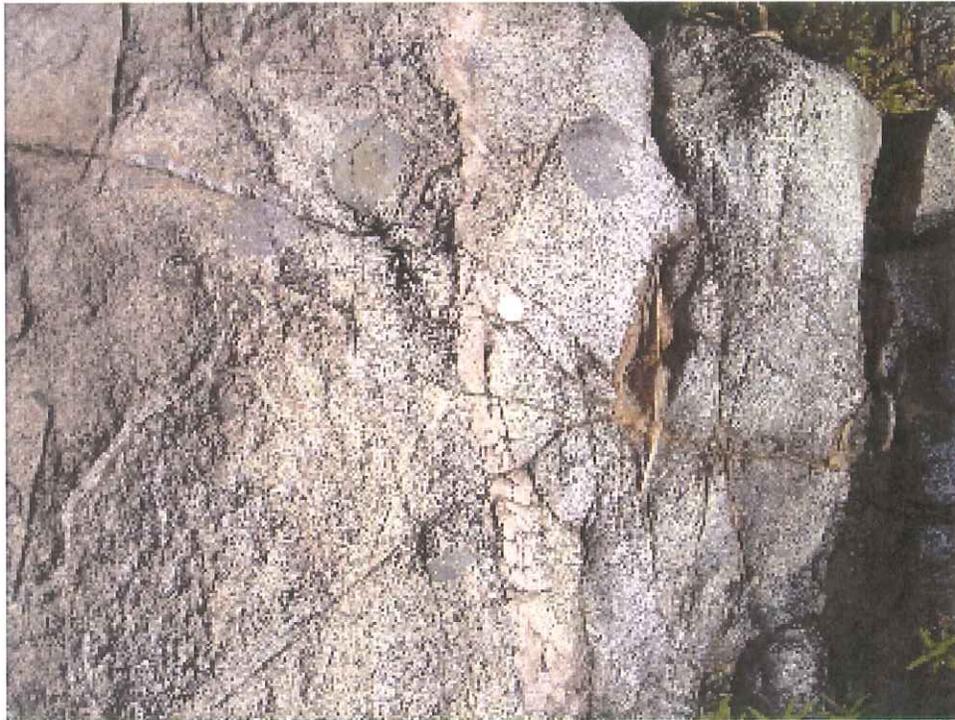
The site lies in the north central portion of the San Lorenzo Batholith. Previous studies have established that the batholith is mainly composed of granodiorite that was mostly emplaced about 70-80 million years ago (M'Gonigle, 1978, Cox et al, 1977). Field exposures in the site area and cores drilled along the dam centerline were all composed of granodiorite. The exposed granodiorite rocks are composed of 30-60% white feldspar (mainly plagioclase), 20-50% clear quartz, 20-30% black hornblende and 0-5% pink feldspar (orthoclase). Metamorphosed mafic xenoliths are common in larger exposures and were identified in the Black and Veatch cores. The xenoliths range in size considerably but are usually between 5-20 cm in diameter. Some of the xenoliths have been epidotized where the granodiorite is cut by epidote veins (Photo 1). A few thin, pink feldspar rich aplite dikes were also observed in the exposures with concentrated epidote veins (Photo 1). The granodiorite is also cut by both orthogonal and conjugate joint sets.

Photo 1 Granodiorite with xenoliths and cross cutting aplite dike and joints.

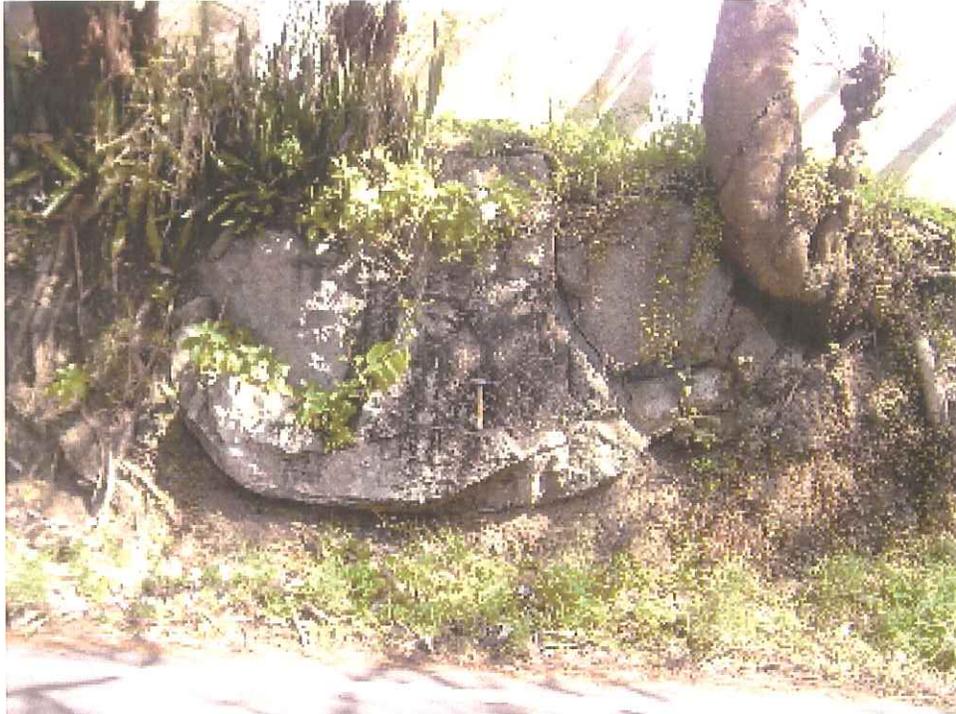
The infiltration of water along the joints has promoted deep chemical, granular weathering and the production residual grus and saprolitic sand soil. Preferential water infiltration along the dominant orthogonal joints has resulted in spheroidal weathering and the production of corestones boulders that characterize the hillside exposures of the granodiorite (Photo 2). Because of the high percentage of quartz in the rock the residual soils are extremely high in sand content. The sand soils are highly erodable and this results in the river being overcharged with sand (Photo 3). The extremely high sand bed

Photo 2 Spheroidal weathering: corestone surrounded by grus and sand residuum.

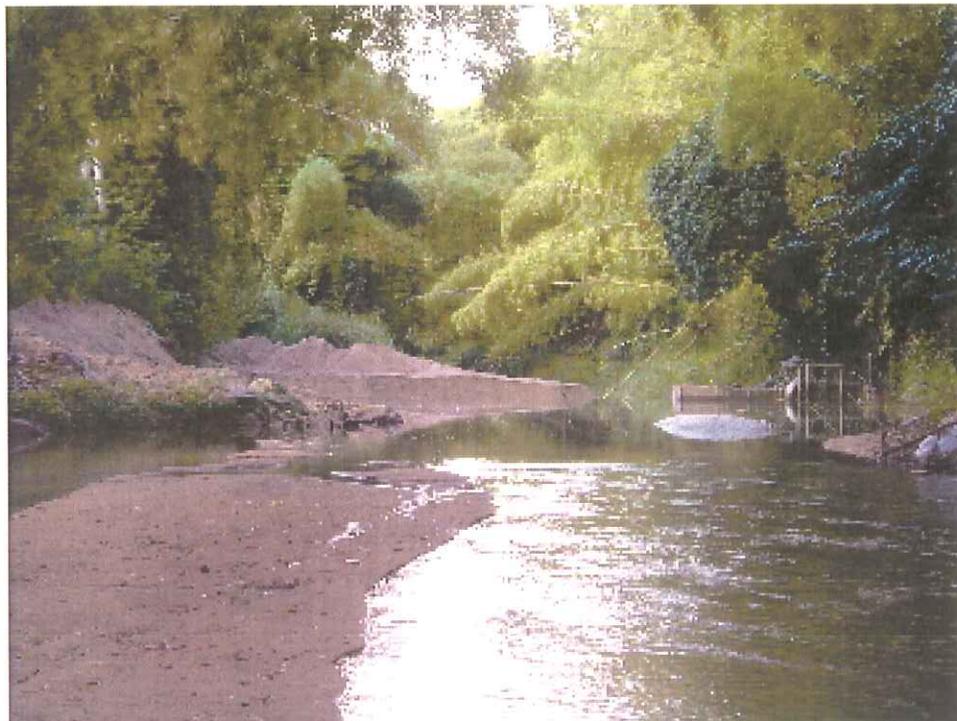
load of river poses a significant problem to maintaining the reservoir capacity of the dam. At present the periodic extraction of the bed load sand from the river channel is required

Photo 3 Bed load sand trapped behind the small holding dam below the dam site.

to maintain the capacity of the small holding dam at the intake plant downstream of the proposed dam site. A mitigation plan for this sedimentation problem must be considered.

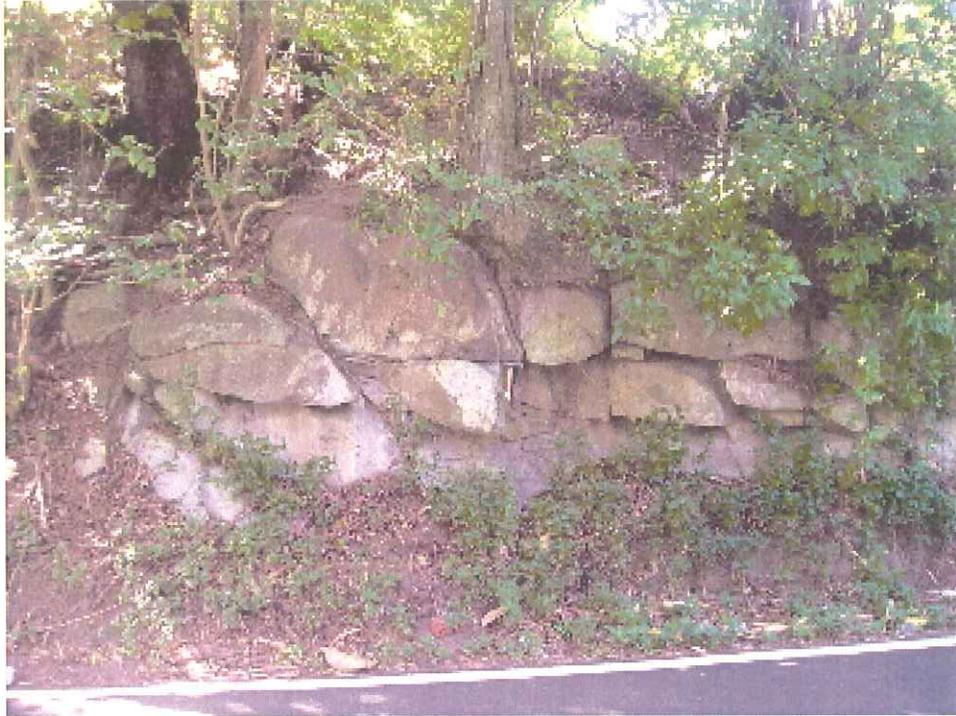
The sub-horizontal joint set 3 differs markedly in character from the vertical sets. The sub-horizontal set tends to be semi-continuous on the order of 5-15 meters or greater, wavy to anastomotic with slightly rough to irregular surfaces (Photos 4-5-6). The sub-

Photo 4 Sub-horizontal sheeting and orthogonal joints in PR 919 road cut at site #4.

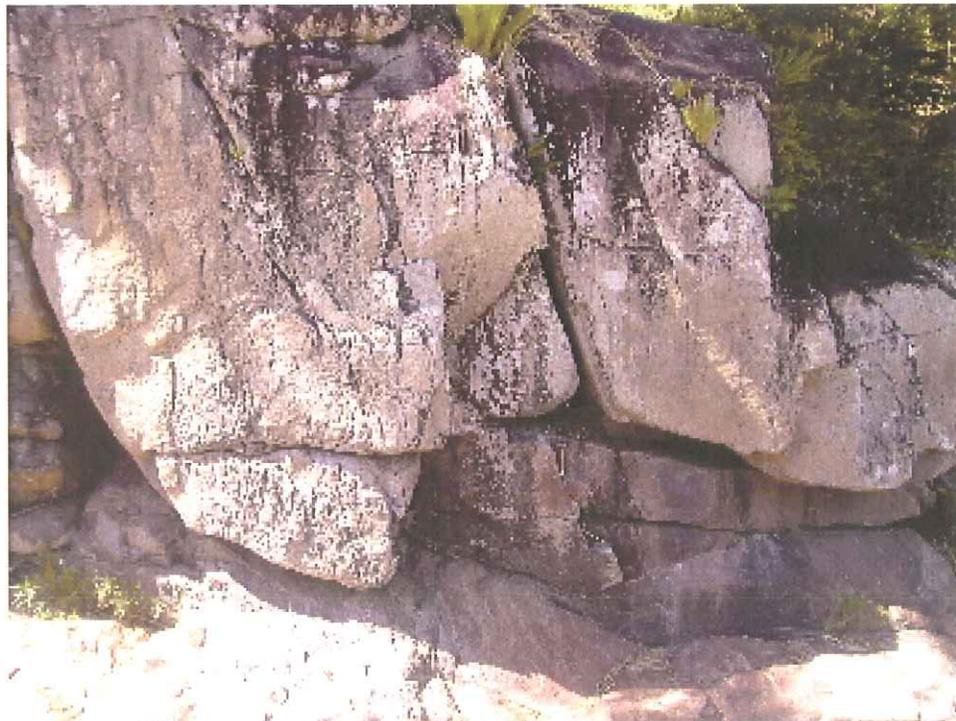
Photo 5 Sub-horizontal and steeply inclined joints on the riverbank at site #10.

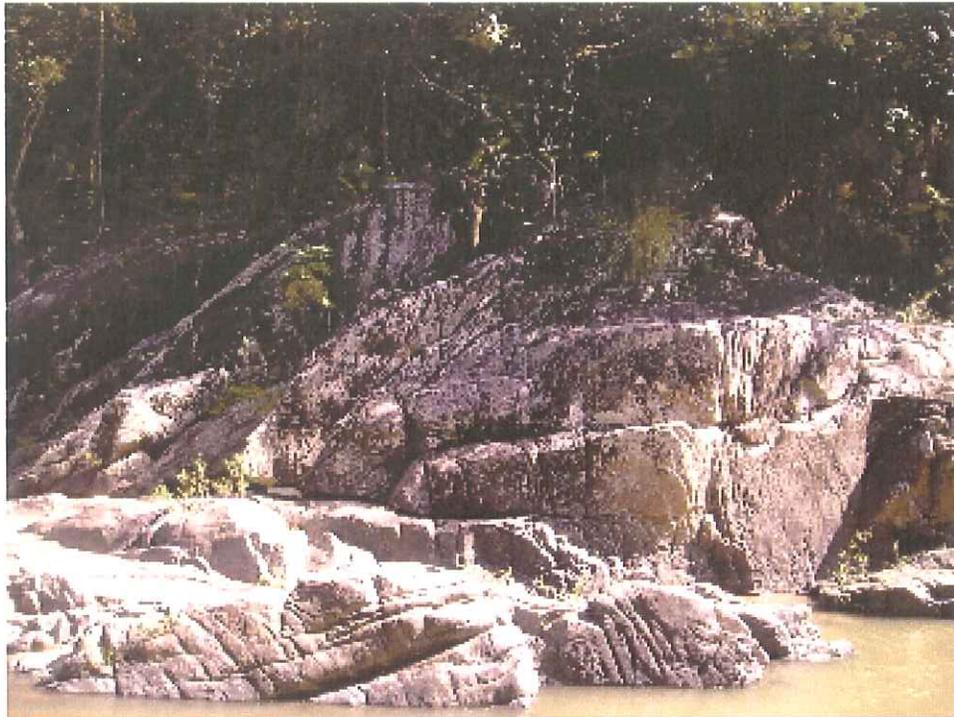
Photo 6 Sub-horizontal and inclined joints on adjacent river bank at site #10.

horizontal joints are open wide to very wide (2-5 cm) and sometimes filled with clayey soil or sandy residuum. Spacing of the semi-continuous joints is 1-10 meters. Intervals between the semi-continuous joints are characterized by discontinuous joints with spacing from 2cm to 1.0 m. The occurrence and continuity of the sub-horizontal joint sets at the dam site is of particular importance. The Black and Veatch cores along the dam centerline were analyzed to that affect. Semi-continuous sub-horizontal joints and corestone boundaries were recognized in the cores as no recovery zones that were underlain by weathered rock. Sub-horizontal joints were also recognized from the core descriptions with angles between 0-20°. Core borings BV-1 and BV-8 are about 200 meters apart and at the same elevation 102 meters on opposite ends of the dam centerline. Both borings encountered corestone boundaries at elevations of 98 – 94 – 93 – 91-2 meters. BV-8 probably encountered another boundary or sub-horizontal joint at elevation 86.3-85.8 meters. Boring BV-7 was located on the west side of the centerline at an elevation of 90.2 meters. Corestone boundaries – sub-horizontal joints were encountered at elevations of 85.5 – 84.6 – 83.2. Sub-horizontal joints were noted in the core at elevations of 77.1 and 76.1. Unfortunately no core descriptions that cover the same intermediate elevation interval as BV-7 were provided for the east side of the centerline on the opposite side of the river. Therefore continuity of the joints across the river channel at these elevations cannot be assessed.

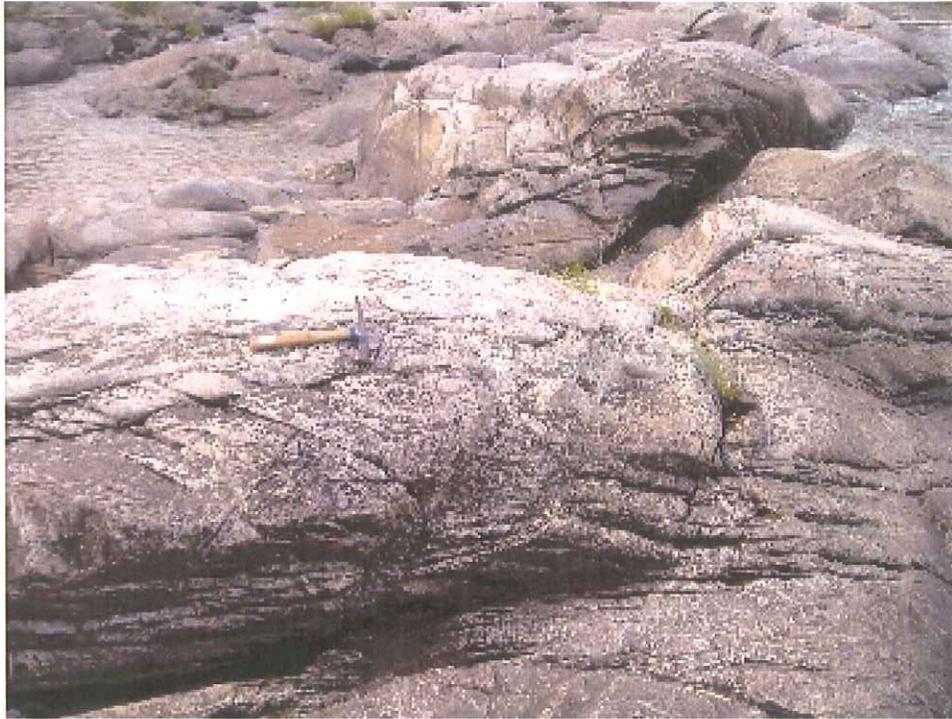
Rock exposures in and along the river channel were inspected for evidence of bedrock faults. Special attention was paid to two stretches of the river where rock was extensively exposed within the channel. The river flows WSW over rock along a 370 meter stretch between two right angle bends about 2 km downstream and southeast of the site (Figure 7, #7-8-9). The bend in the river marks the change in the river course from NW to NNW. If the fault from the Rio Humacao extends northwestward along the Rio Valenciano it should cut across the rock exposures in the WSW flowing stretch (Figure 2b). The locations of the joint measurements in this stretch are shown in Figure 7 along with stereographs numbered 7-8-9. NNW trending steeply inclined joints define a dominant cross channel joint set at the eastern end of the stretch (Figure 7, #7). No evidence of shear was seen on the joint faces nor were there fracture zones developed. Numerous joints cut across xenoliths but no displacements were observed. A well developed fracture zone was observed at the western end of the stretch (Figure 7, #9). The fracture zone was defined by closely spaced N trending steeply inclined joints (Photo 7). Spacing between the joints range between 2-10 cm up to 25 cm within a 3-4 meter

thick zone. The dihedral angles between conjugate fractures formed in the fracture zone suggest E-W extension and N-S compression. The only slip striations observed were on a perpendicular northward inclined epidote vein-joint. The slip striations were parallel to the dip but too degraded to determine sense of motion (Figure 7, #9). A small exposure of intensely fractured rock was observed in the river channel just downstream of the western bend (Figure 7, #9). The exposure was characterized by bluish veins that contain pyrophyllite. Overall no evidence was found to indicate that this stretch of the river is traversed by either NW or NNW trending faults, shear zones or mylonite zones.

Photo 7 N-S trending fracture zone with conjugate joints at western river bend site 9

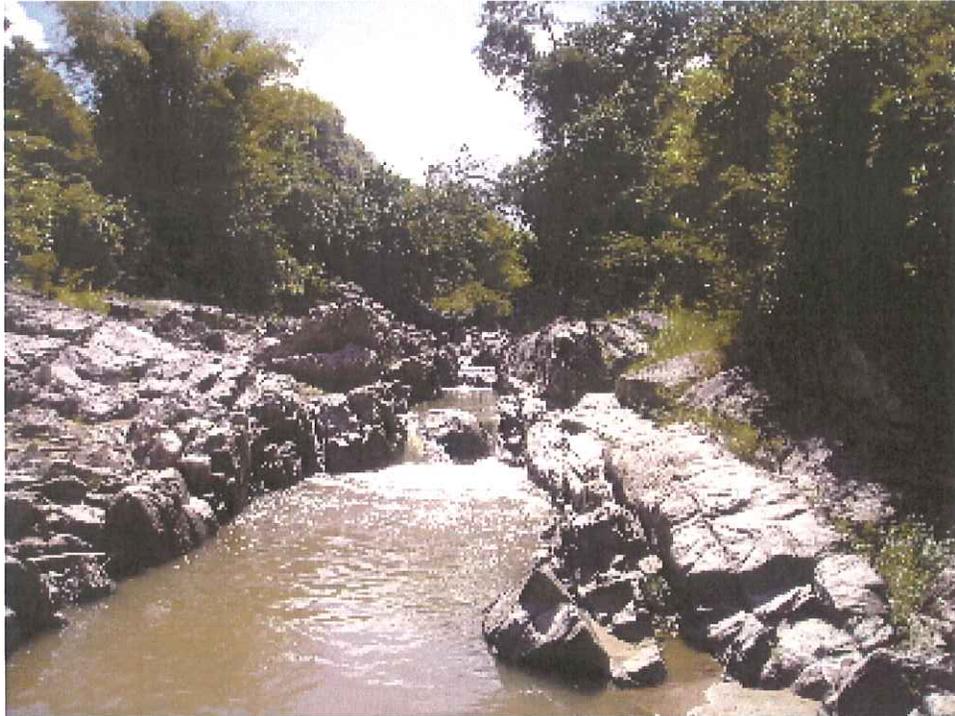
Photo 8 Rio Valenciano flowing along and within north trending continuous joints.

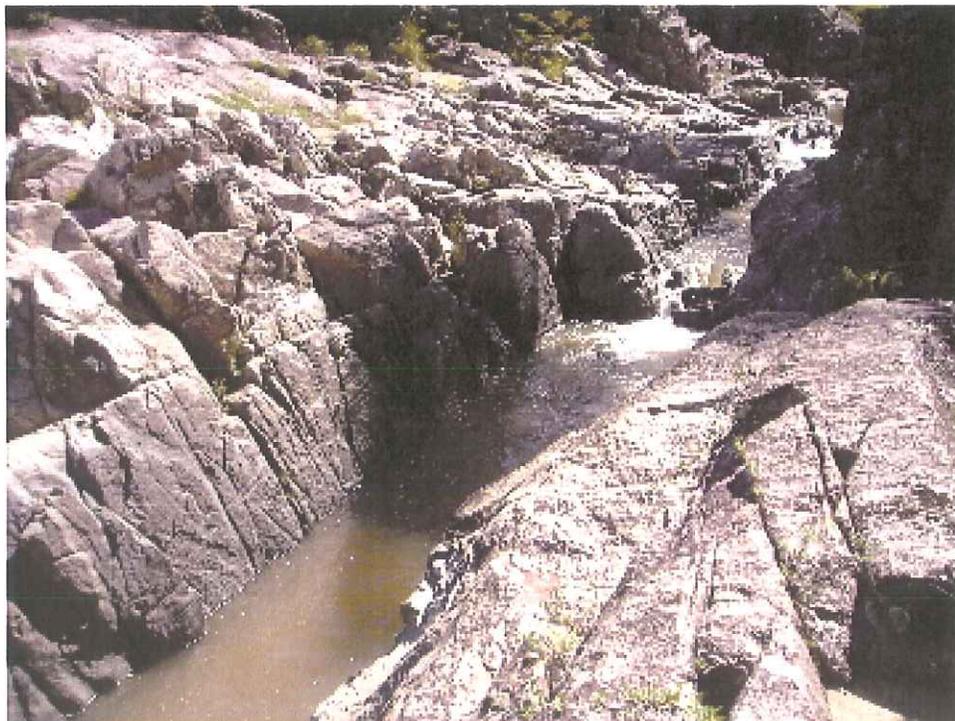
Photo 9 Rio Valenciano flowing along and within north trending continuous joints

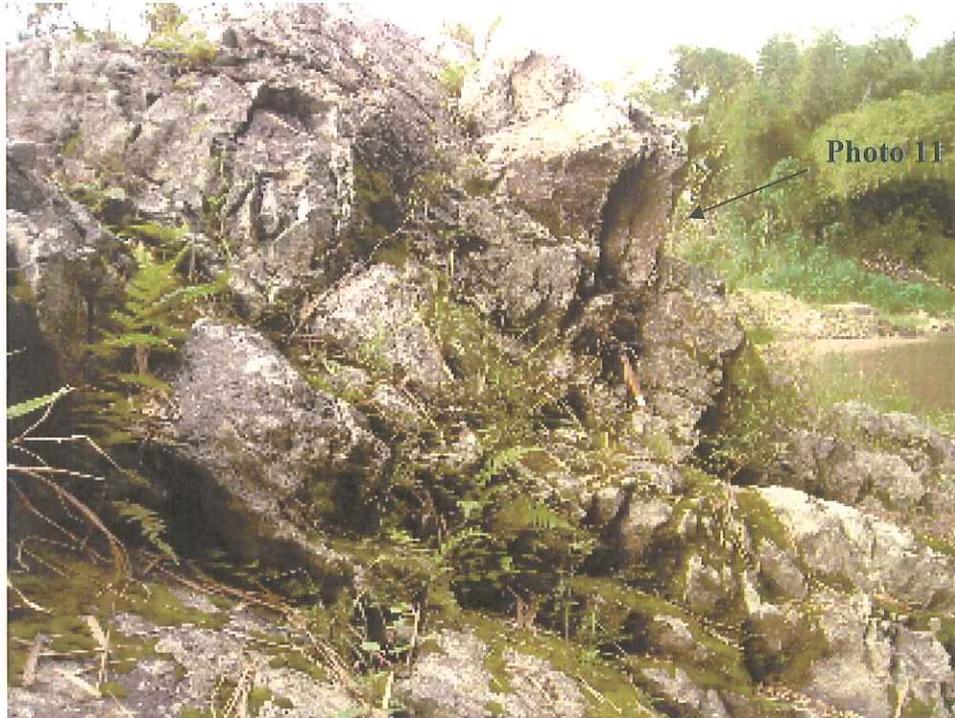
About 500 meters downstream from the dam site the river abruptly changes course towards the north and is joined by Quebrada la Santa from the west (Figure 7). A few small exposures of highly fractured rock occur along the west side of the channel (Photo 10) and in recent excavations at the mouth of the quebrada. The highly fractured

Photo 10 Fracture shear zone 500 meters downstream form the dam site.

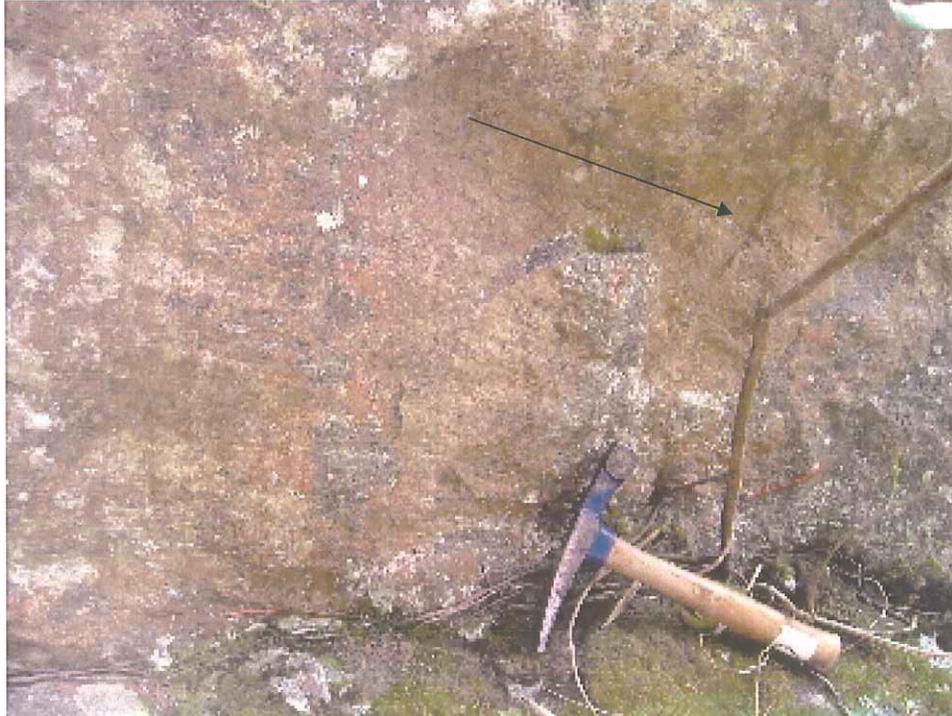
joints. An exposed NNW trending joint face shows slickenside striations in epidote and iron oxide with a rake of 25° (Figure 7, #11 Photo 11). Releasing steps in the slickenside surface suggests an oblique right lateral displacement along the fault with a small normal

Photo 11 Slickensides on NNW trending shear plane arrow shows slip direction.

component. That is, the west side of the fault is moving to the north-northwest and down whereas the east side of the fault is moving to the south-southeast and up. The measured strike of the shear plane and parallel joint set is exactly parallel and aligned with the river channel (Figure 7). It is likely that these exposures are then representative of the structural conditions of the rock below the river channel at the dam site. Extending this fracture-shear zone parallel to the strike of the shear plane places it along a NNW trending stretch of the Quebrada la Santa, the quebrada that flows into the river just north of the fracture-shear zone exposures Figure 7. Although the main channel of the quebrada bends off to the west at the end of this stretch, an extensive and topographically pronounced NNW trending drainage gully confluent the quebrada at that point (Figure 7). A relatively flat exposure of intensely fractured and sheared rock occurs on the inside of the bend at the confluence point (Photo 12). Notably, the east side of the channel at the bend is confined by a vertical NNW trending joint face in massive granodiorite. The fracture-shear zone is dominated by continuous a NNE trending joint-fracture set with a more closely spaced discontinuous NE trending fracture within the NNE joint intervals (Photo 12). The NE discontinuous joints tend to curve counterclockwise into the continuous NNE joints at their terminations. Intersection of the two fractures produces rhomboid to elliptical rock phacoids. The counter clockwise rotation and orientation of the phacoids are compatible with NNE left lateral shear (Photo 12). Despite being aligned with the right lateral shear-fracture zone observed in the river

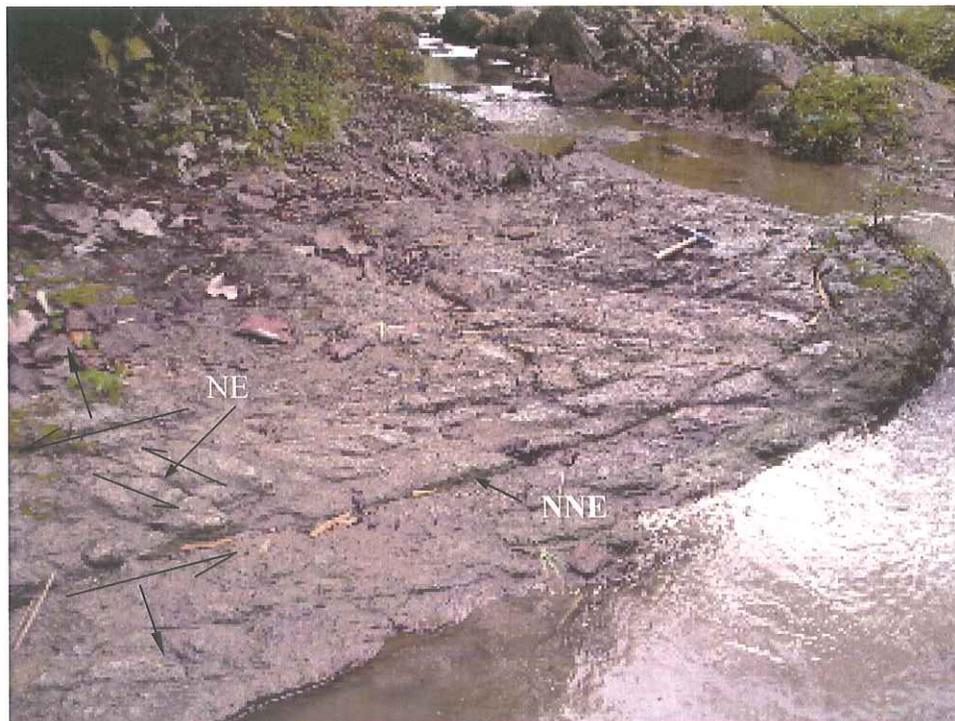
Photo 12 NE-NNE left lateral shear fractures in shear zone at quebrada bend.

and probably enclosed between NNW trending joints, the sense and direction of shear in the quebrada bend exposure is strikingly different. There are two possibilities for compatibility between the two shear zone observations. The NNE left lateral shear may

be a conjugate-antithetic shear system developed in the NNW right lateral shear zone. The other compatible possibility is that the NNE fractures are extensional and intervening NW fractures are left lateral Reidal shears developed within the right lateral shear zone. There is no geomorphic evidence to suggest the alternative that a separate NNE trending shear-fracture zone intersects the NNW right lateral shear zone at the quebrada bend.
