# Golden Environmental Corp.

## JURISDICTIONAL DETERMINATION DORADO OFFICE PARK

JOSE EFRON AVENUE  
HUIGUILLAR WARD  
DORADO, PUERTO RICO

MARCH 23, 2005

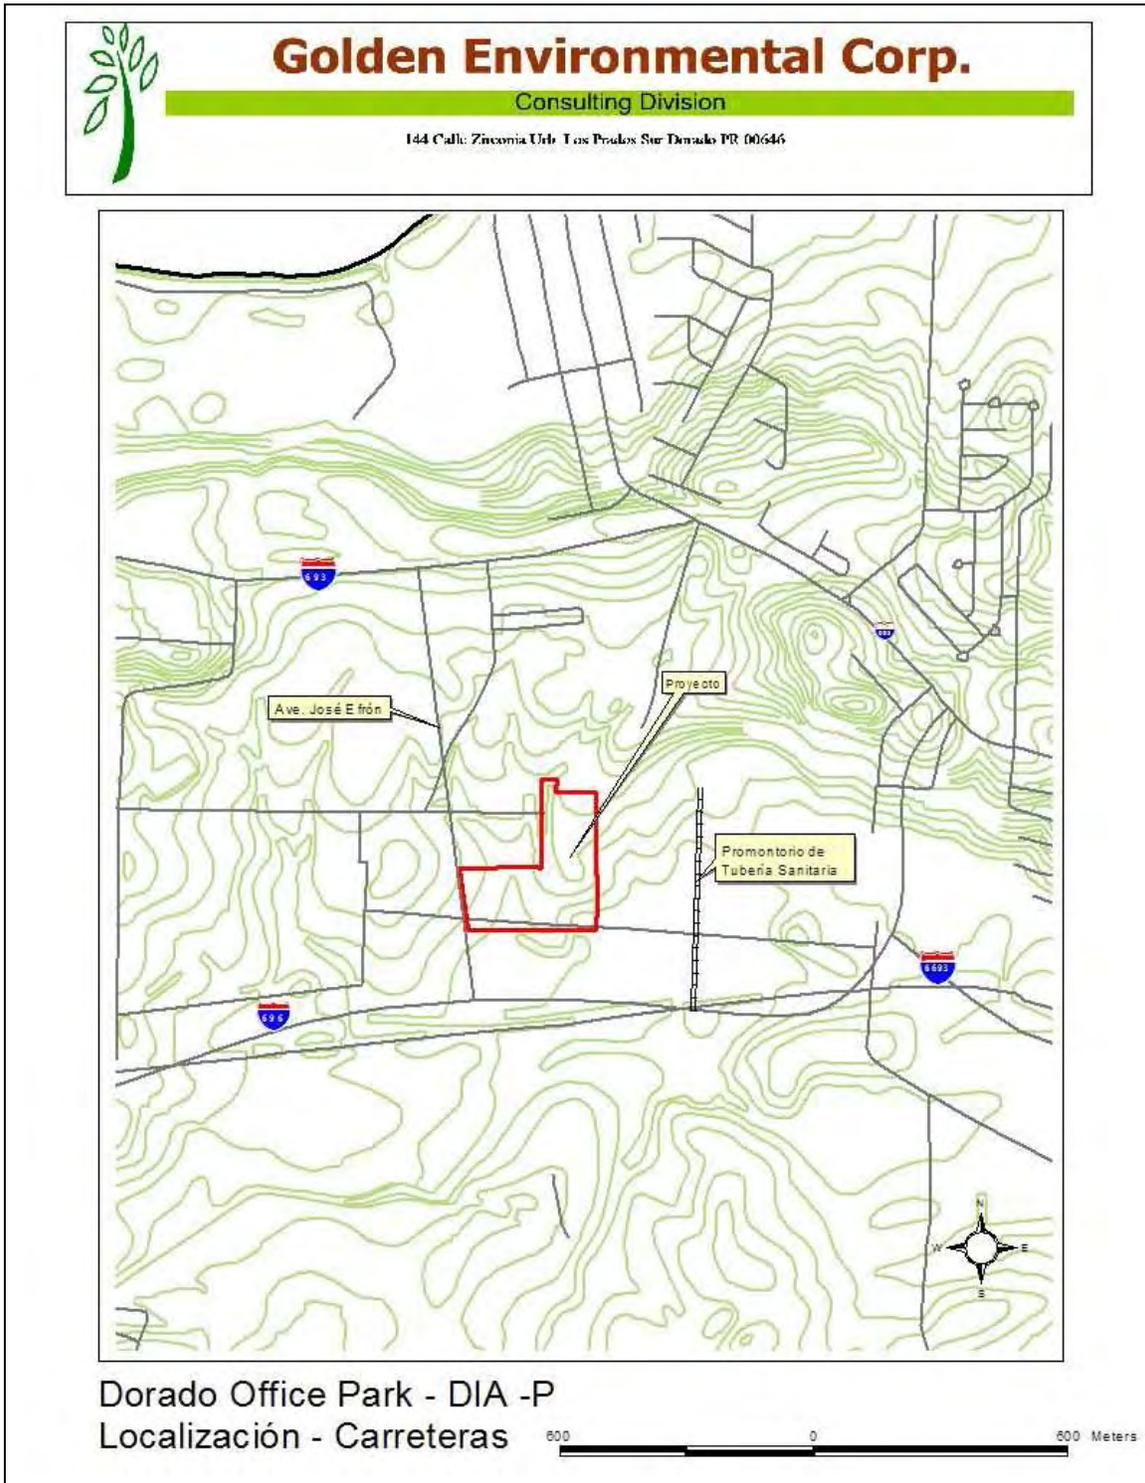
Appendix 1. Topographic Map

The U.S.G.S Topographic Quadrangle for the Municipality of Dorado shows the elevation contours for the parcel as lines within 2 to 6 meters above mean sea level (MSL). It doesn't show any marsh or wetland symbols for the area. In terms of water bodies the TQ shows that a man made channel was dig running north to south into the property and then west out of the property. This channel used to run west all the way to the "Río la Plata". Now, a sanitary line coming out of "Quintas de Dorado" development diverts the waters south of road 6693. It seems that those channels used to serve water for agricultural endeavors and as drainage. No other significant features can be observed on the TQ.

Sociedad Especial Efrón Dorado, S.E. through its consulting engineer José E. Martínez is proposing the development of a 22 cuerdas parcel of land for the construction of an Office Park that consists of seven buildings, parking lots and accessory structures. The proposed parcel is located at Jose Efrón Avenue, south of State Road PR 693, on the Municipality of Dorado. (see Appendix 1. Location on Topographic Map).

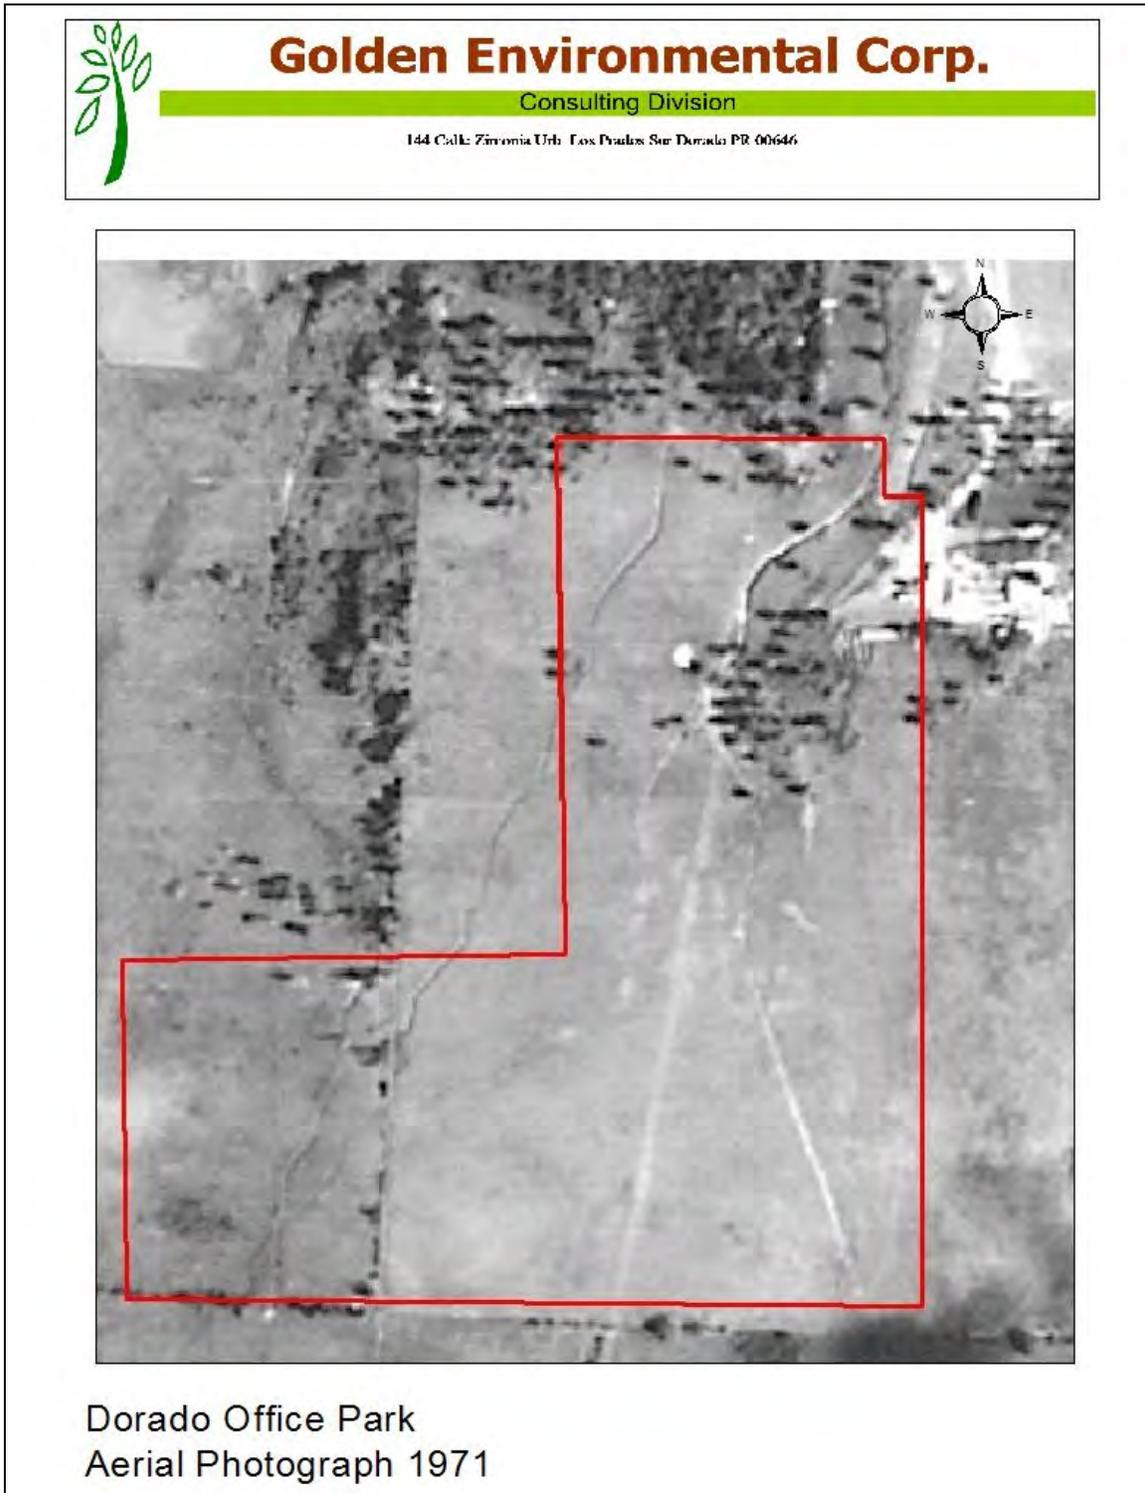
Appendix 2. 1971 Aerial Photograph

- i. A 1971 PR Highway Authority (ACT) aerial photograph shows that area was completely deforested and covered by pastures. The small channel that crosses trough the property is still visible.
- ii. A 1981 PR Highway Authority (ACT) aerial photograph shows that area was still completely deforested and covered by pastures. The small channel that crosses trough the property is less visible and mostly limited to the southwestern part of the property.

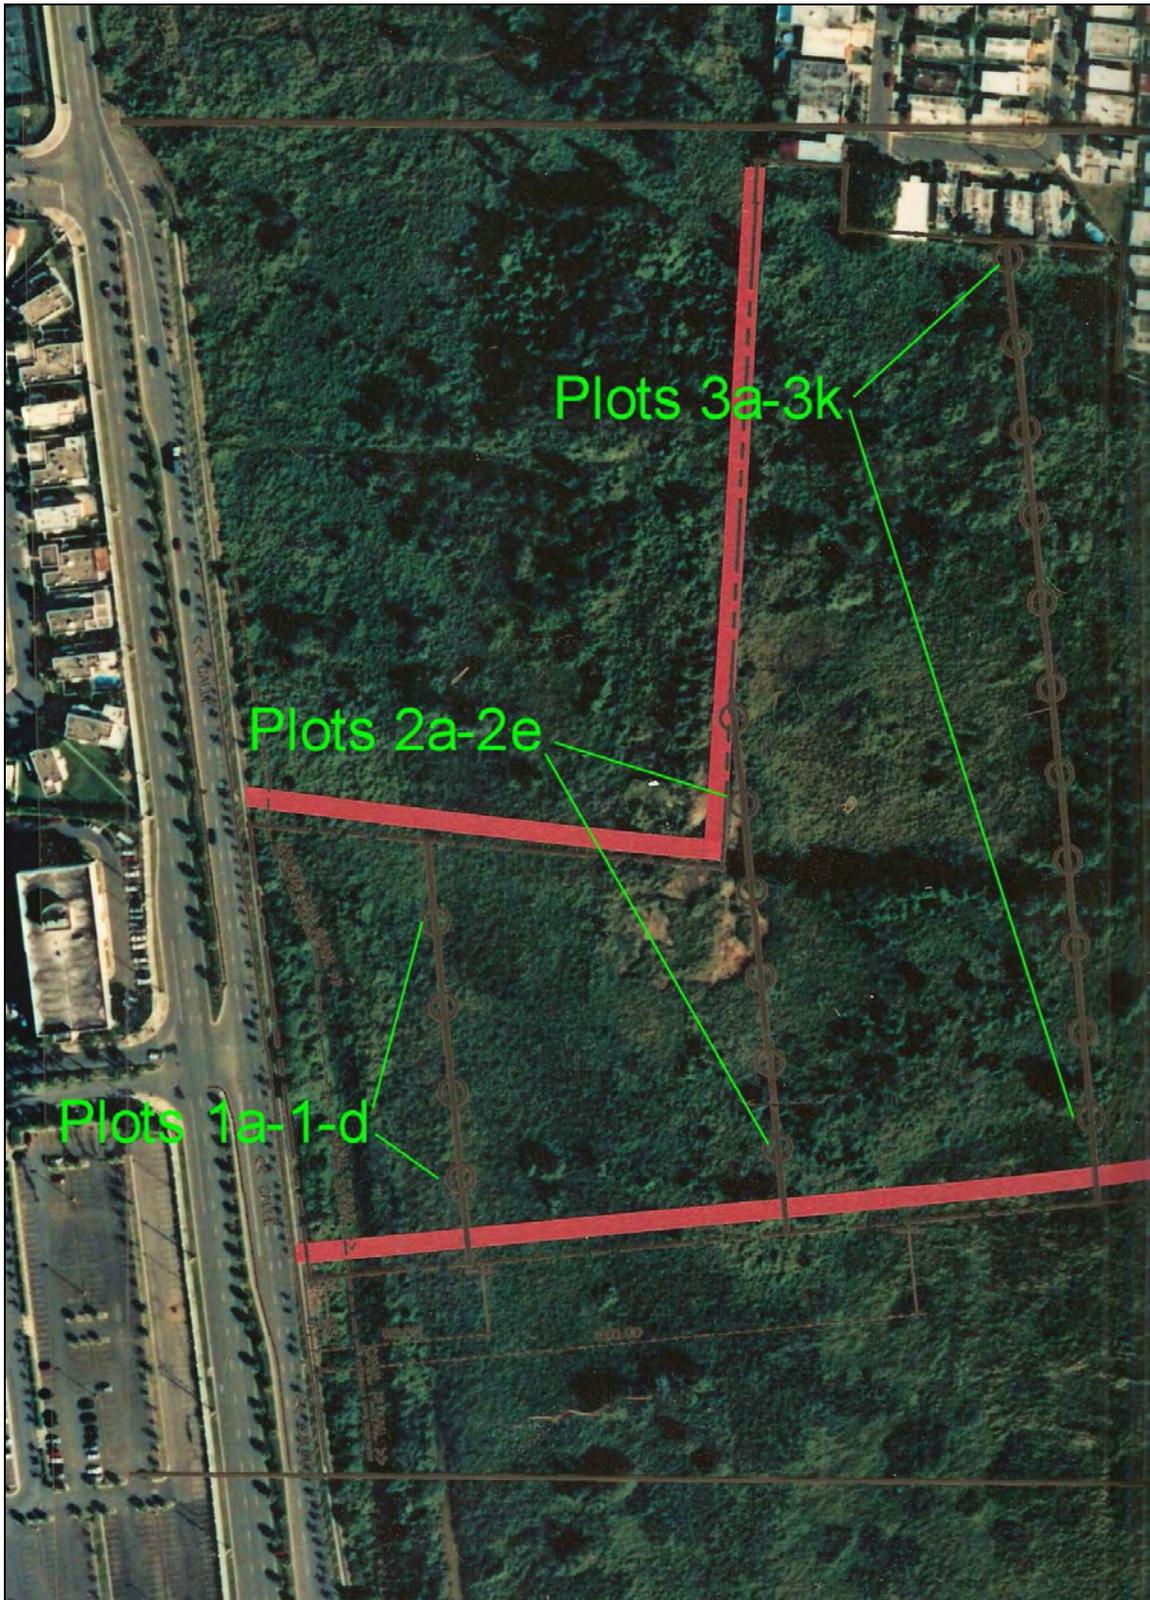
Appendix 4. Sampling Plots (Aerial Photograph 2004)

- iii. The most recent aerial photograph taken January 28, 2004 by the Highway Authority (ACT) shows that there are no visible channels and there’s emerging vegetation. It also shows the extent on the sanitary duct coming out of Quintas de Dorado development towards road 6693. This promontory limits the natural flow of superficial water towards the “Caño” that serves Río la Plata. The small wetland area within the property is clearly visible.

- i. The study area was analyzed based on the gathered data and several walk through sessions.
- ii. Establishment of a baseline (aprox. 1,140 feet) running parallel to the southern property line.

- iii. Establishment of three (3) transects perpendicular to the baseline running north into the property. Transects started at 183, 549 and 915 feet respectively from the southern property line.

- iv. A minimum of 4 plots were established along each transect at a maximum distance of 100 feet from each other, even if the up land area was reached. A total of 20 plots were examined. All plots were marked and numbered with a stake and flagging tape. At each plot a 30 feet radius was established if trees were present otherwise a 10 feet radius was established for the identification of shrubs and herbs. The percent of dominant species that were classified as OBL, FACW, of FAC was further determined and documented. In addition, a soil pit 16 inches deep was dig and observed in the center of every established plot regardless of the recorded vegetation. Finally, any indication of wetland hydrology was noted on the plot log.

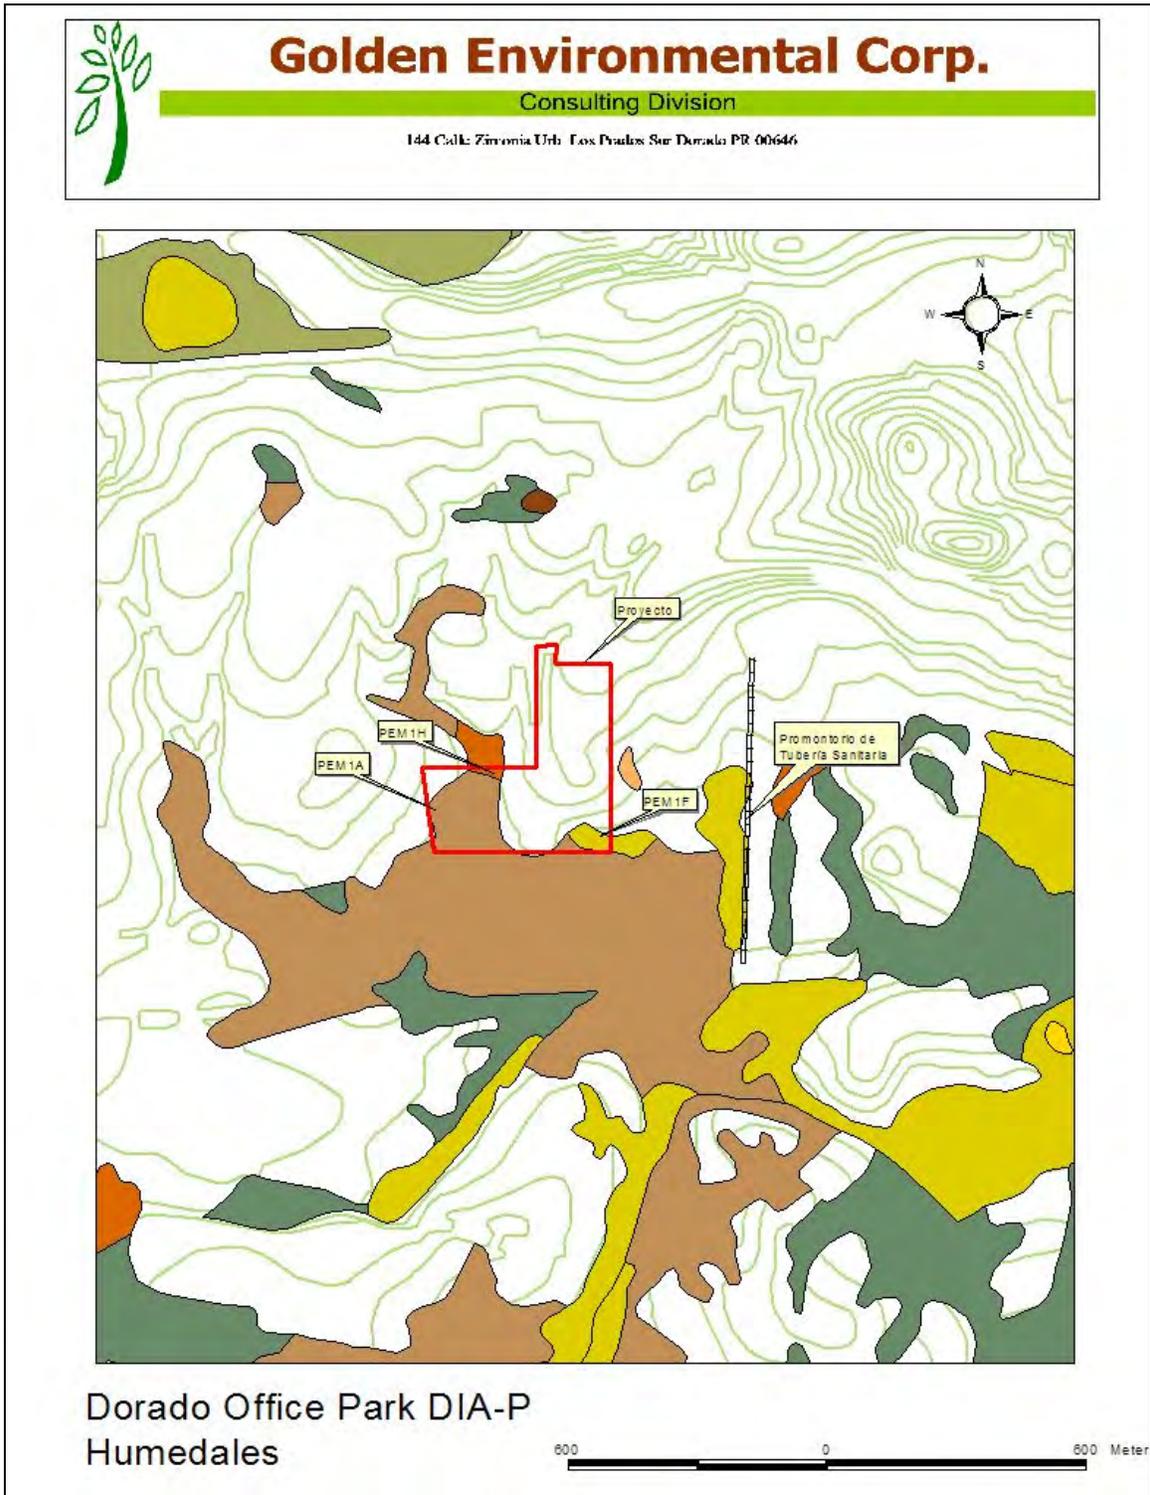
Appendix 5. NWI Map

The NWI depicts a portion of the parcel (mostly at elevations lower than 7 meters above MSL) as part a of a Palustrine System (P\_EM1\_A\_) and (P\_EM1\_F) that includes all nontidal wetlands dominated by trees, shrubs, emergents, mosses or lichens, and all such wetlands that occur in tidal areas where salinity due to ocean derived salts is below 0.5 ppt. Wetlands lacking such vegetation are also included if they exhibit all of the following characteristics:

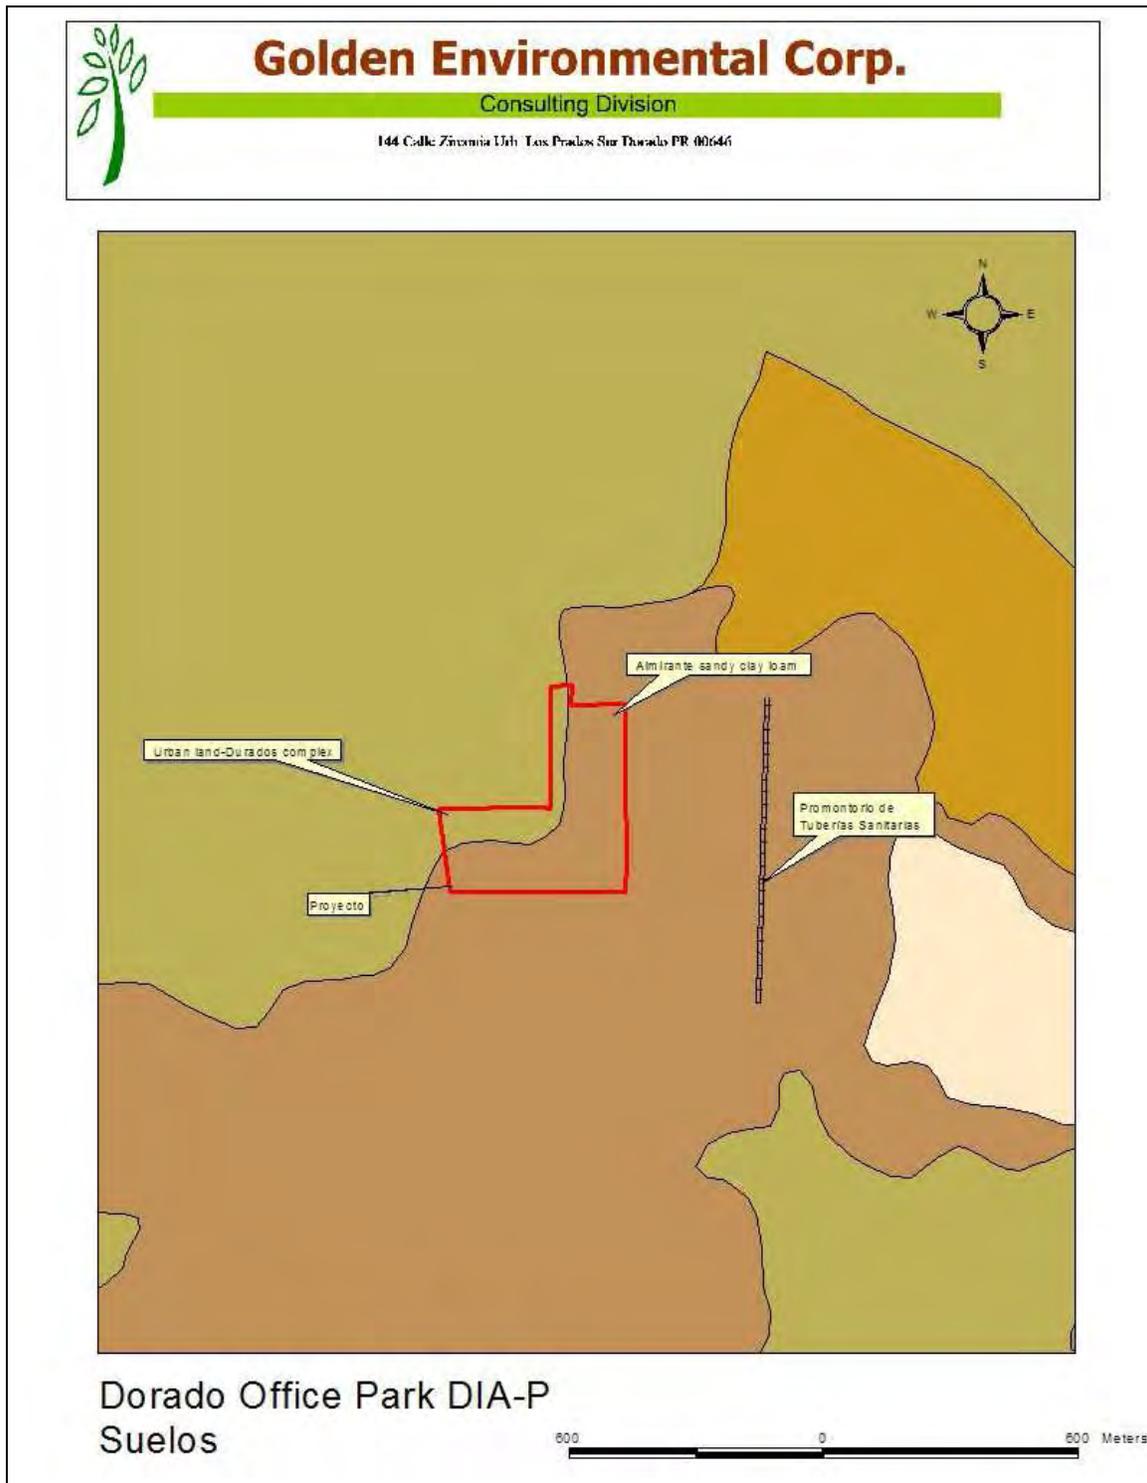
Appendix 6. USGS Soil Survey Map

The soil survey map for the parcel includes mostly one type of soil "Almirante clay sandy loam". This soil type is not included in the list of hydric soils of Puerto Rico as revised December 15<sup>th</sup>, 1995.

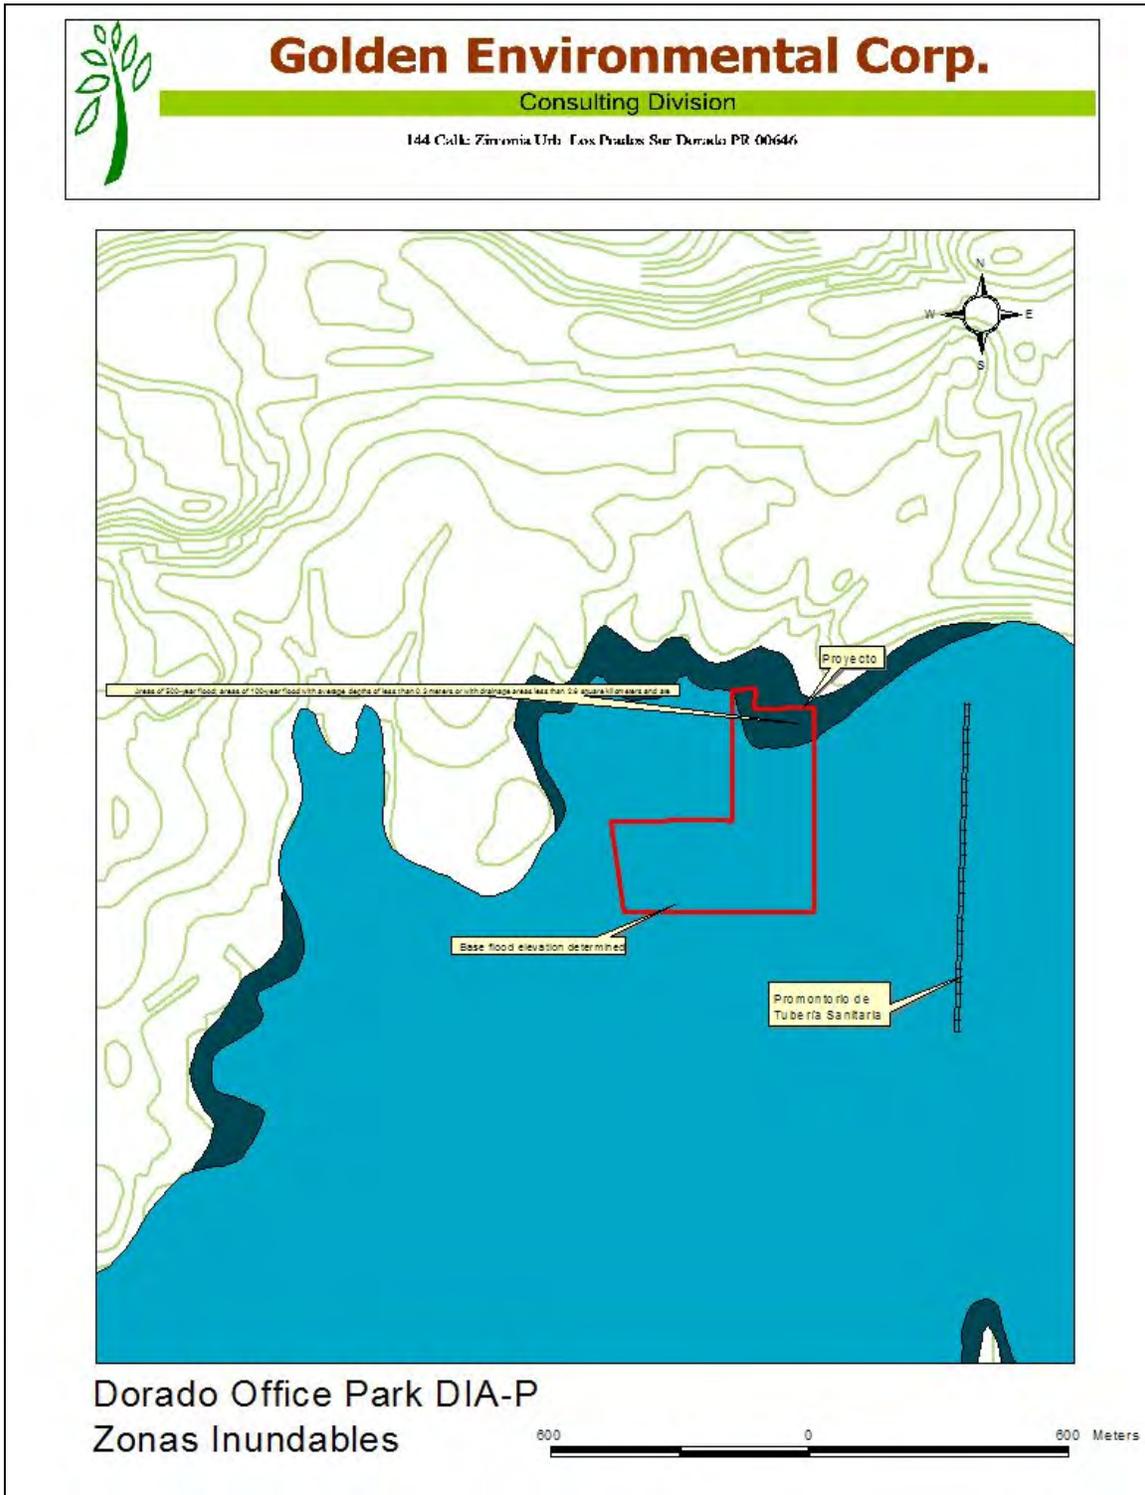
Appendix 7. Flooding Zones Map

The flooding map for the area includes part of the property as subject to flooding on 100 years events at a level of 6 meters m.s.l. (see Apendix 7. Flooding Zones Map)

The parcel topography is generally flat with contour lines from 6 to 8 meters above mean sea level (MSL) and the mean inundation level within a 100 years flood is 6.00 meters above MSL. Historically, the parcel has been used for cattle grazing.

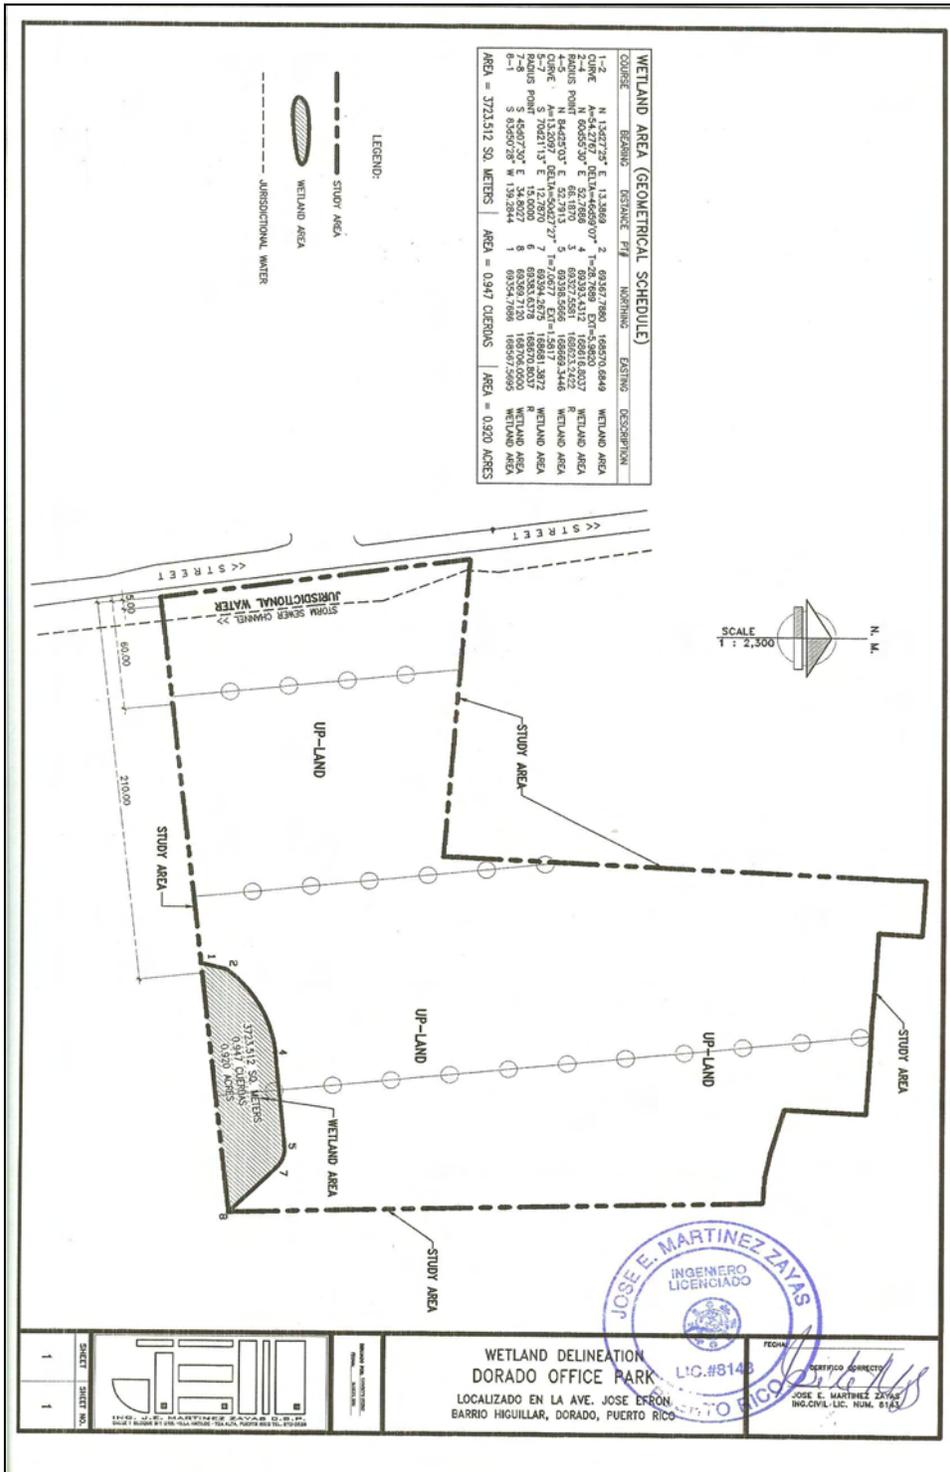
Appendix 8. Determined Wetland Area

Although the mapped soil for the project area is not included in the list of hydric soils for Puerto Rico, a small area within the property (Aproximately .920 acres) has been inundated for a period long enough as to effectively maintain wetland vegetation and hydrology (plot 3a). The rest of the parcel to be developed fails to meet the required wetland indicators and is considered upland. The delineated wetland area is linked to the segment of the parcel with topography below the 2.0 meters above m.s.l line.

Appendix 8.,8b. "Determined Wetland Area" shows the extent of the existing wetland area.
