## **Determinación Jurisdiccional de Humedales**

**Wetland Jurisdictional Determination Study**

**Barrancas Property  
Ponce, Puerto Rico**

June 2003

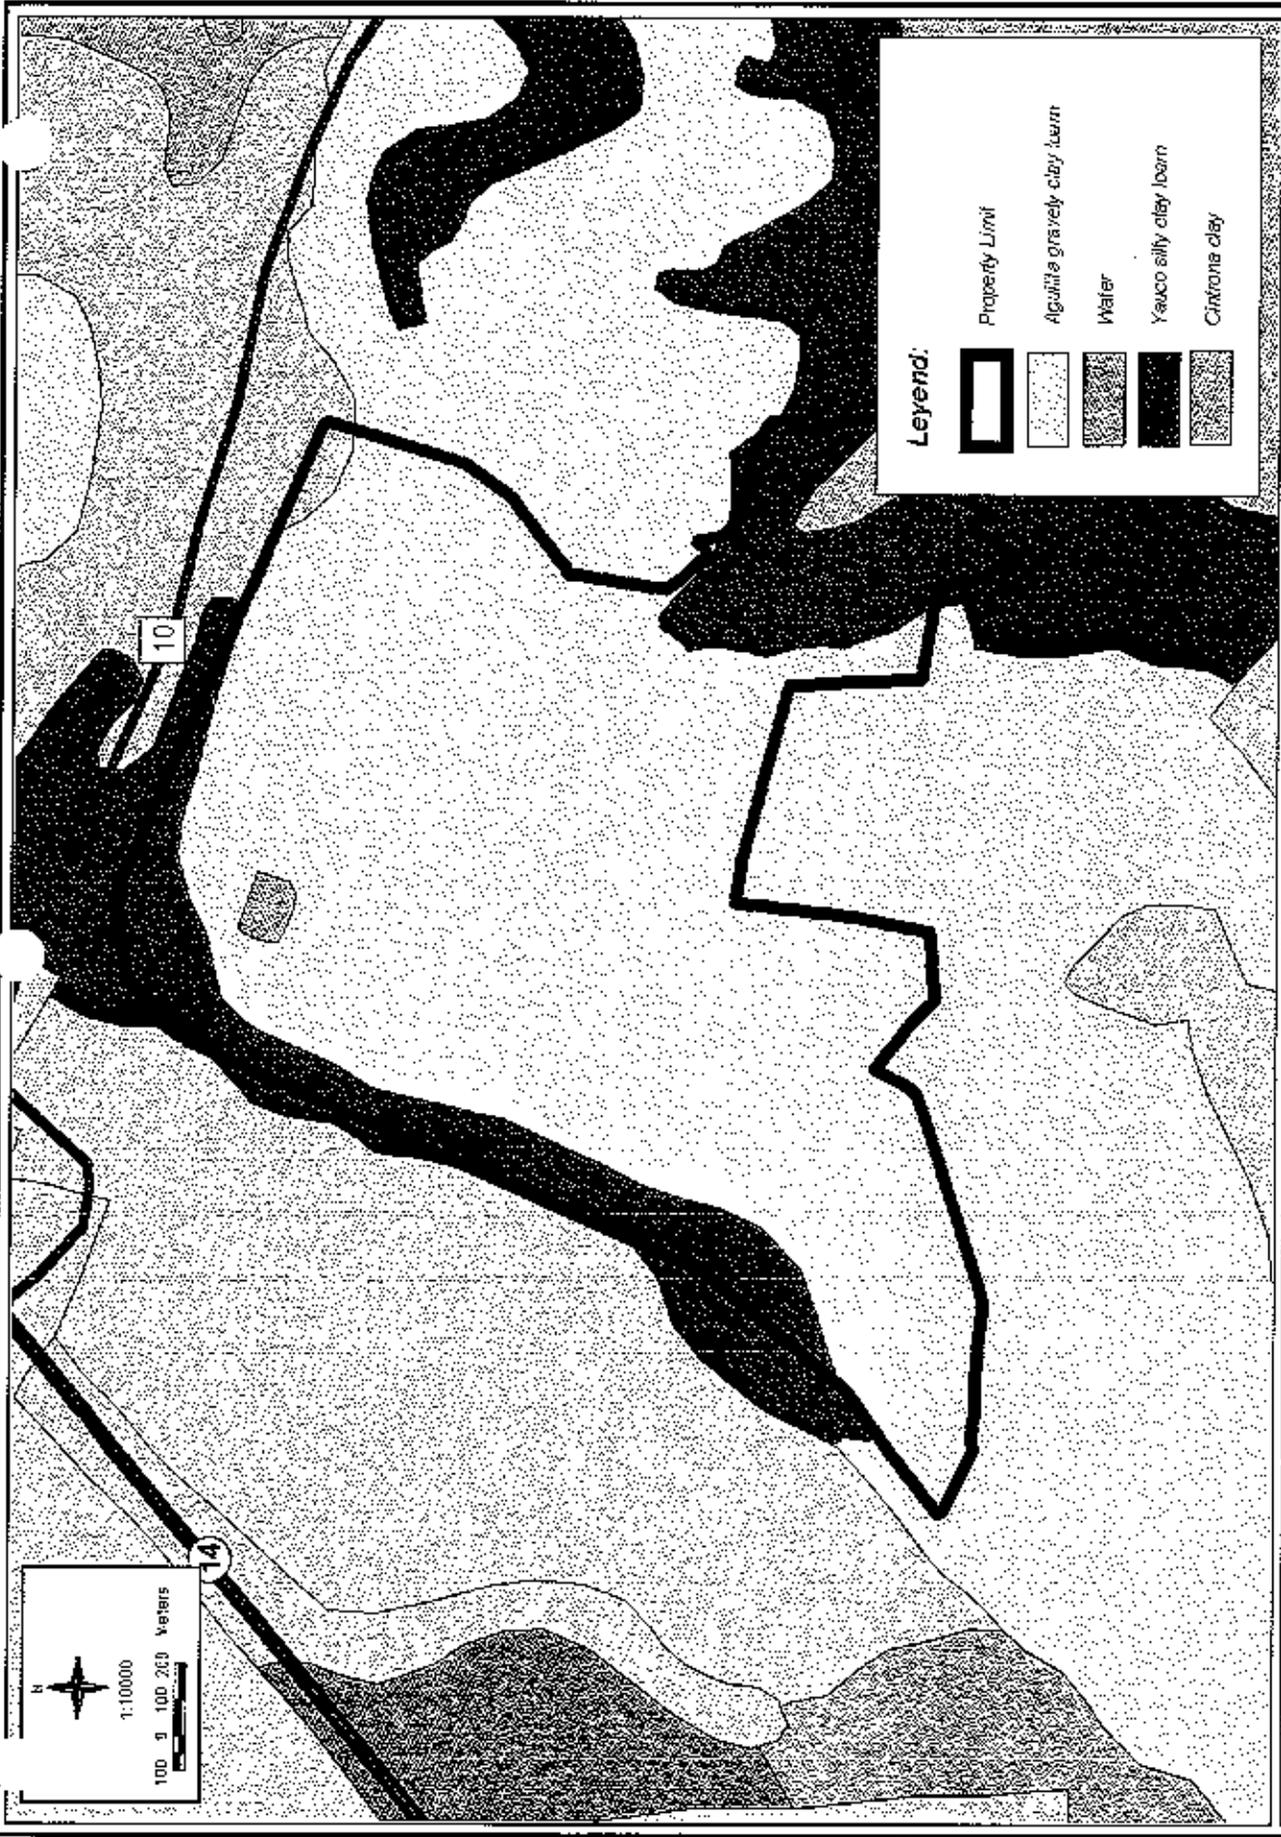
The soils found at the Property consist of the series: Aguilita Gravelly Clay Loam, Yauco Silty Clay Loam, and Cintrona Clay (see Figure 2). The topography of the Property consists mostly of hills ranging from 30 to 100 meters above mean sea level. Table 1 shows the soil series that are found within the study area.

**Figure 2: Soil Survey Map**  
 Wetland Jurisdictional Determination Study-Barrancas Property-Ponce, Puerto Rico

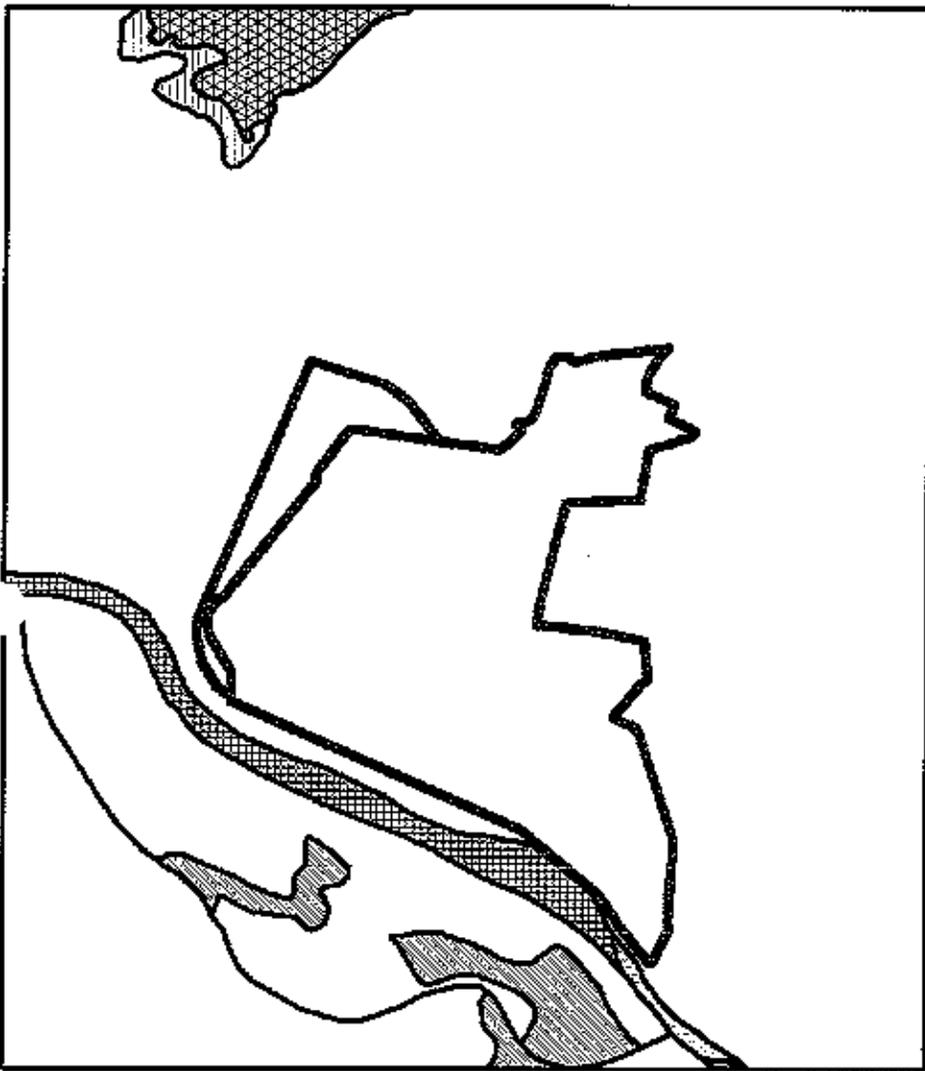
The National Wetland Inventory Map is shown in **Figure 3**. As demonstrated in this figure, neither wetlands nor rivers are found within the Property, however canalized Río Bucaná is found to the West and out of the Property.

**Figure 3: National Wetland Inventory Map**  
 Wetland Jurisdictional Determination Study-Barrancas Property-Ponce, Puerto Rico

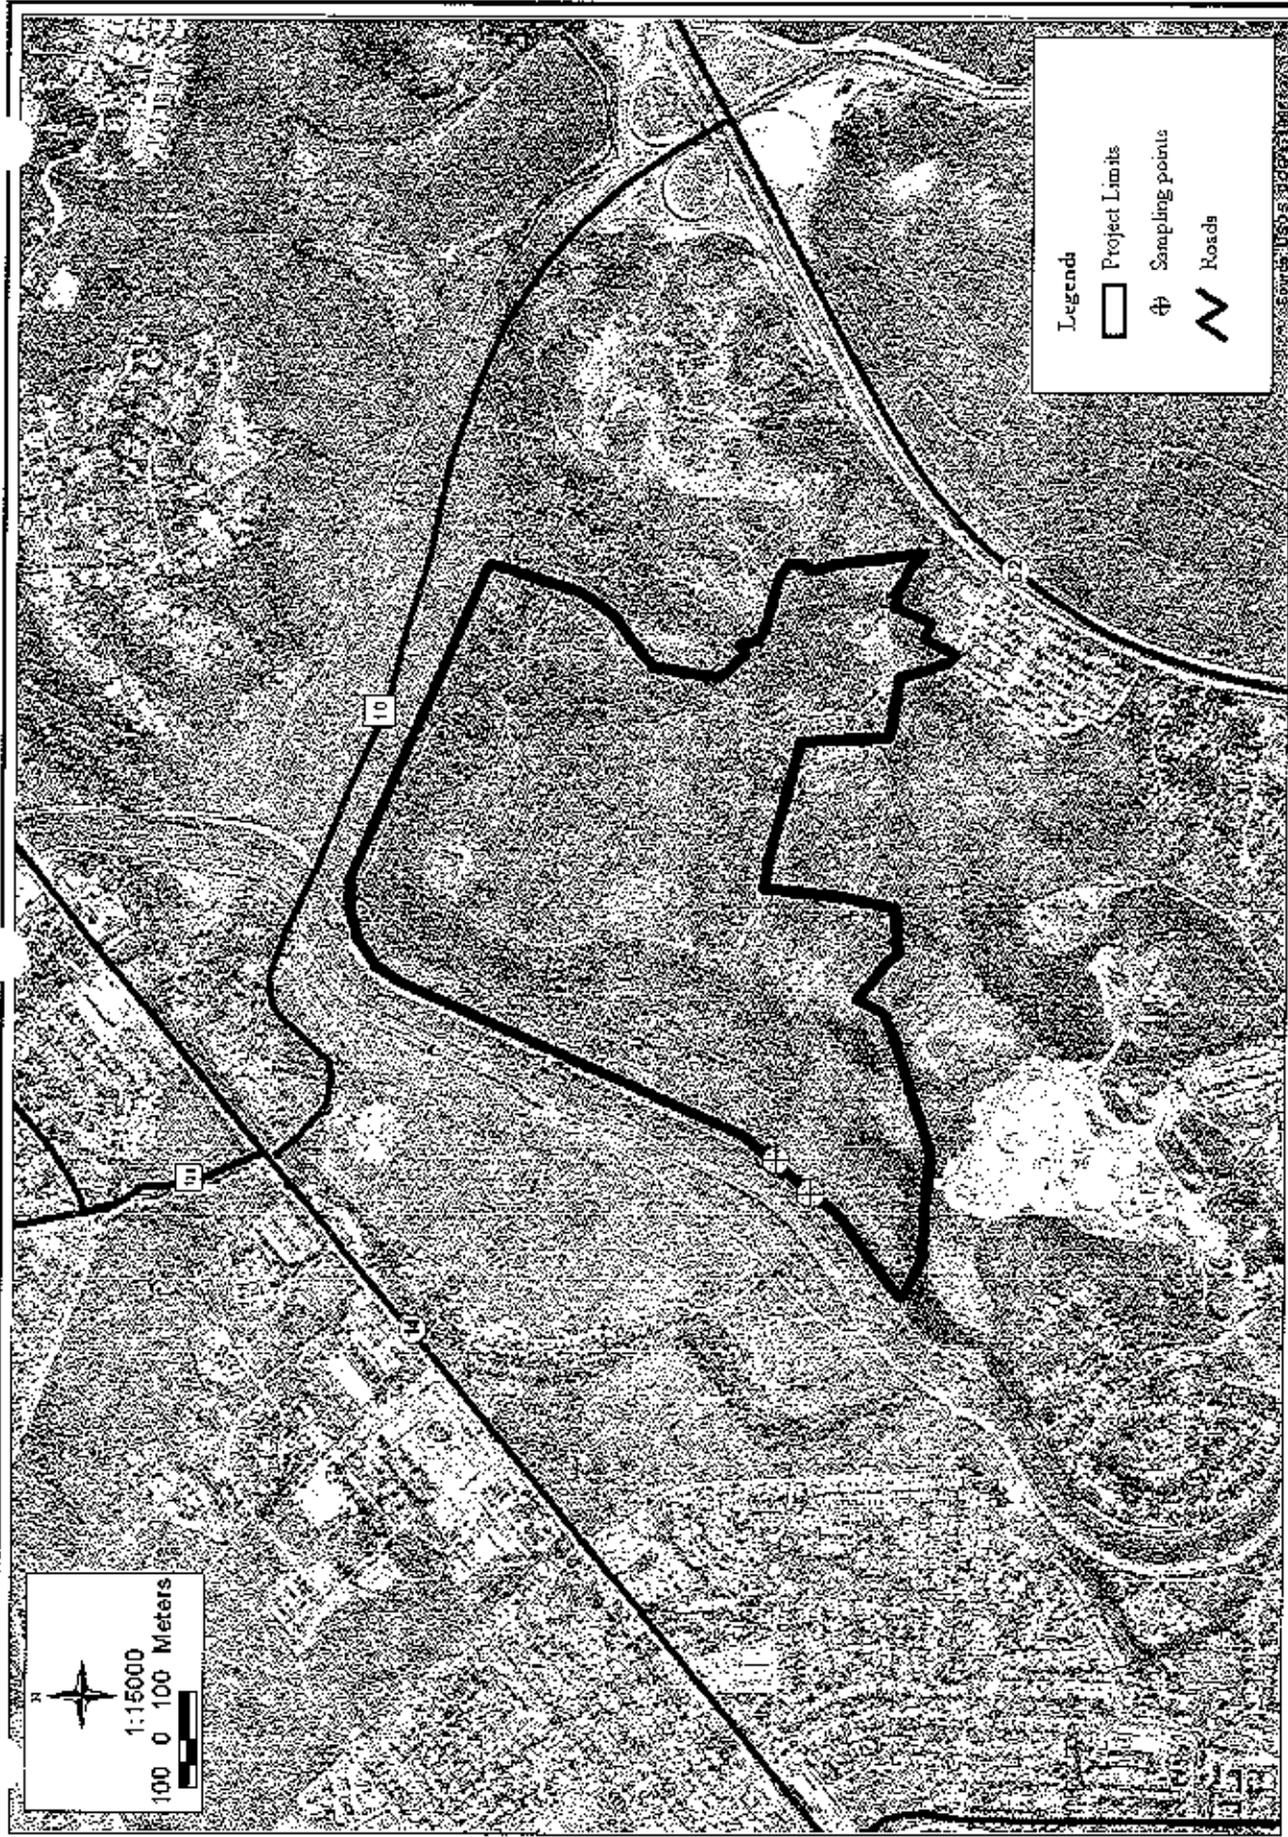
**Figure 5: Sampling Points**

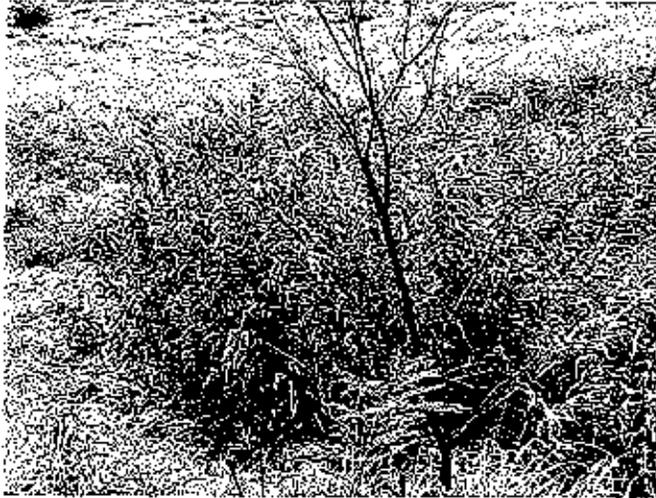
The dominant vegetation within the area is Cow cane (*Arundo donax*) classified as FAC in the 1988 *National List of Plants that Occur in Wetlands, USFWS*. No hydrology indicators were found within the canal. The soil found within this area corresponds to the series Yauco silty clay loam. This soil is not considered as a hydric soil. Appendix C includes the photographic documentation related to the sampling points.

Photo 1: Vegetation found within sampling points, which is dominated by Cow cane (*Arundo donax*).
