**Sampling point TB-3
Monte Arenas
PR- 645 Quebrada Arenas Ward
Vega Baja, Puerto Rico**

4.0 WETLAND HYDROLOGY

HYDROLOGIC-HYDRAULIC STUDY
FOR MONTE ARENAS DEVELOPMENT
VEGA BAJA, PUERTO RICO

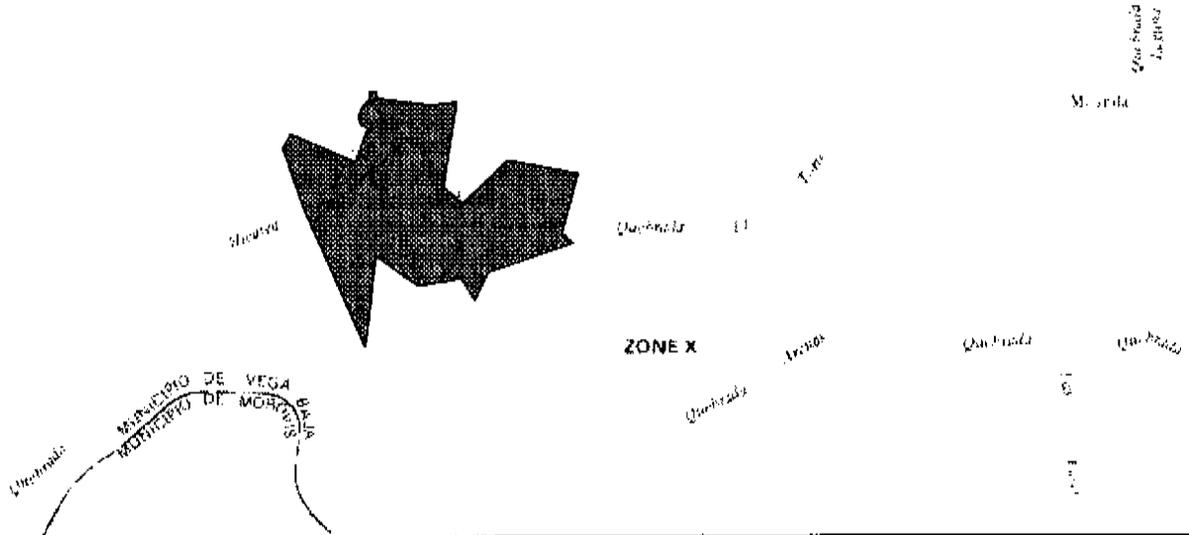
Figure 7

**FEMA Flood Map
Monte Arenas
PR- 645 Quebrada Arenas Ward
Vega Baja, Puerto Rico**

According to the Flood Insurance Rate Map (FIRM) published by FEMA; Community Panel Number 720000-0040E the site is located outside the flood zone as delimited by the agency (Figure 7).

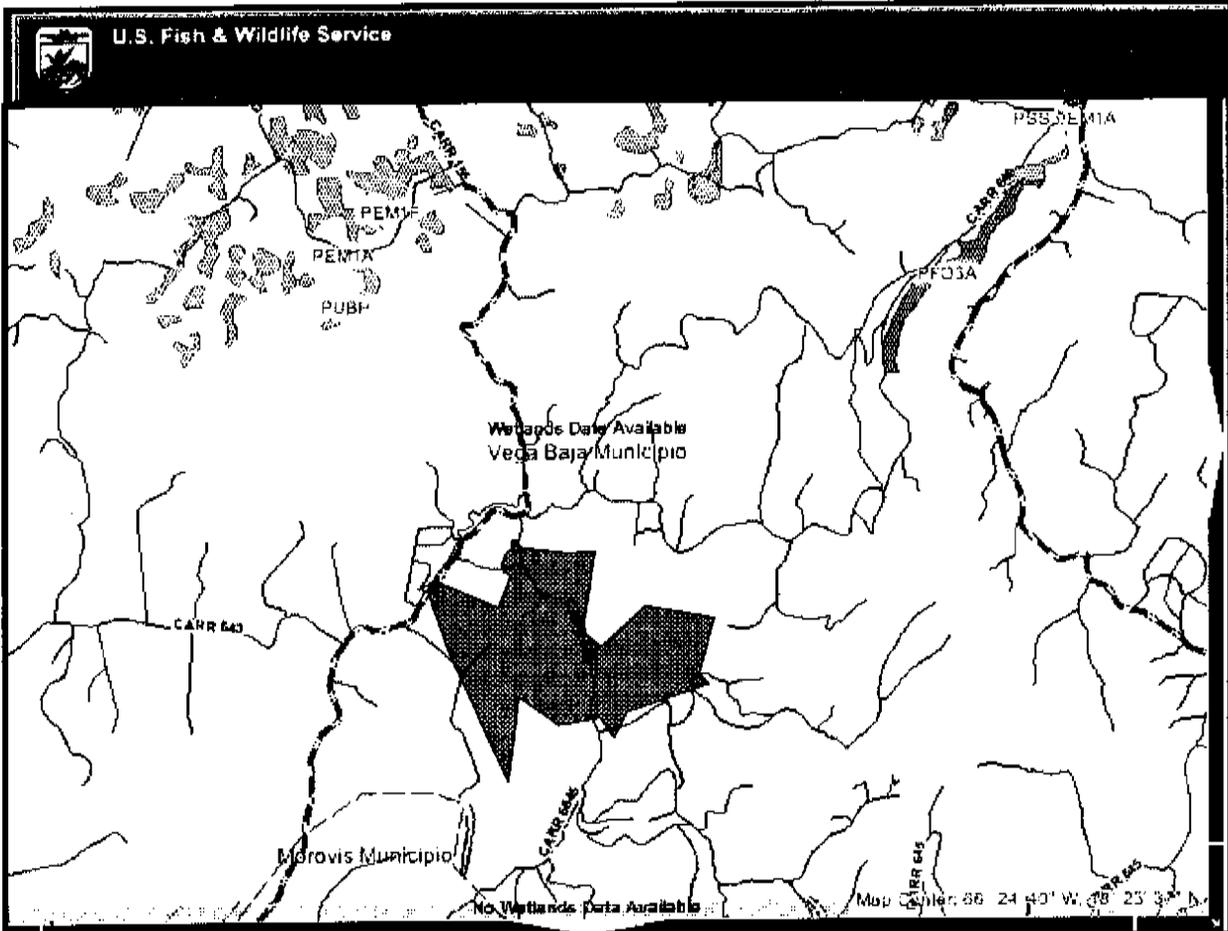
Figure 8

**National Wetland Inventory Map (USFWS)
 Monte Arenas
 PR- 645 Quebrada Arenas Ward
 Vega Baja, Puerto Rico**

The National Wetland Inventory Map of the U. S. Fish and Wildlife Service neither the Puerto Rico Planning Board list Quebrada Arenas Ward in Vega Baja as a wetland area (Figure 8). The storm water runoff follows the site topographic contours or slopes (Figure 9).

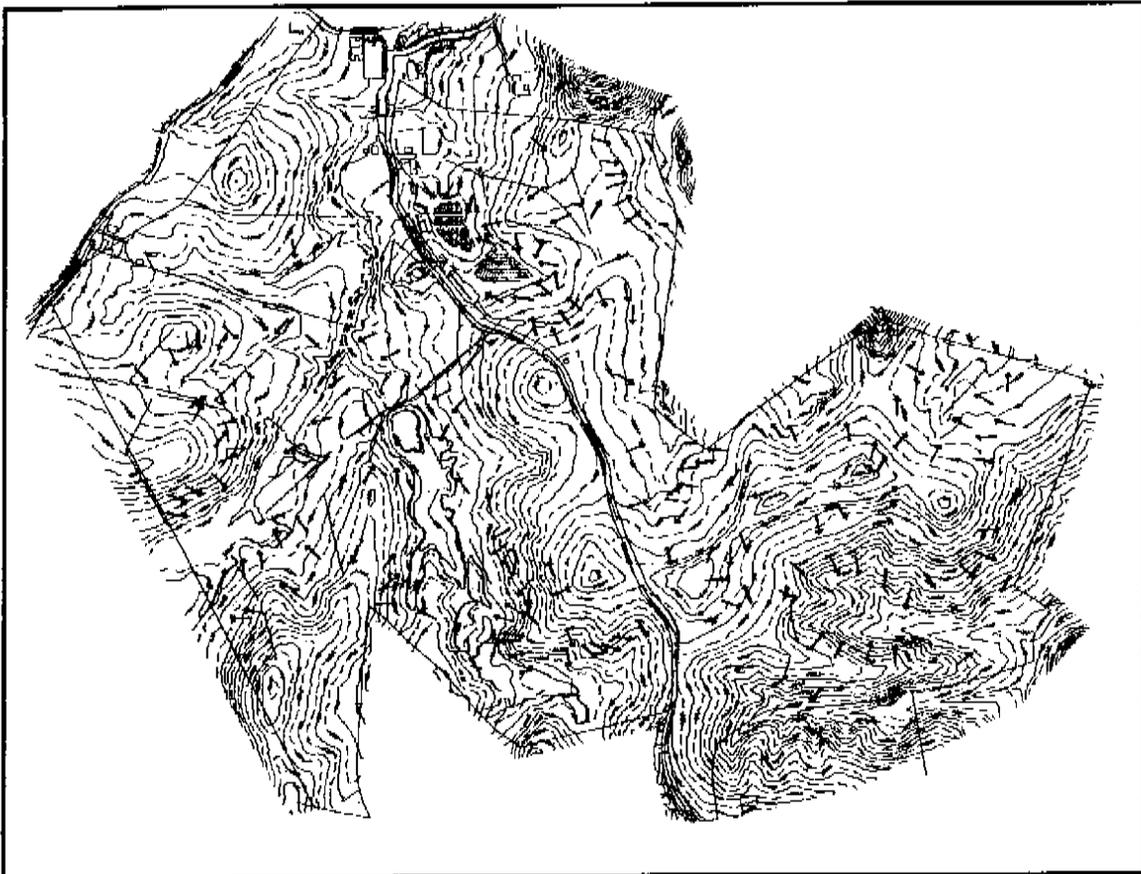
Figure 9

**Storm Water Courses
Monte Arenas
PR- 645 Quebrada Arenas Ward
Vega Baja, Puerto Rico**

An approximately 0.51 acre (0.53 cuerdas) oxidation pond exists at the project site (Figure 9). This pond is considered as a permanent water body since it is not connected to a navigable water body. This pond was used, until the first days of November, to collect waters produced by the cattle farm activities. There is no presence of wetland vegetation in and around this pond.

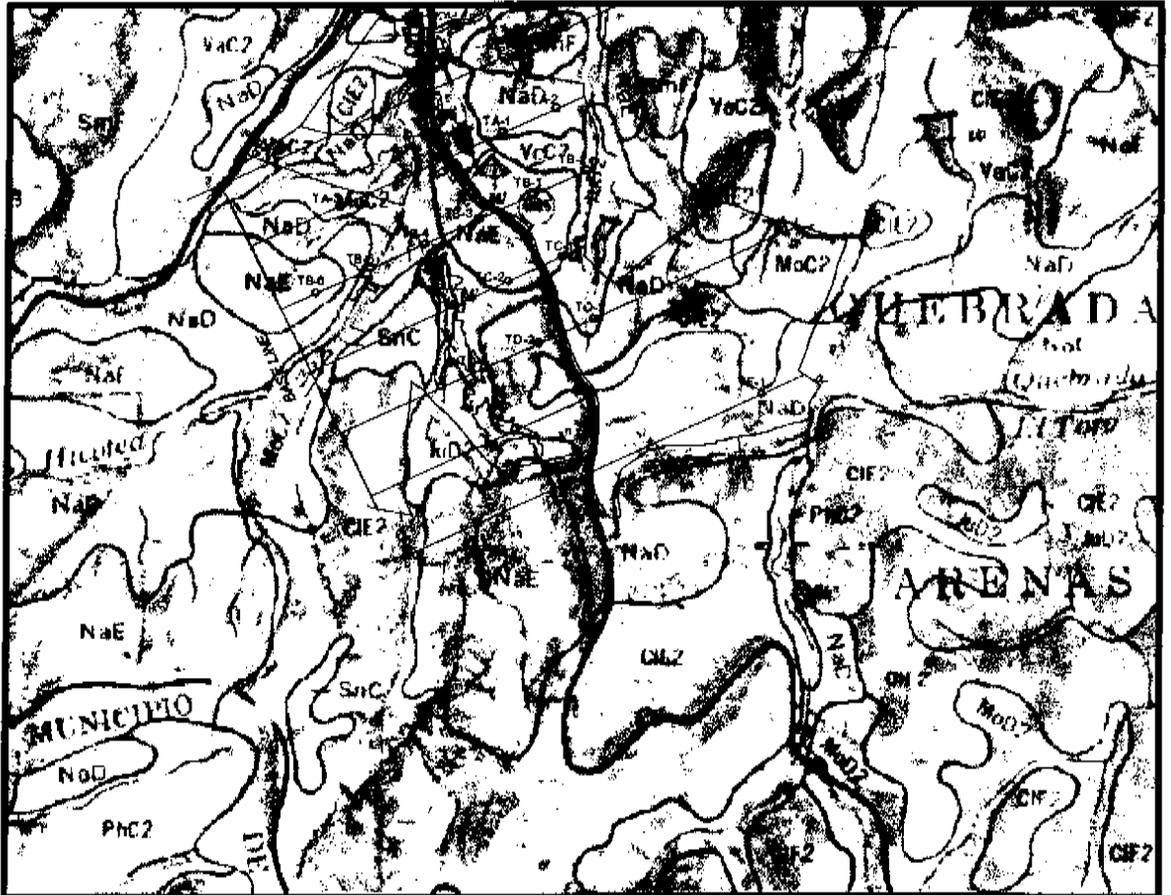
<p>Figure 11</p>	<p>SAMPLING POINTS OVER SOIL MAP Monte Arenas PR- 645 Quebrada Arenas Ward Vega Baja, Puerto Rico</p>
------------------	--

These soils and the sampling points are depicted with their respective symbols in the Soil Map provided in Figures 10 and 11, respectively.

The Jurisdiction of the site is limited to the area complying with the mandatory technical criteria. See Preliminary Wetland Delineation, Transect and Sampling Points Location and Aerial Photo (Table 1, Figure 11 and 13).

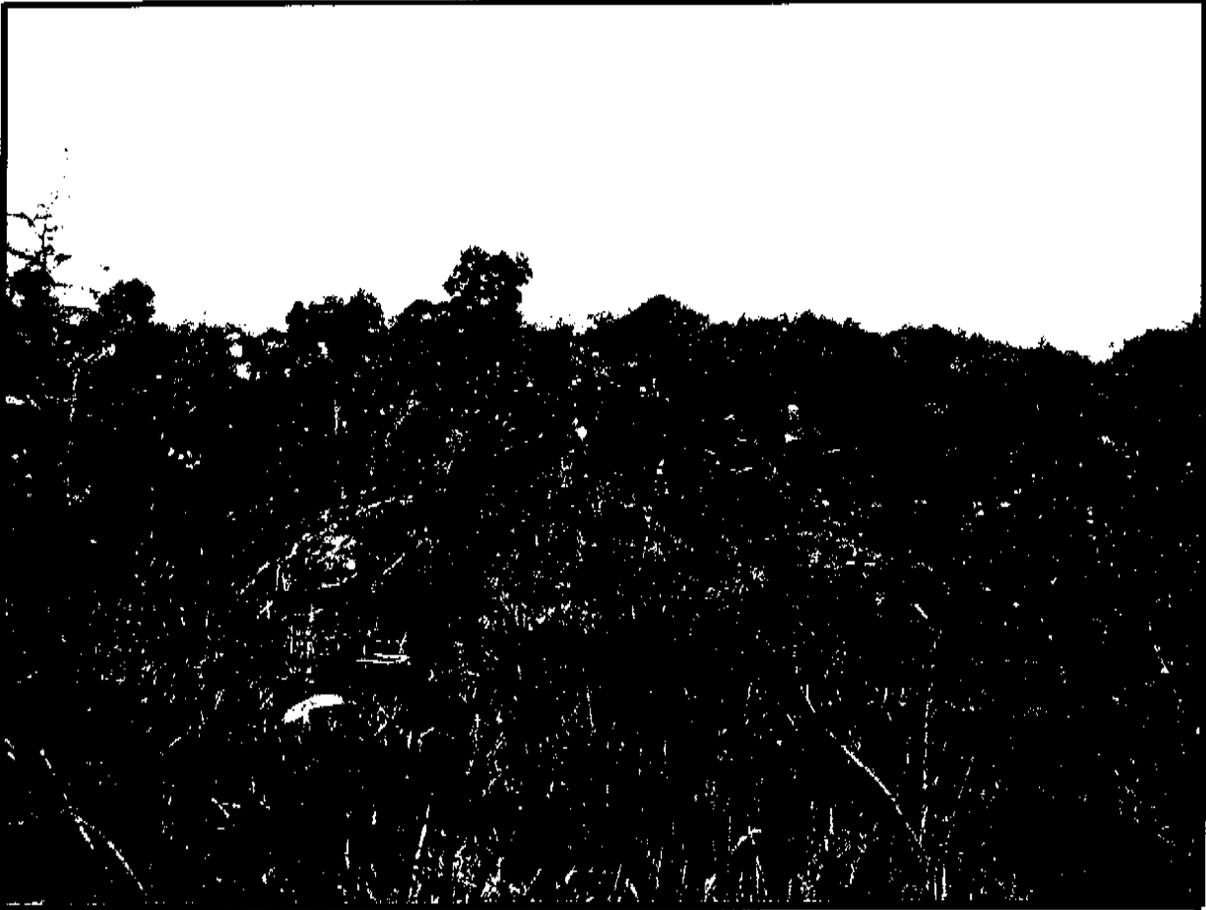
Photo 24

SITE VEGETATION TYPE
Monte Arenas
PR-645, Quebrada Arenas Ward
Vega Baja, Puerto Rico

Various types of plant associations were identified within the surveyed area (Photo 24 and 25). The grassland was dominated by several species including: *Brachiaria mutica*, *Mimosa pigra*, *Rhynchospora nervosa* and *Urochloa maxima*. *Psidium guajava* shrubs were found along the site. The plants that were found in the sampling points are listed in the following table.

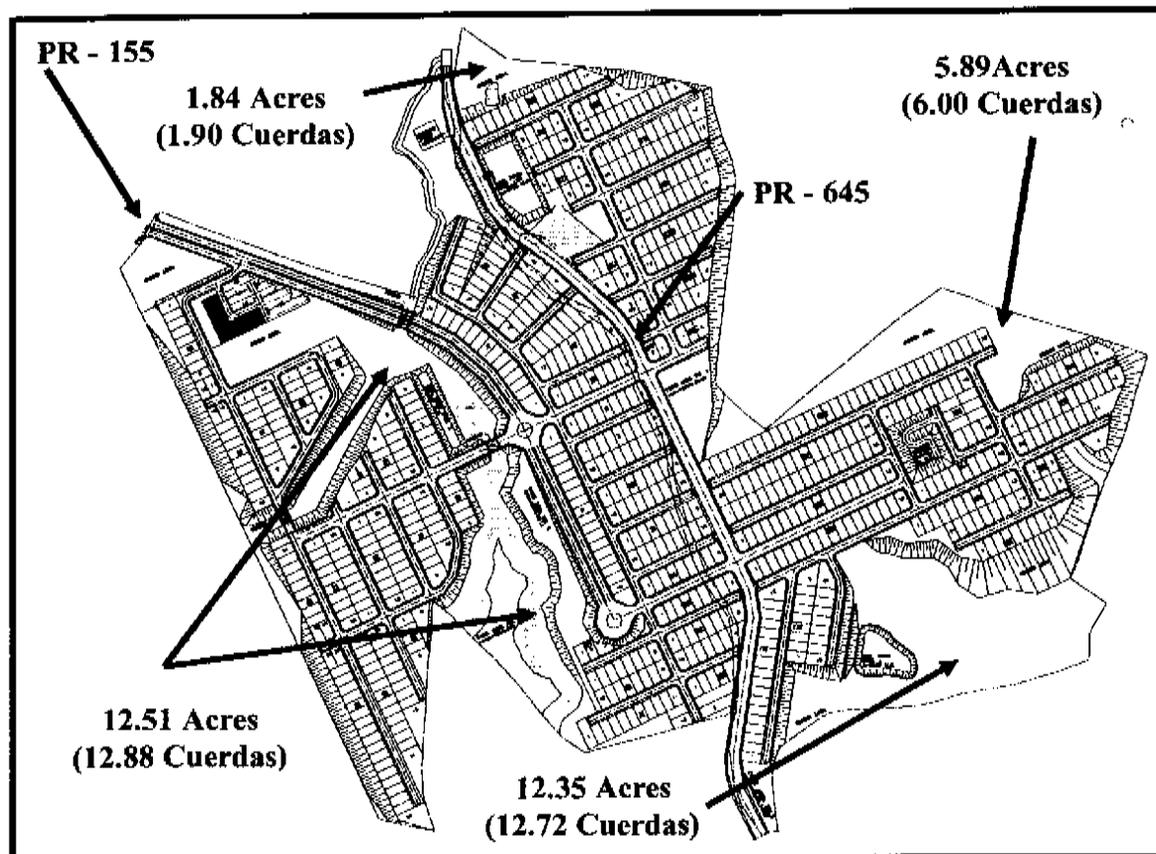
Figure 12

**Areas to be Conserved
 Monte Arenas
 PR- 645 Quebrada Arenas Ward
 Vega Baja, Puerto Rico**

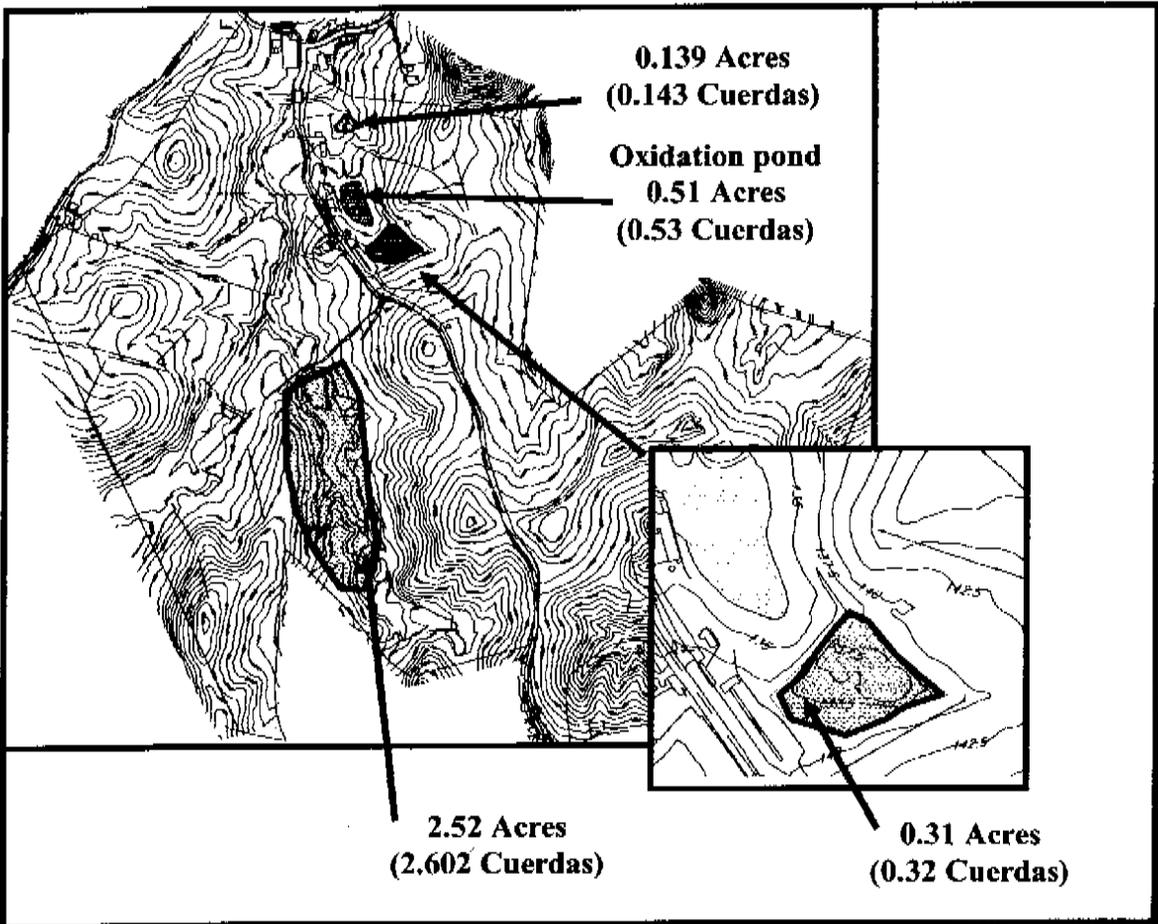
Figure 13

Areas to be Impacted
Monte Arenas
PR- 645 Quebrada Arenas Ward
Vega Baja, Puerto Rico

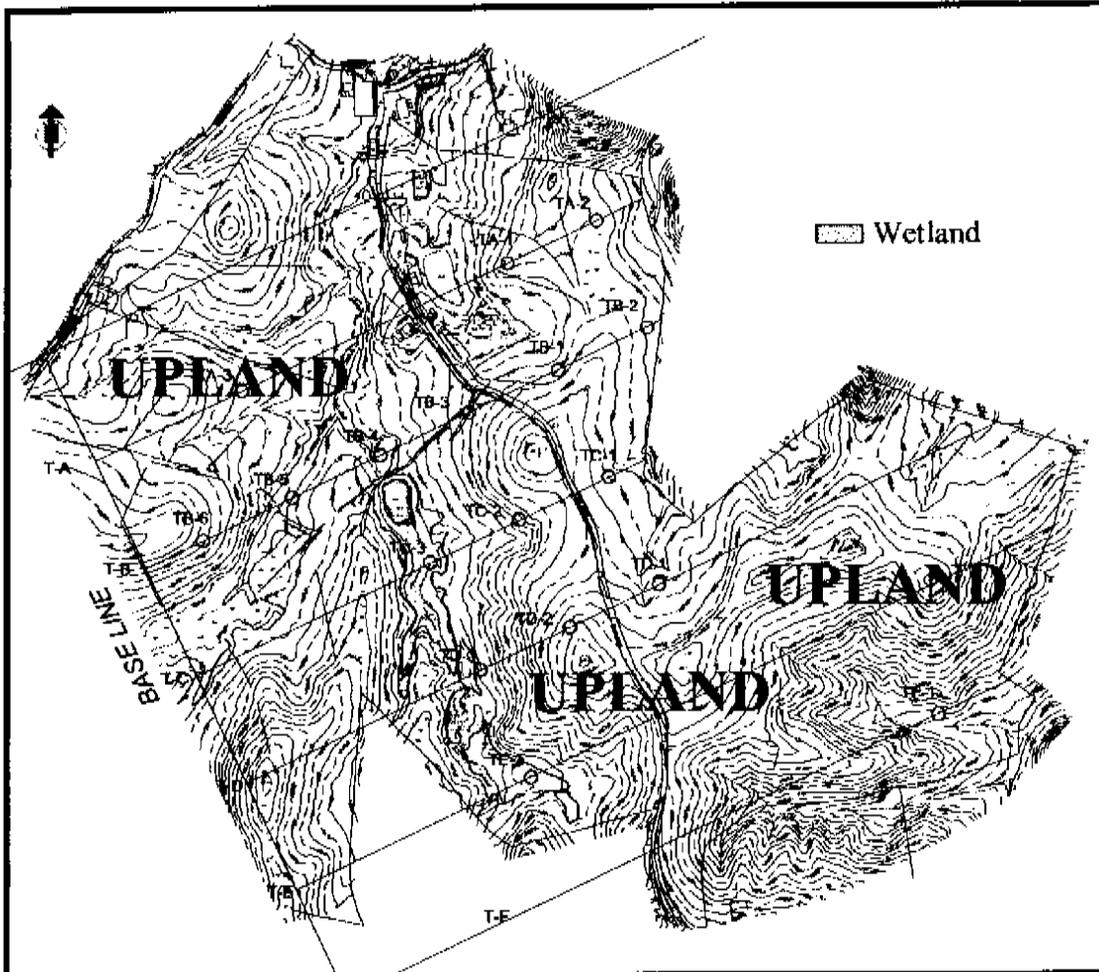
<p>Figure 14</p>	<p>Preliminary Jurisdictional Determination Monte Arenas PR- 645 Quebrada Arenas Ward Vega Baja, Puerto Rico</p>
-------------------------	--
