**Desarrollo Turístico-Residencial  
Villas del Mar Hau Beach Resort  
Barrio Bajuras de Isabela**

PRELIMINARY JURISDICTIONAL DETERMINATION  
OF WATERS OF THE UNITED STATES

*VILLAS DEL MAR HAU DEVELOPMENT*  
*ISABELA, PUERTO RICO*

*July 2007*

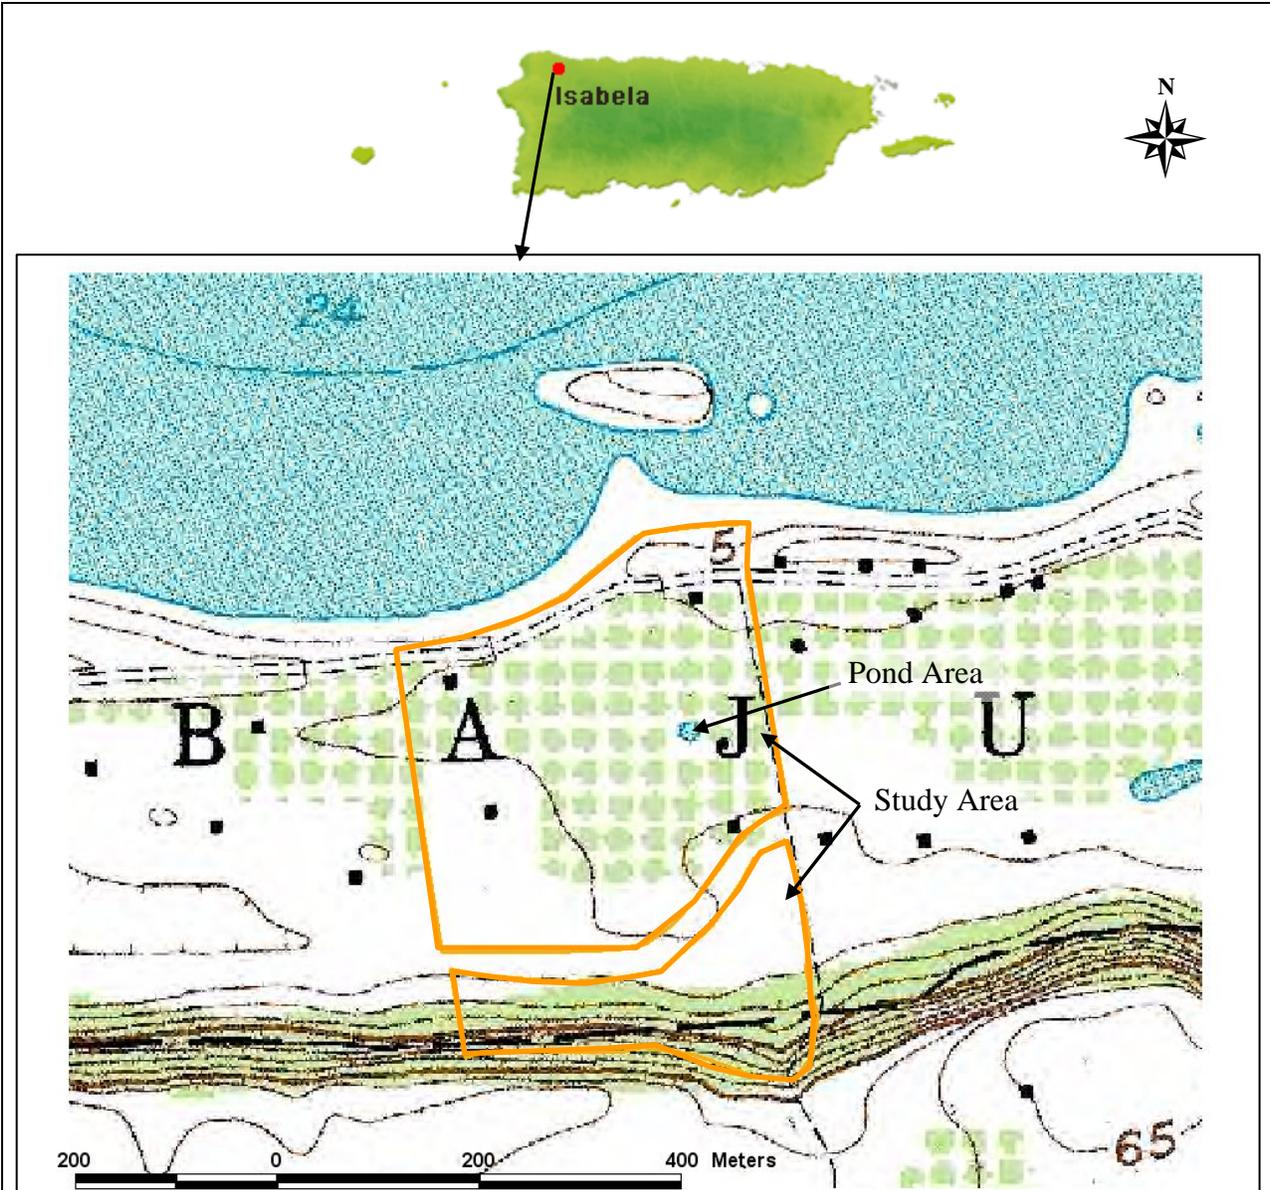
**Figure 1**

- a) USGS quadrangle map (Figure 1) – The map shows a small ponded area in the northern tract forming a circumference. To the north, the beach area and Atlantic Ocean can be observed. These areas are outside the property. There are no stream beds or other wetland indicators within the study area.

Location and Topographic Map

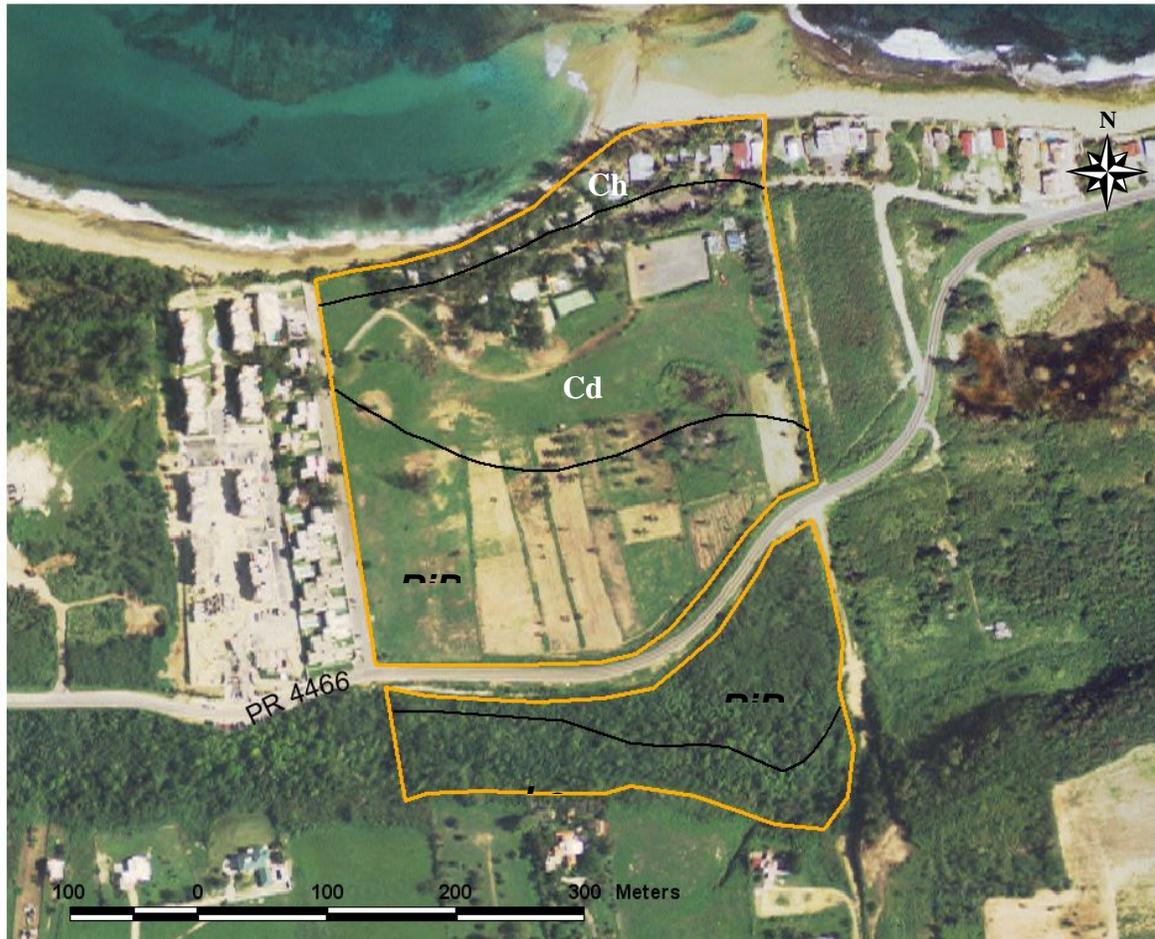
**Figure 2**

Soils Map

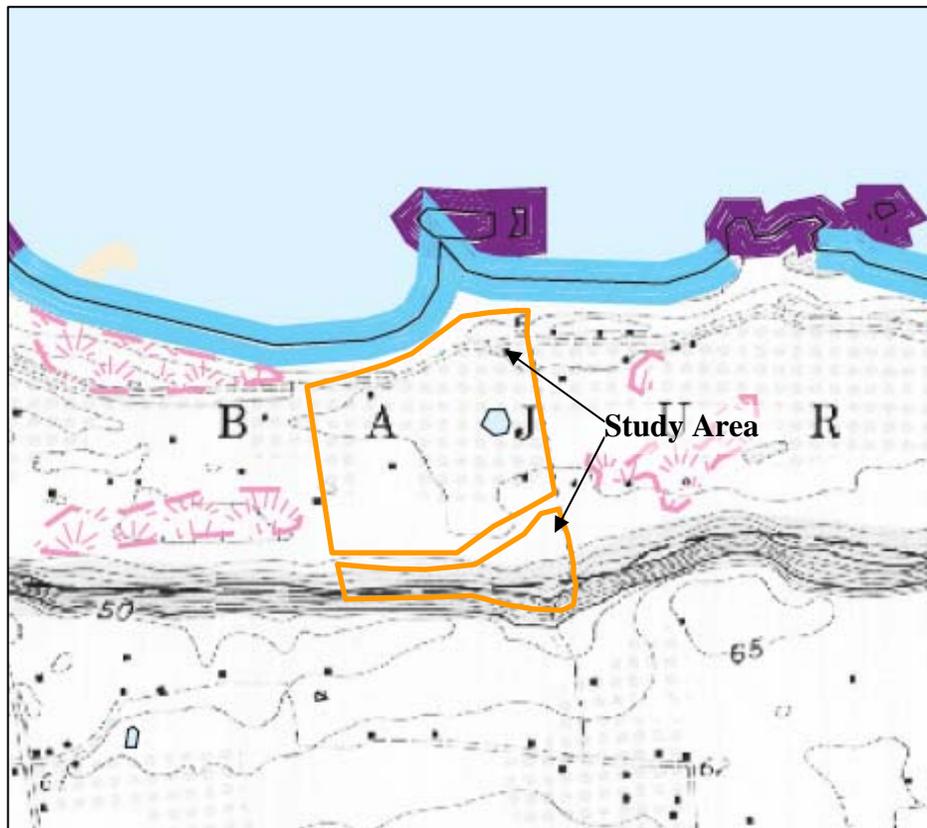
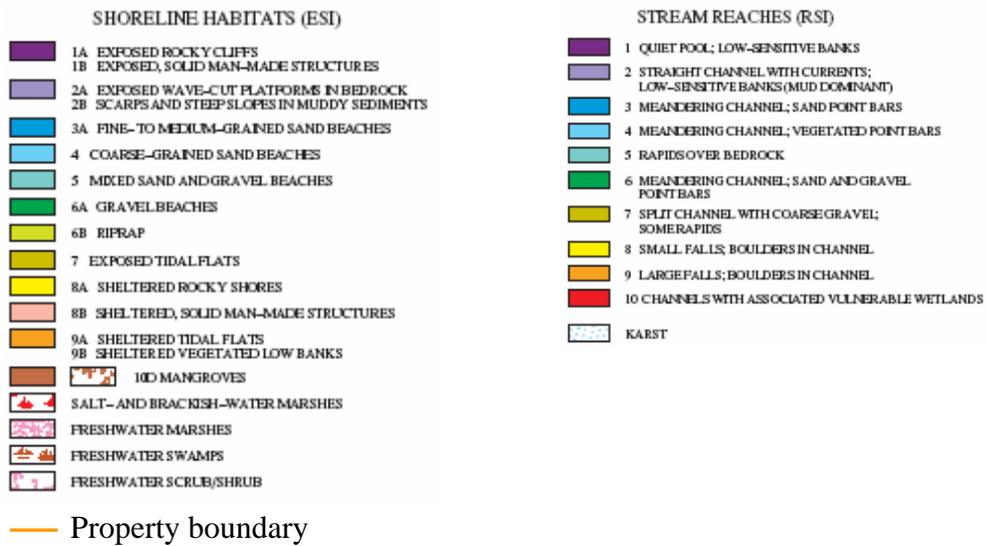
**Figure 3**

Environmental Sensitivity Index Map

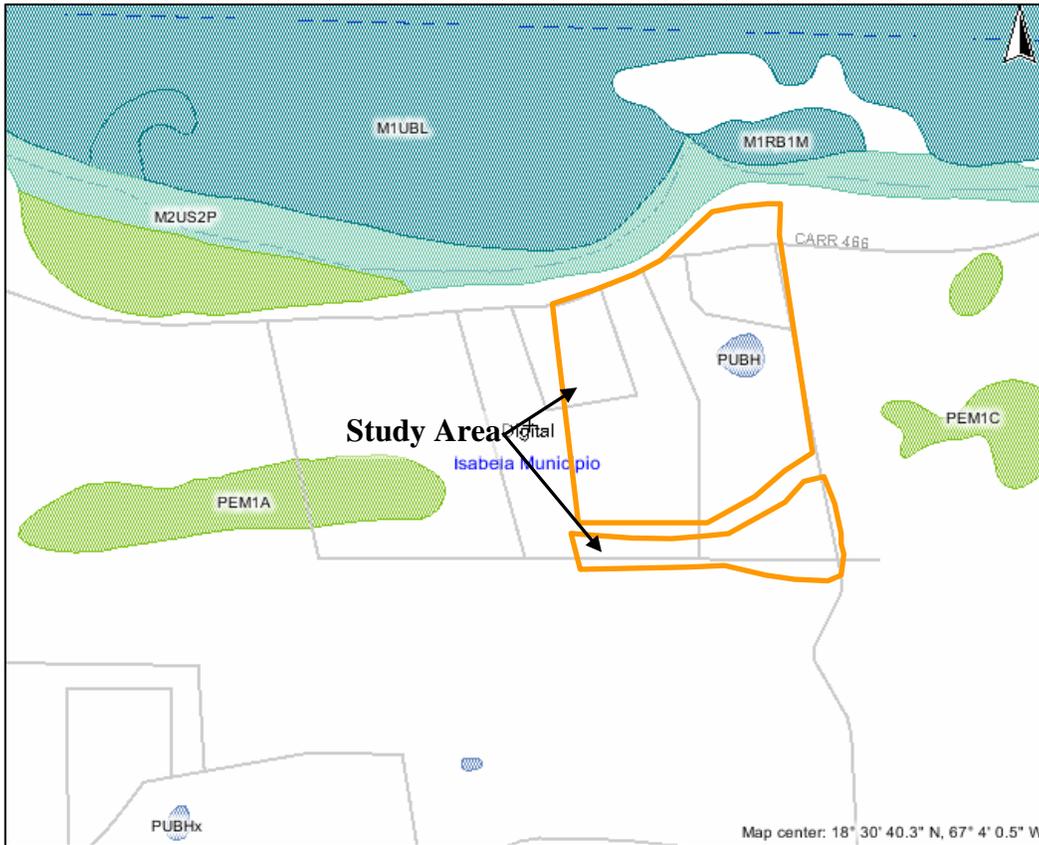
Figure 5

- e) National Wetlands Inventory Map (Figure 5): This map identifies the pond area observed in Figure 1 with the wetland code PUBH which corresponds to Palustrine, unconsolidated bottom, permanently flooded area. According to the Cowardin<sup>15</sup> classification of wetlands, the Palustrine System, which is one of the five major systems, includes nontidal wetlands dominated by trees, shrubs, persistent emergents, emergent mosses or lichens, and all such wetlands that occur in tidal areas where salinity due to ocean-derived salts is below 0.5 percent. This system groups the vegetated wetlands traditionally called by such names as marsh, swamp, bog, fen, and prairie. It also includes the small, shallow, permanent or intermittent water bodies often called ponds. The Palustrine System is bounded by upland or by any of the other four systems. Based on this map, there are no other mapped wetlands within the study site.

National Wetlands Inventory Map

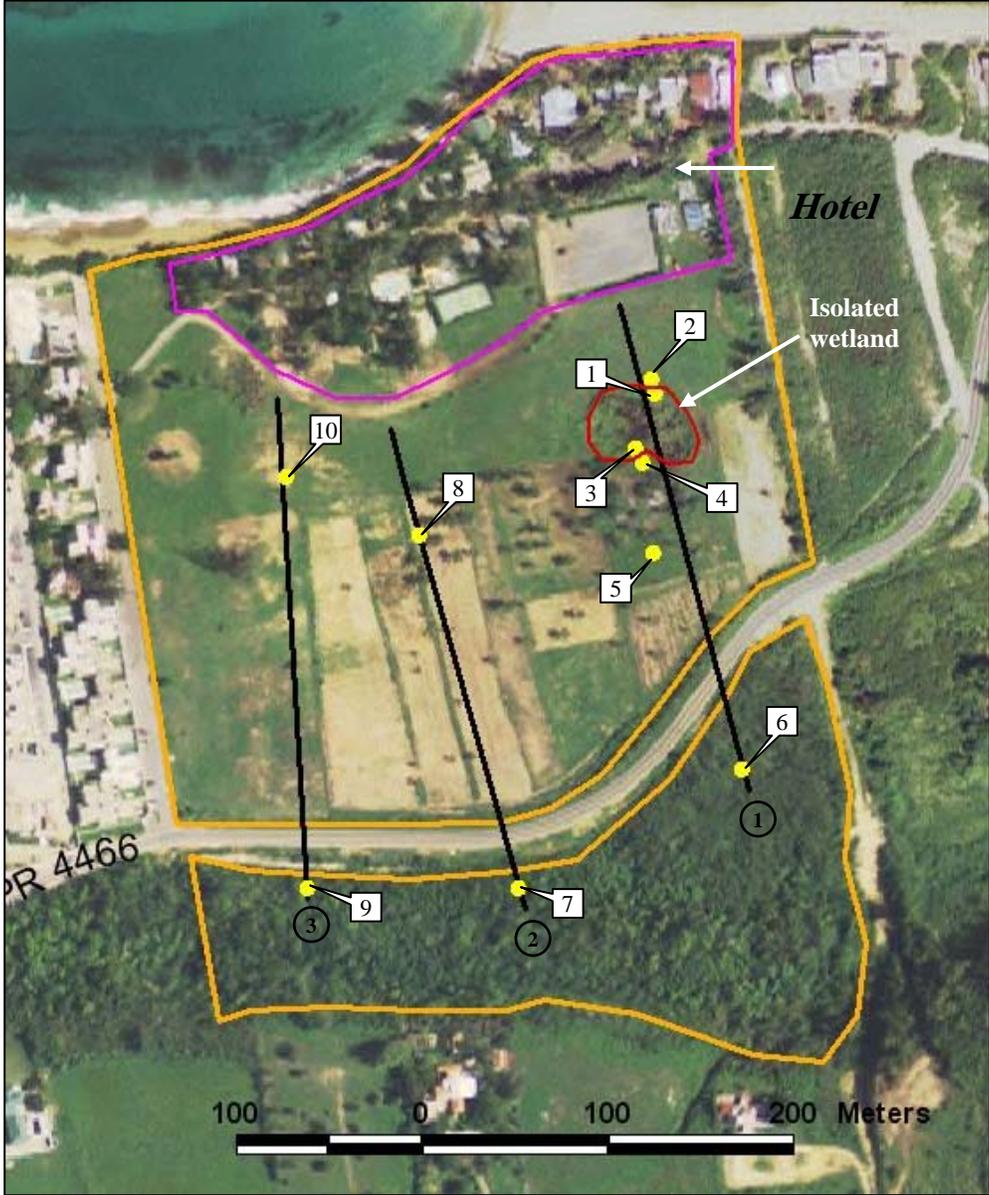
Figure 7  
 Preliminary Jurisdictional Determination Map

The fieldwork was conducted on June 24, 2007. Prevailing weather conditions during the survey were sunny and dry. A walkthrough of the property was made. The pond area identified during the preliminary work located in the northern tract of Figure 1 was found. The first of three transects was established at this location to cover the pond and its adjacent areas. The other transects were established to the west (Figure 7).

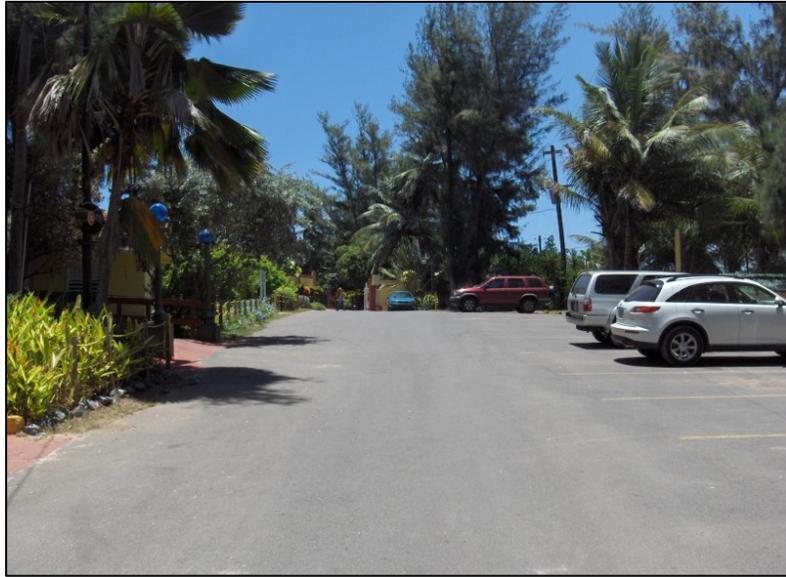
The 7.8 cuerdas of the hotel complex were inspected. This is a developed area with several cabin and apartment buildings along the coastline, paved access road, recreational facilities, restaurant, swimming pool, and souvenir shop. Figure 8 shows photos of this area. The vegetation consists of large Casurina trees, palm trees, and other ornamental plants. No wetland indicators were observed.

8A. View of the paved access road and surrounding facilities.

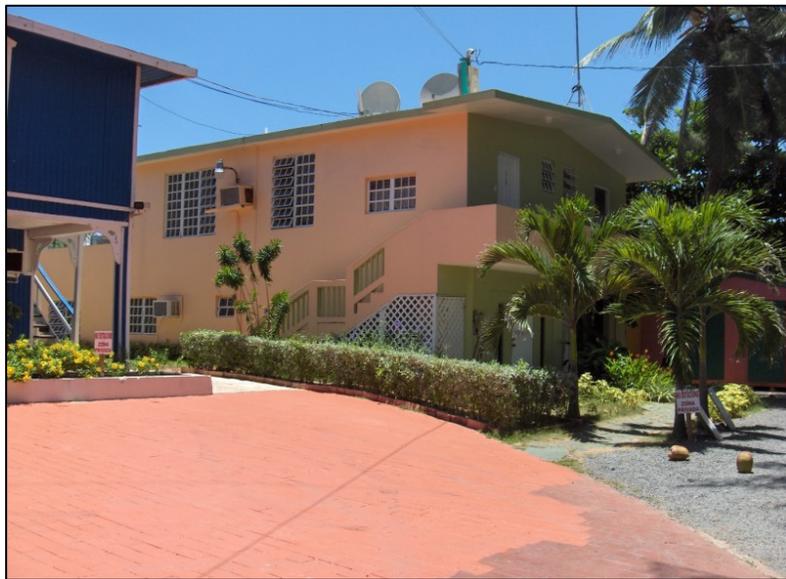
8B. View of the apartment buildings and residential area.

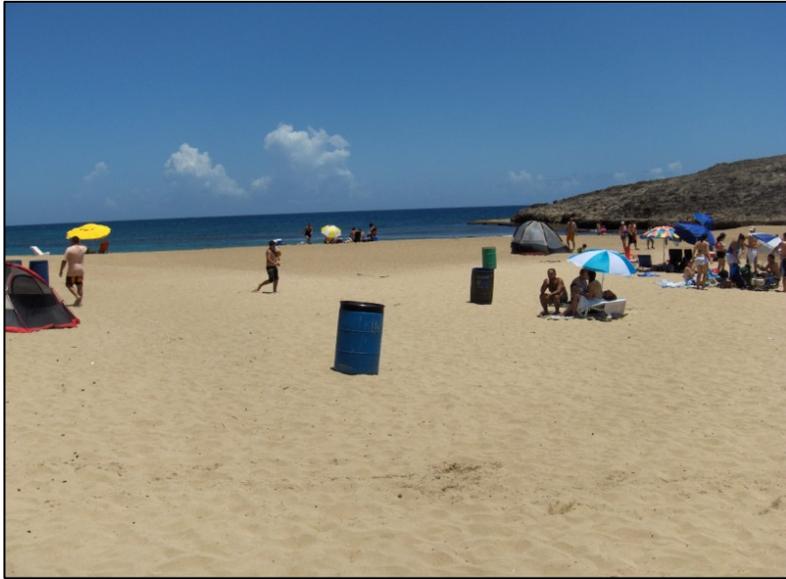
The landward limits of tidal waters of the U.S. extend to the high tide line.<sup>16</sup> The shoreline was inspected to determine the proximity of the study area to the high tide line. The northern boundary of the study area is at least at 20-30 meters above the high tide line. Figure 9 shows photos of this area. This shoreline is a bare sand dune used for recreational purposes. No ditches or streams were observed that could connect the study area with the sea. No wetland indicators were observed.

9A. View of the shoreline (looking north).

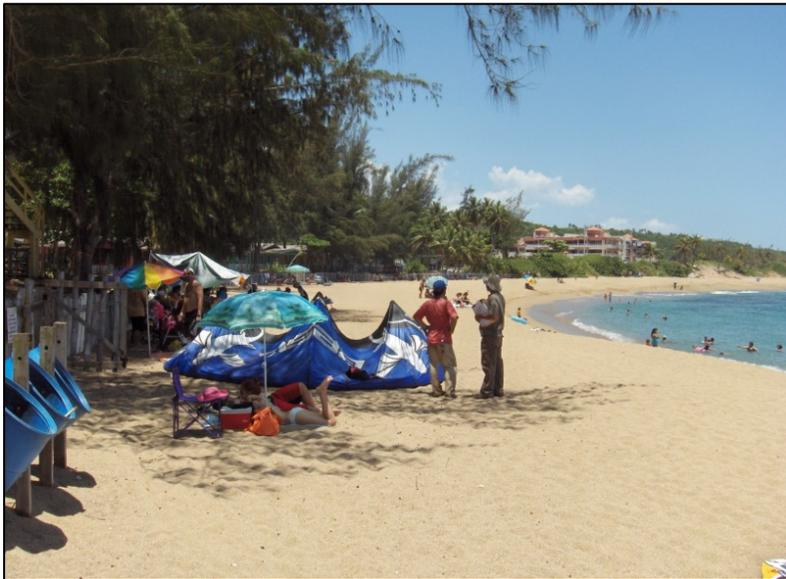
9B. View of the shoreline (looking west).

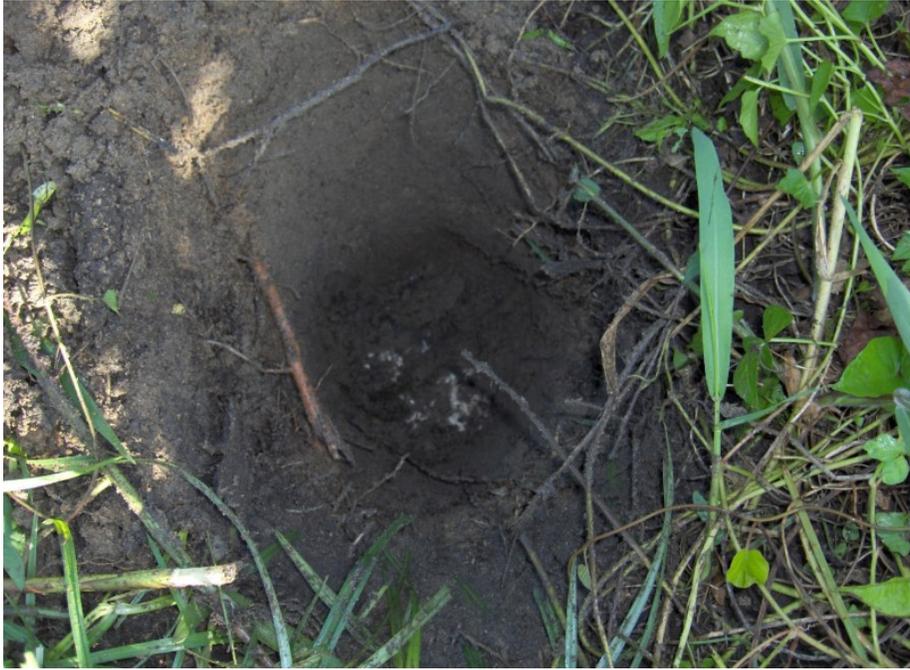
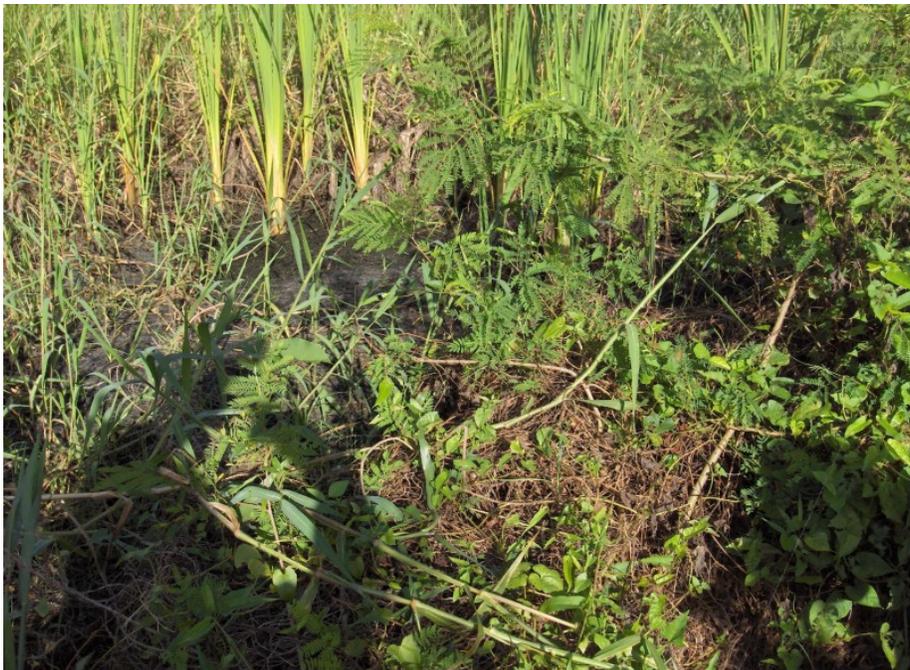
## Photos of Sample Plot 1

Soil pit.

General view of the observation point.

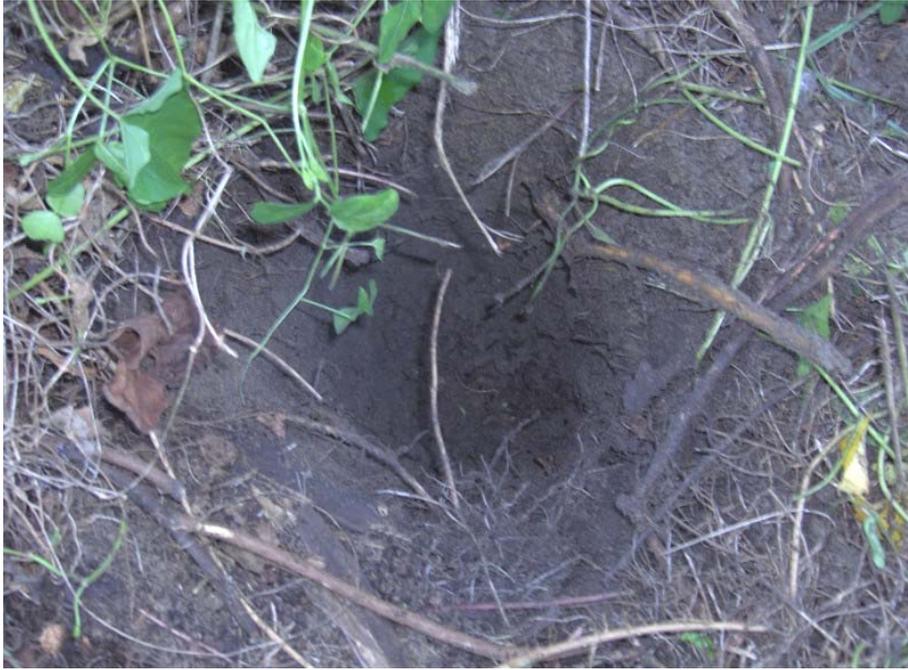
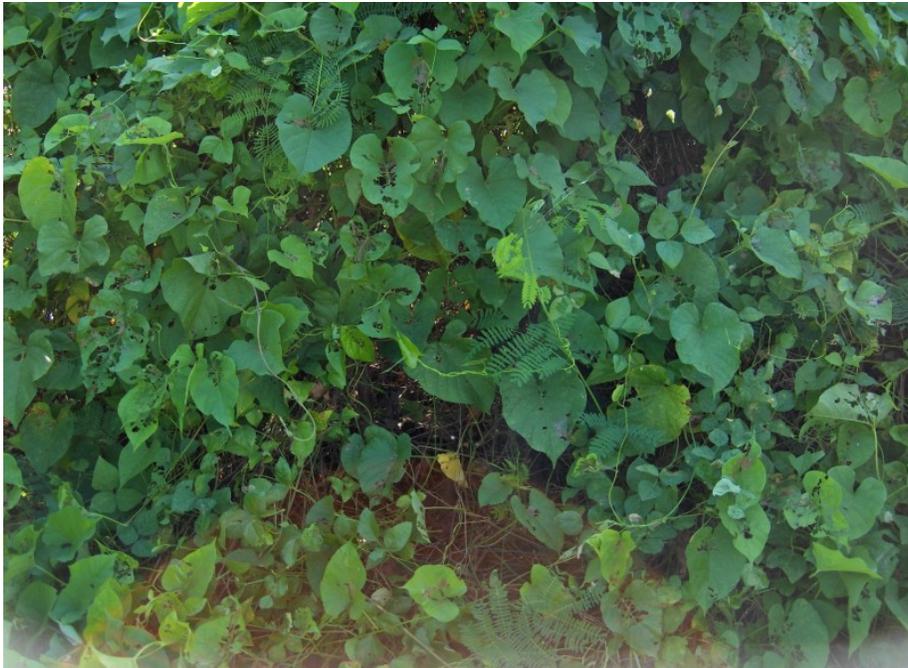
## Photos of Sample Plot 2

<p>Remarks: No hydrology indicators observed.</p>

Soil pit.

General view of the observation point.

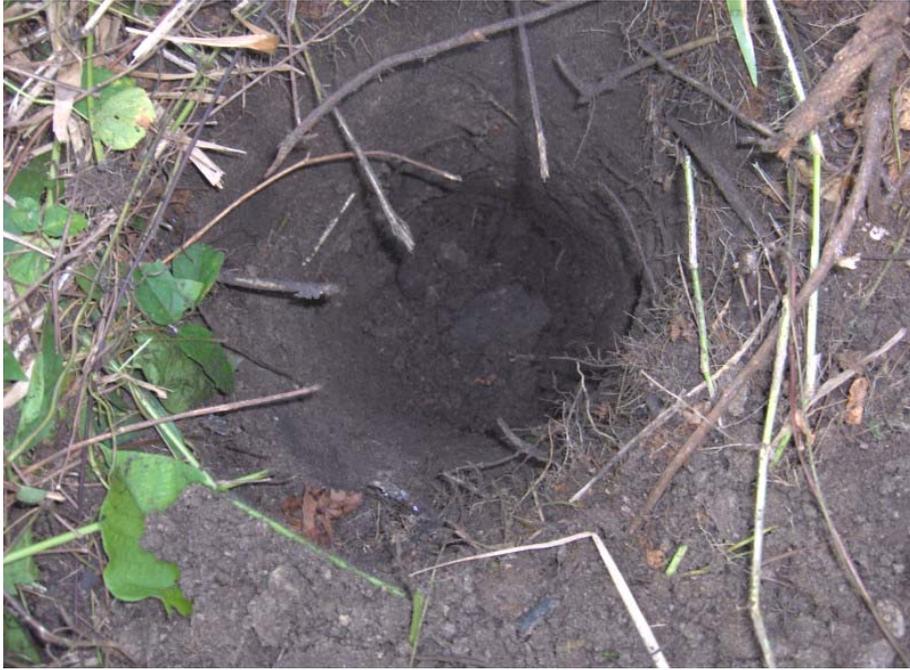
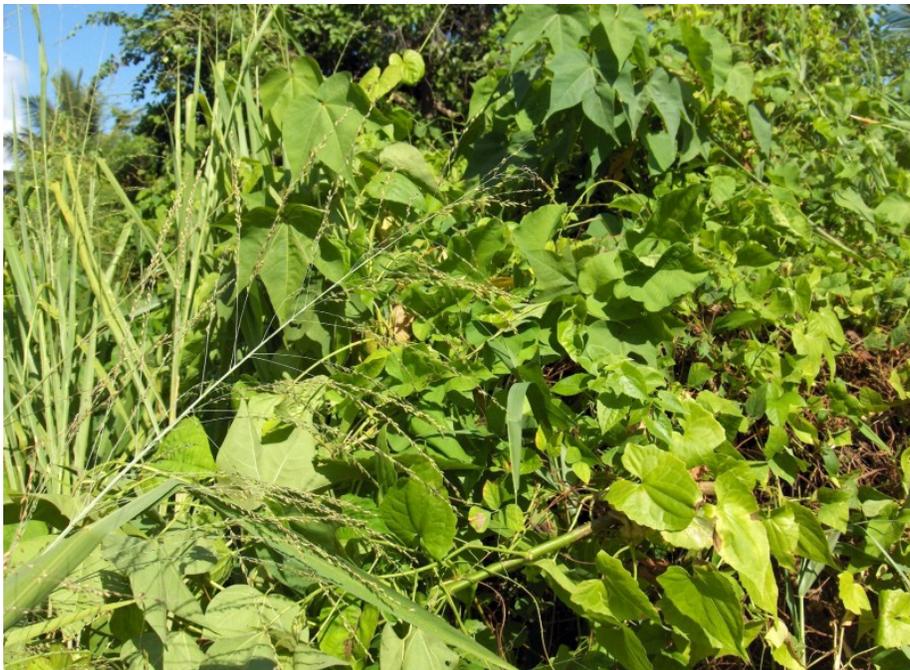
## Photos of Sample Plot 4

Remarks: The hydric component was not found.

Soil pit.

General view of the observation point.

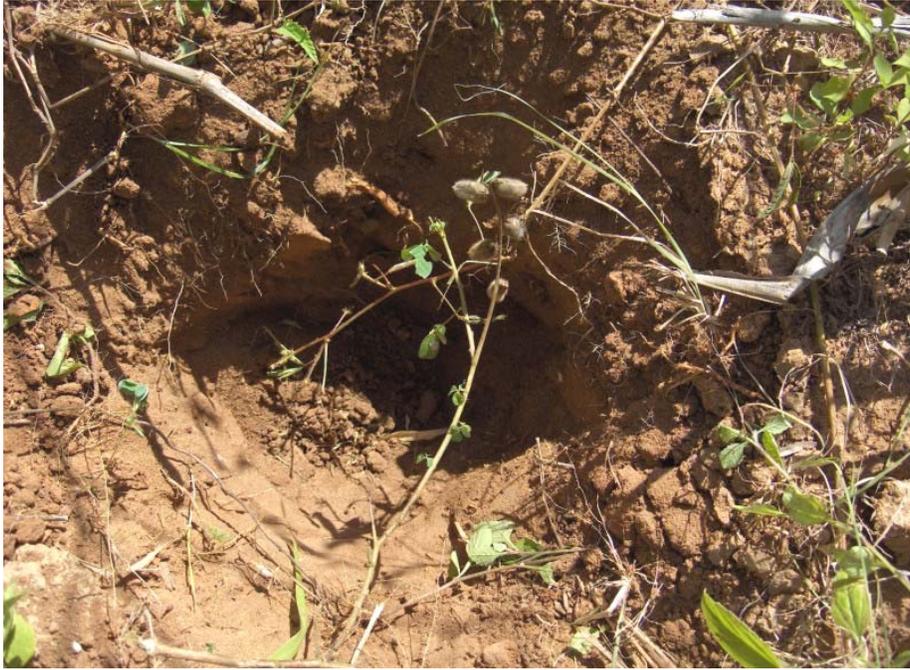
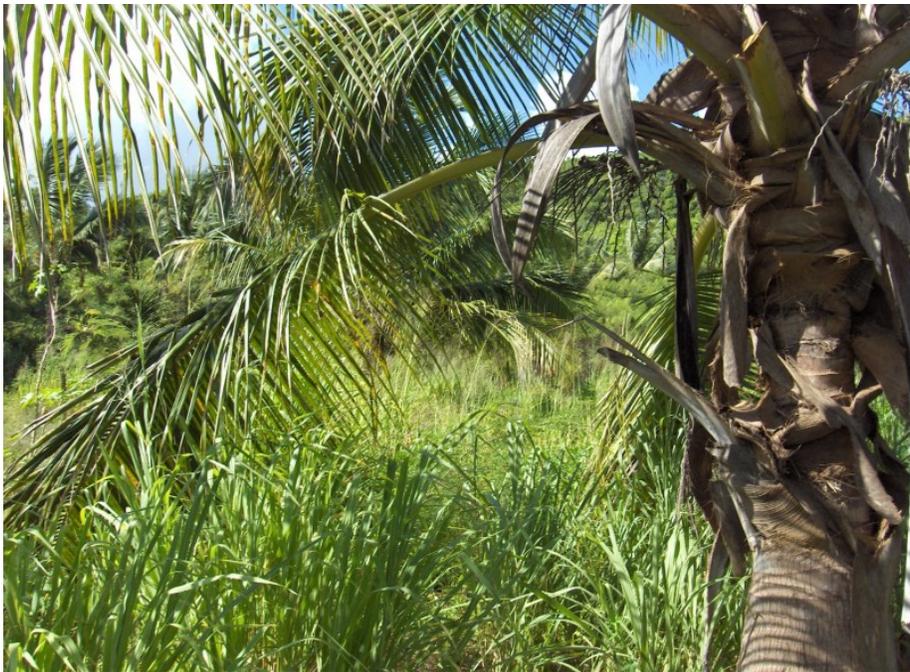
## Photos of Sample Plot 5

SP-5 was established south to the isolated wetland resulting non-wetland. There are coconut palms in this area and agricultural commodities such as cassava are being cultivated. No wetland indicators were observed.

Soil pit.

General view of the observation point.

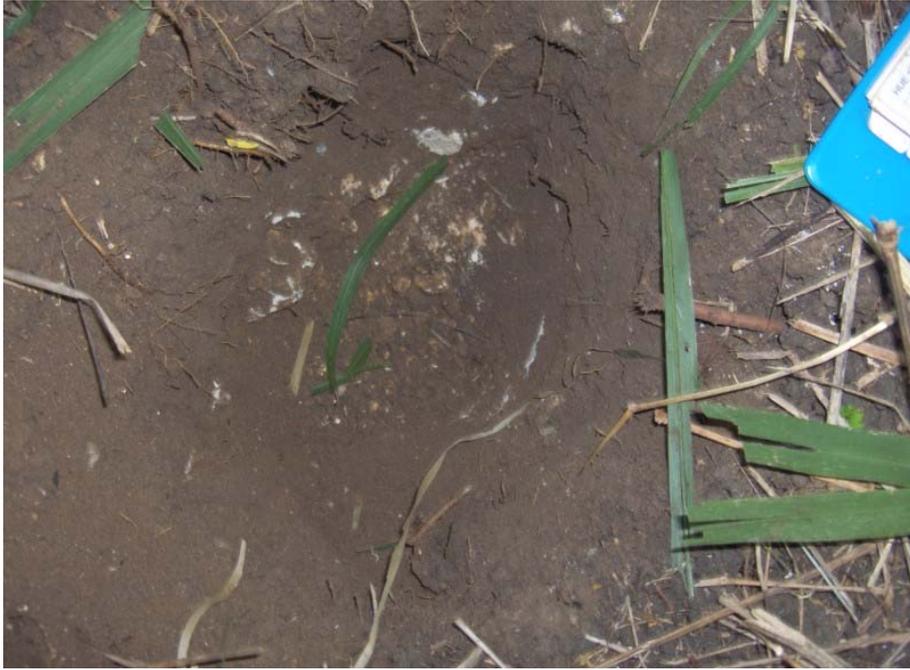
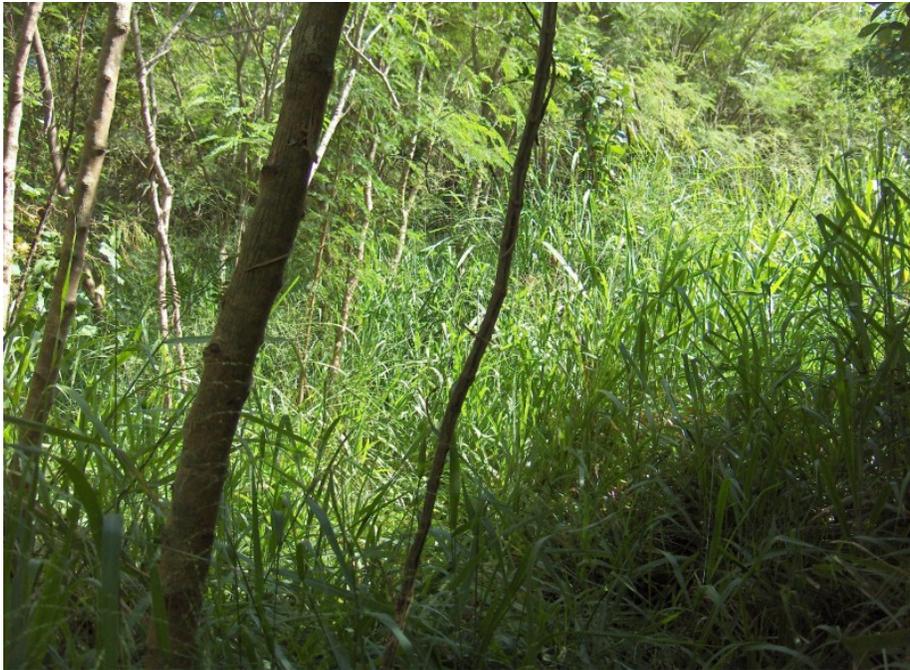
## Photos of Sample Plot

SP-6 was established in the southern tract. It resulted non-wetland. This area is in proximity to the limestone outcrop. The lower soil layers are hard and dominated by the limestone. No wetland indicators were observed.

<u>    </u> Histosol	<u>    </u> Concretions																																																	
<u>    </u> Histic Epipedon	<u>    </u> High Organic Content In Surface Layer of Sandy Soils																																																	
<u>    </u> Sulfidic Odor	<u>    </u> Organic Streaking in Sandy Soils																																																	
<u>    </u> Aquic Moisture Regime	<u>    </u> Listed on Local Hydric Soils List																																																	
<u>    </u> Reducing Conditions	<u>    </u> Listed on National Hydric Soils List																																																	
<u>    </u> Gleyed of Low-Chroma Colors	<u>    </u> Other (Explain in Remarks)																																																	
<p>Remarks: Limestone below 9". Could not dig deeper.</p>

Soil pit.

General view of the observation point.
