Wetland Jurisdictional Determination

Municipal Road to Punta Lima, Santiago y Lima Ward,
Naguabo, Puerto Rico

February 2008

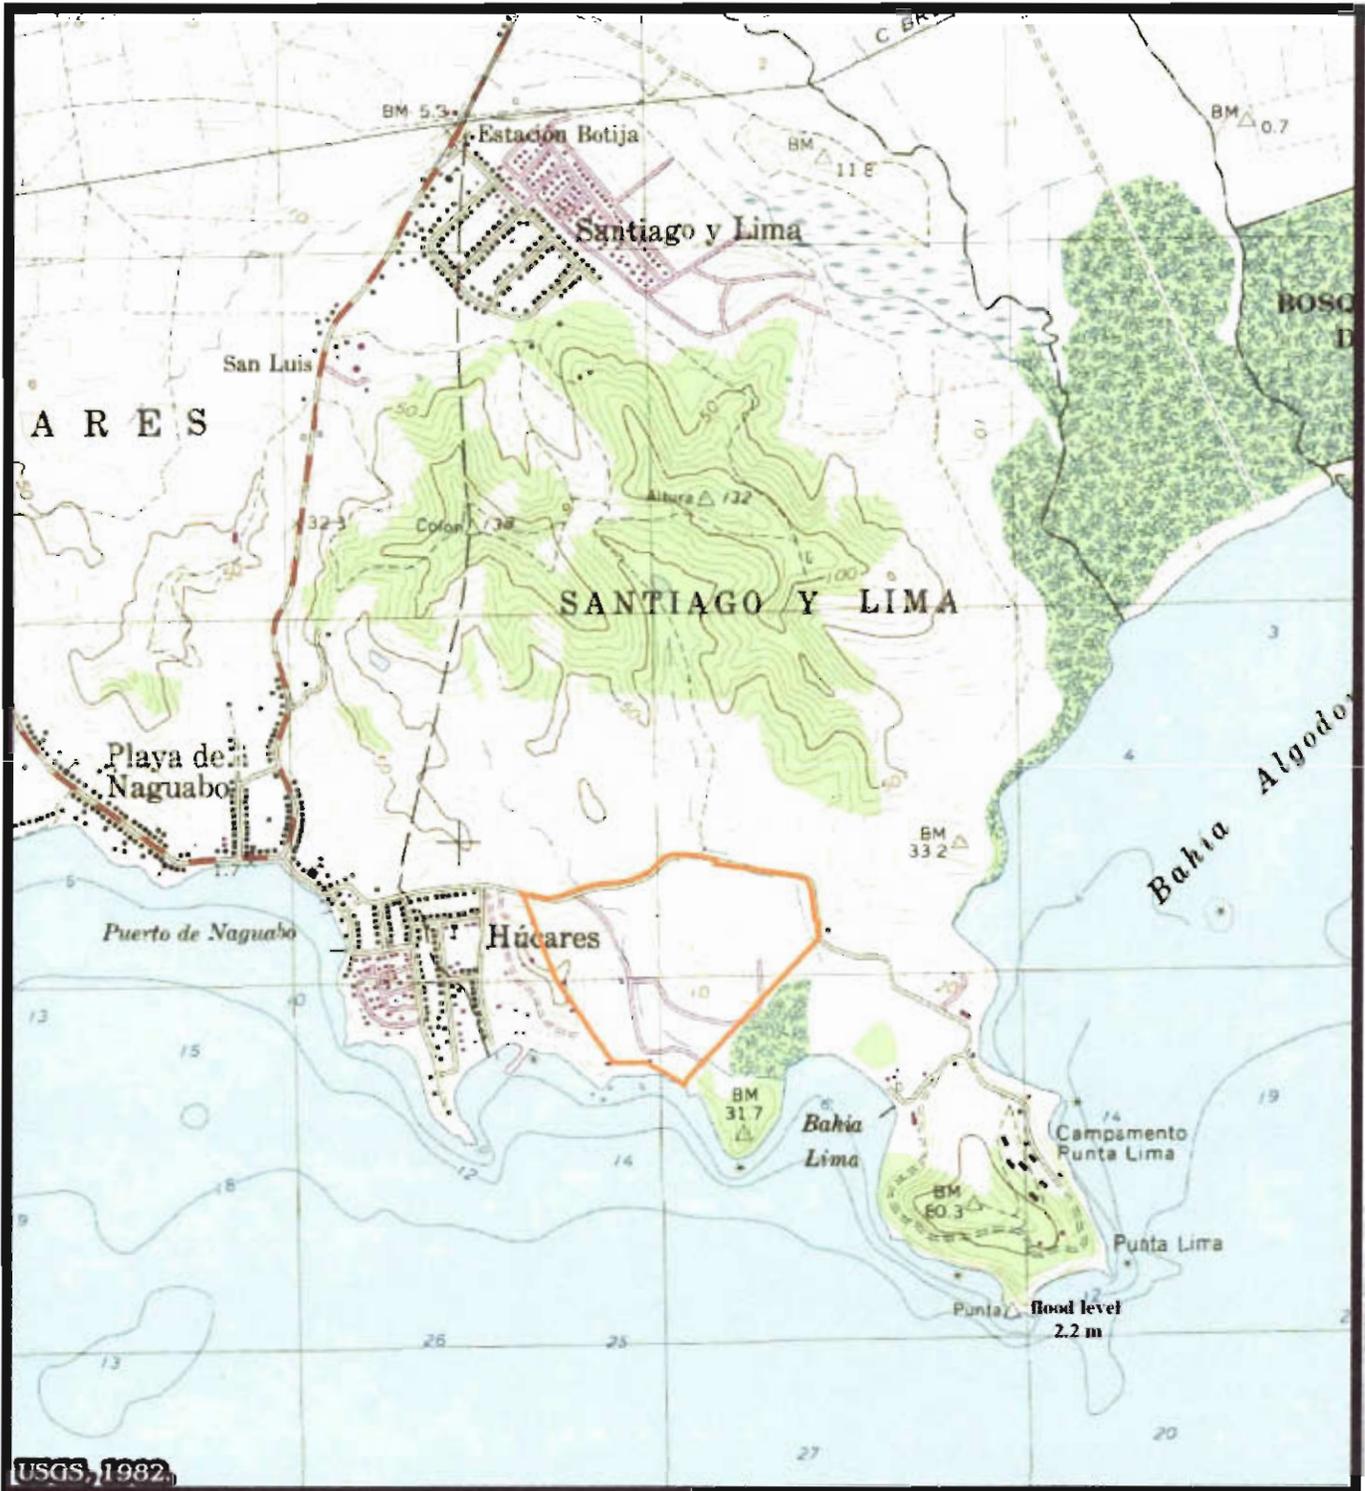
FIGURE 1. TOPOGRAPHIC MAP

Figure 1 illustrates the property boundaries in the Topographic Map of the Naguabo Quadrangle. Figure 2 presents the site location on a 2002 Aerial Photograph. Both figures are part of Appendix 1.

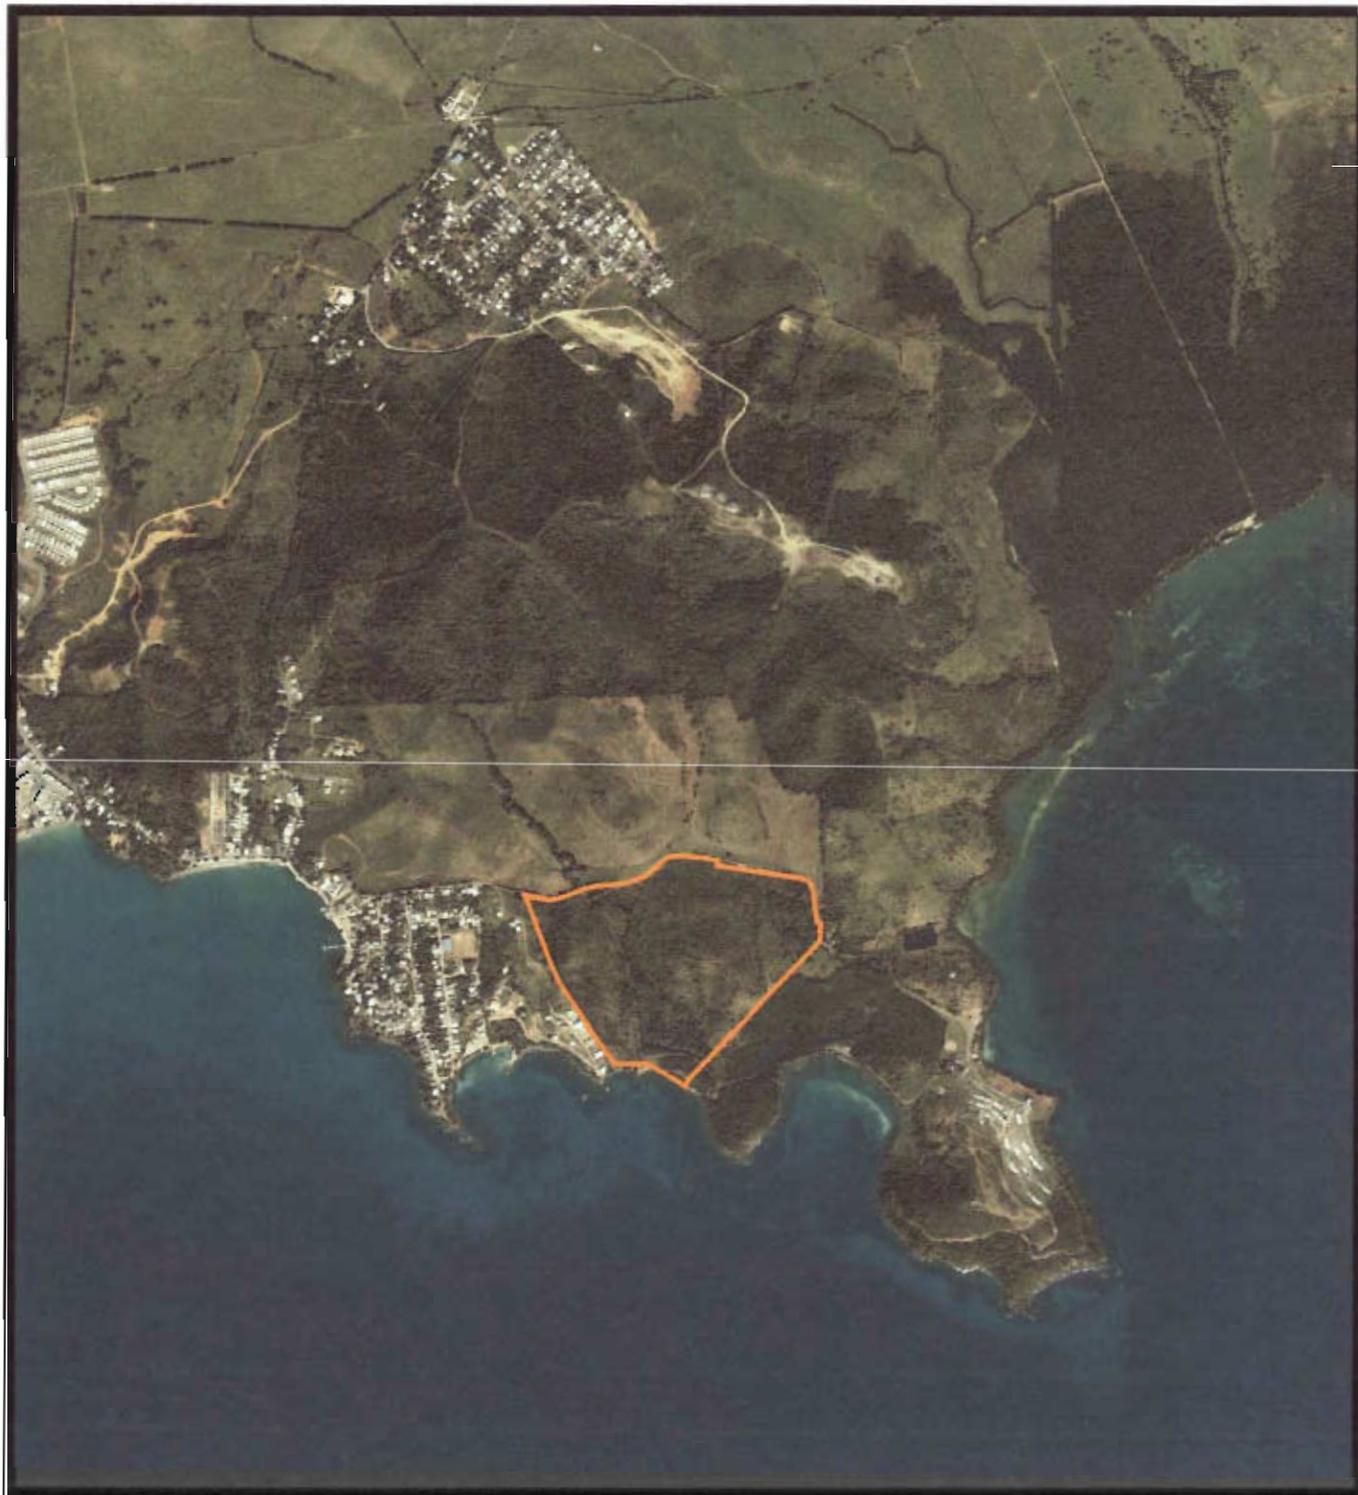
FIGURE 2. IKONOS 2002

- ❖ **Aerial photographs (should be the latest available and must be as clear as possible):** This report includes a 2002 Aerial Photograph, which is used in figure2 presented in Appendix 1. However, the wetland delineation is illustrated over the 1997 aerial photograph due to the better resolution and site interpretation.

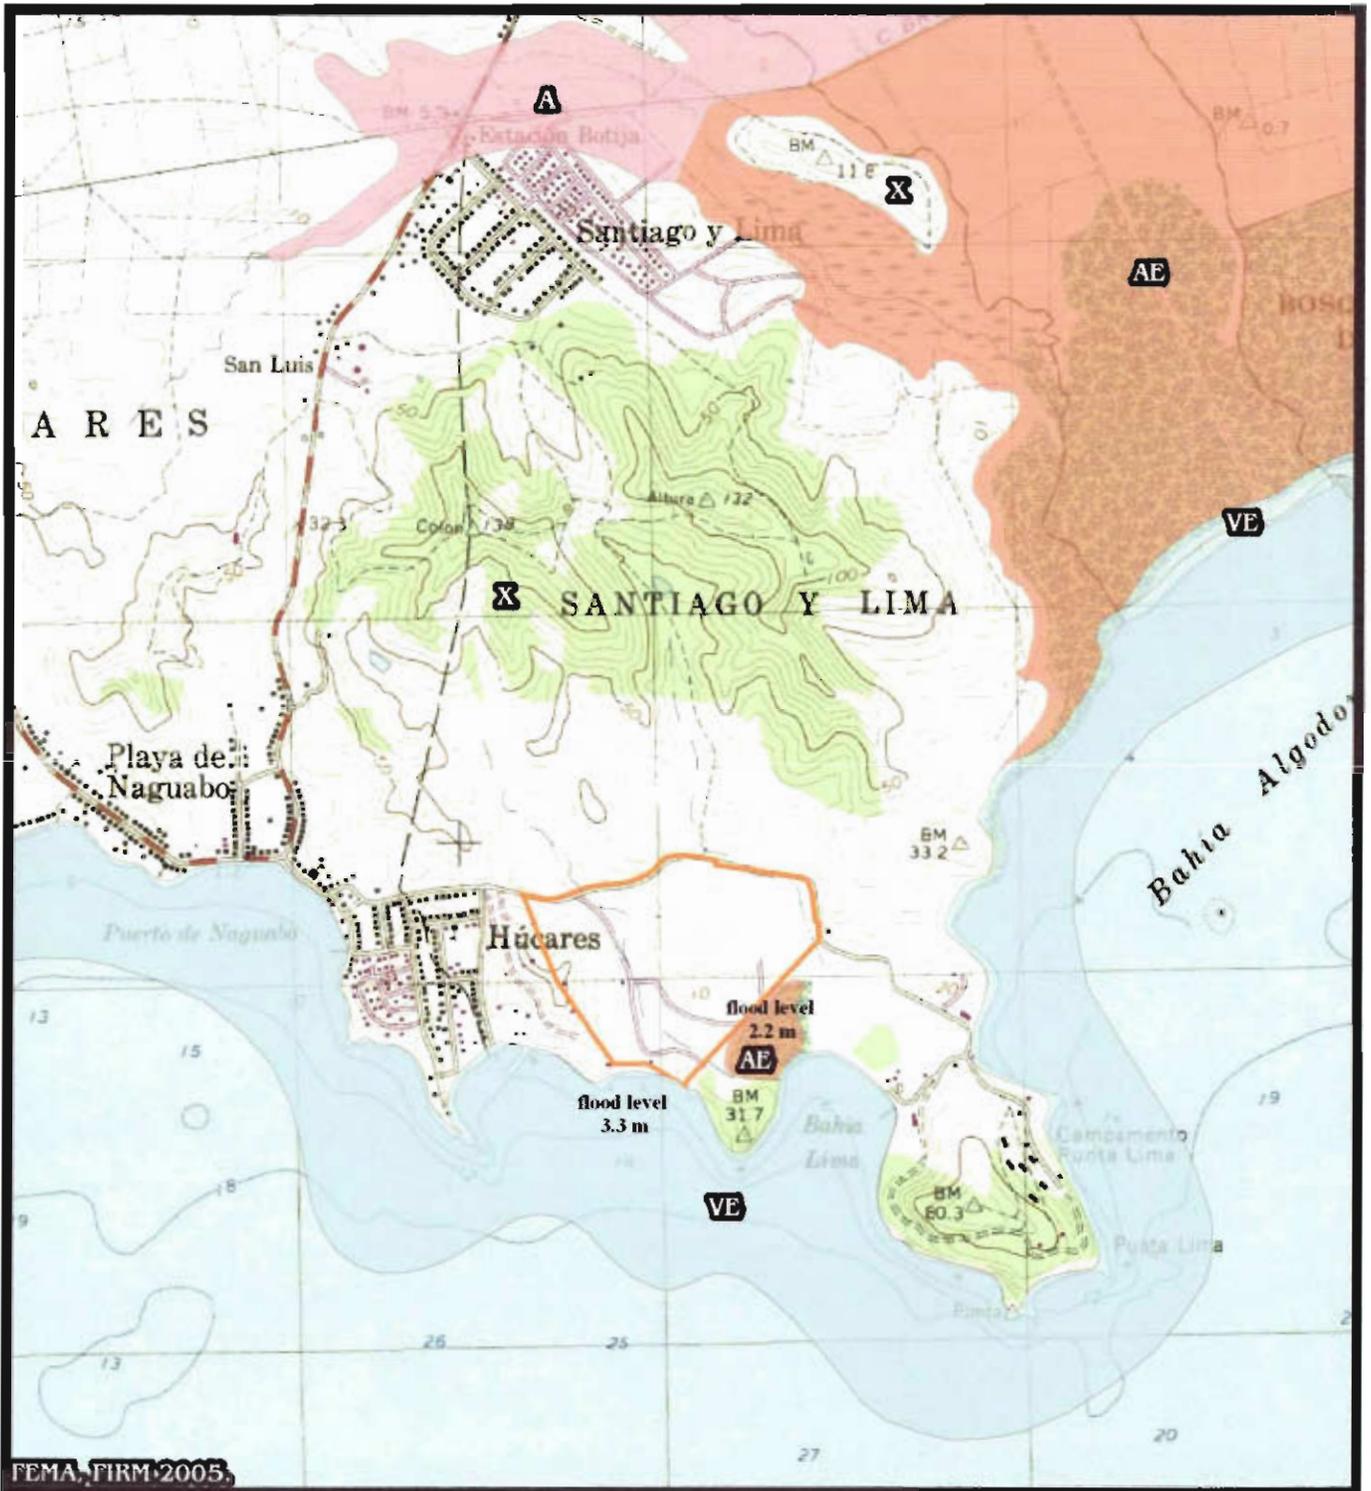
FIGURE 3. FLOOD MAP

A pond area is present at a topographic depression at the end of the intermittent creek 1. This pond is located above mean sea level (See OP-2 photo). The flood prone areas near (but outside) the site are shown in Figure 3.

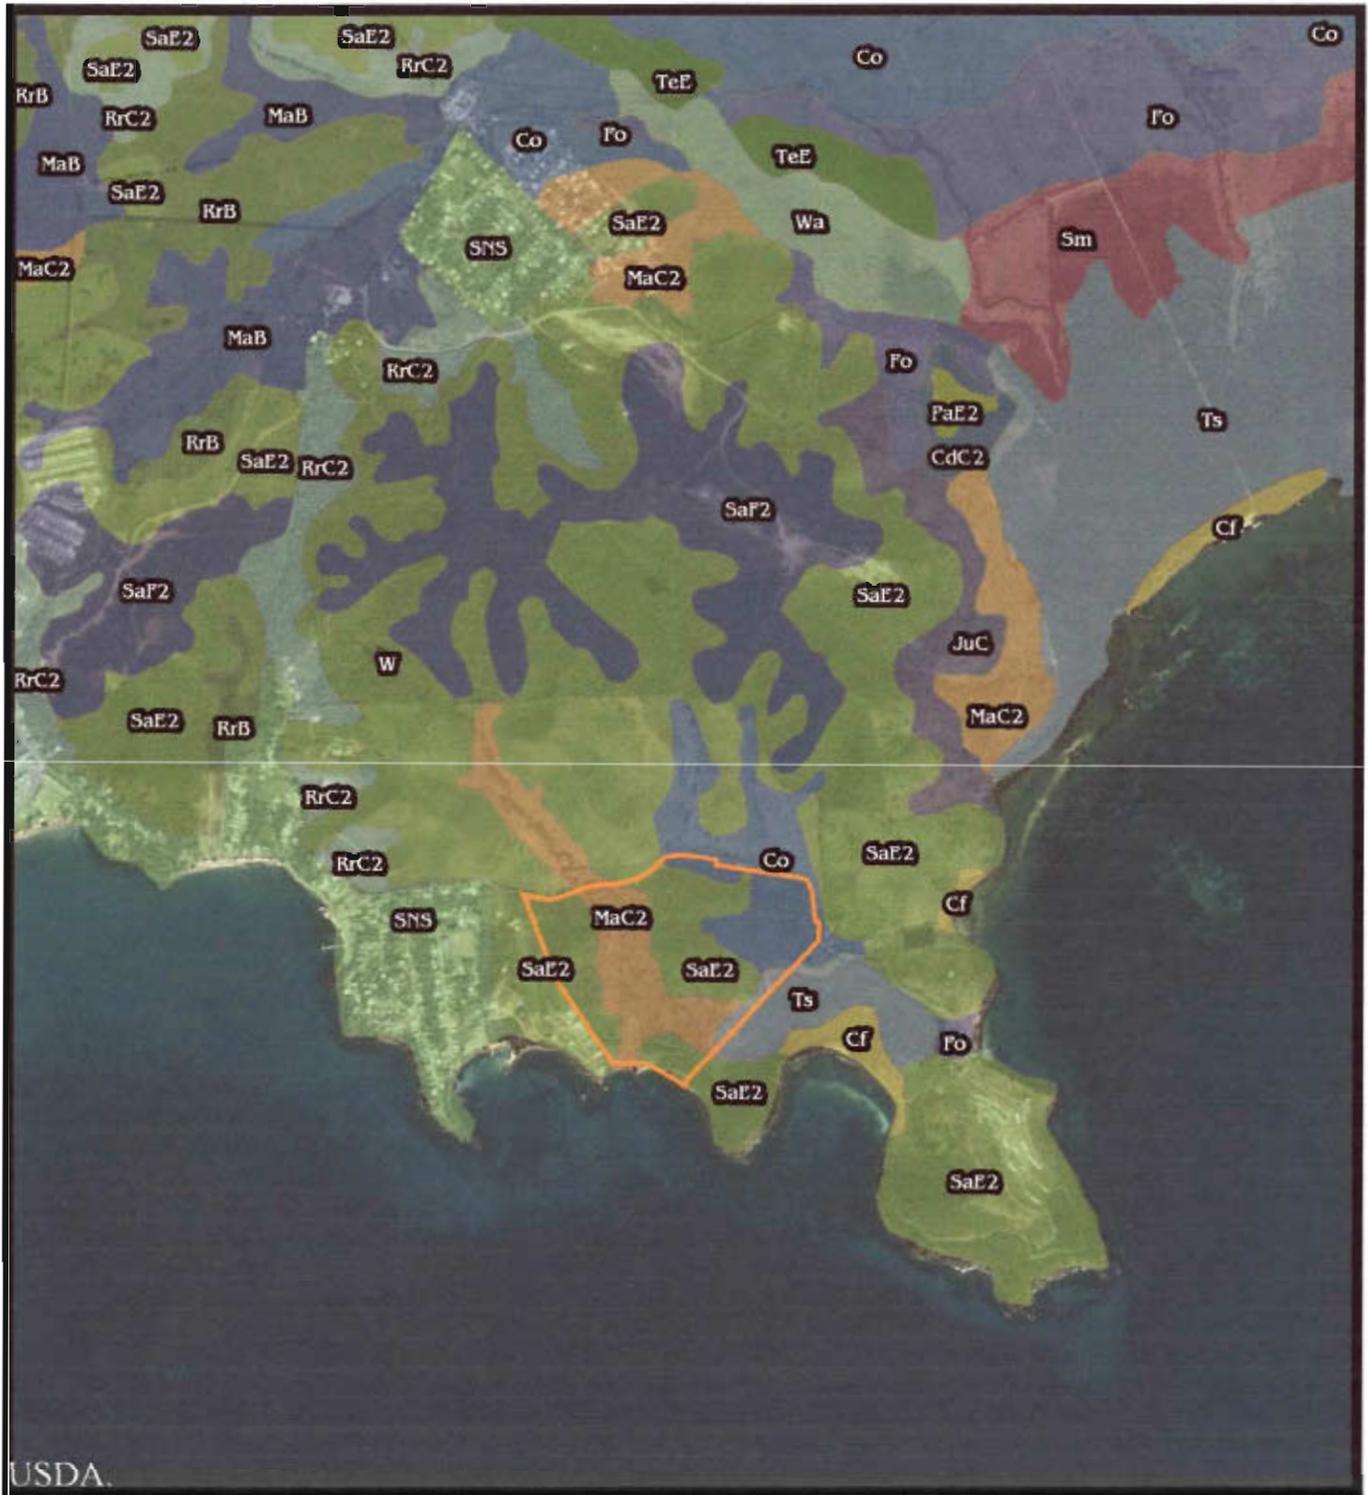
FIGURE 4. SOILS MAP

According to the Soil Survey of the Humacao Area of Puerto Rico, there are four different soils mapped in the study area: Co-Coloso silty clay loam occasionally flooded, TS-Tidal swamps, MaC2-Mabi clay 5 to 12 percent slopes and SaE2- Sabana silty clay loam 20 to 40 percent slopes (See Figure 4). The Hydric Soils List of the Caribbean Area, identify the Tidal Swamp as a hydric soil and the Coloso silty clay loam as a soil with potential hydric inclusions.

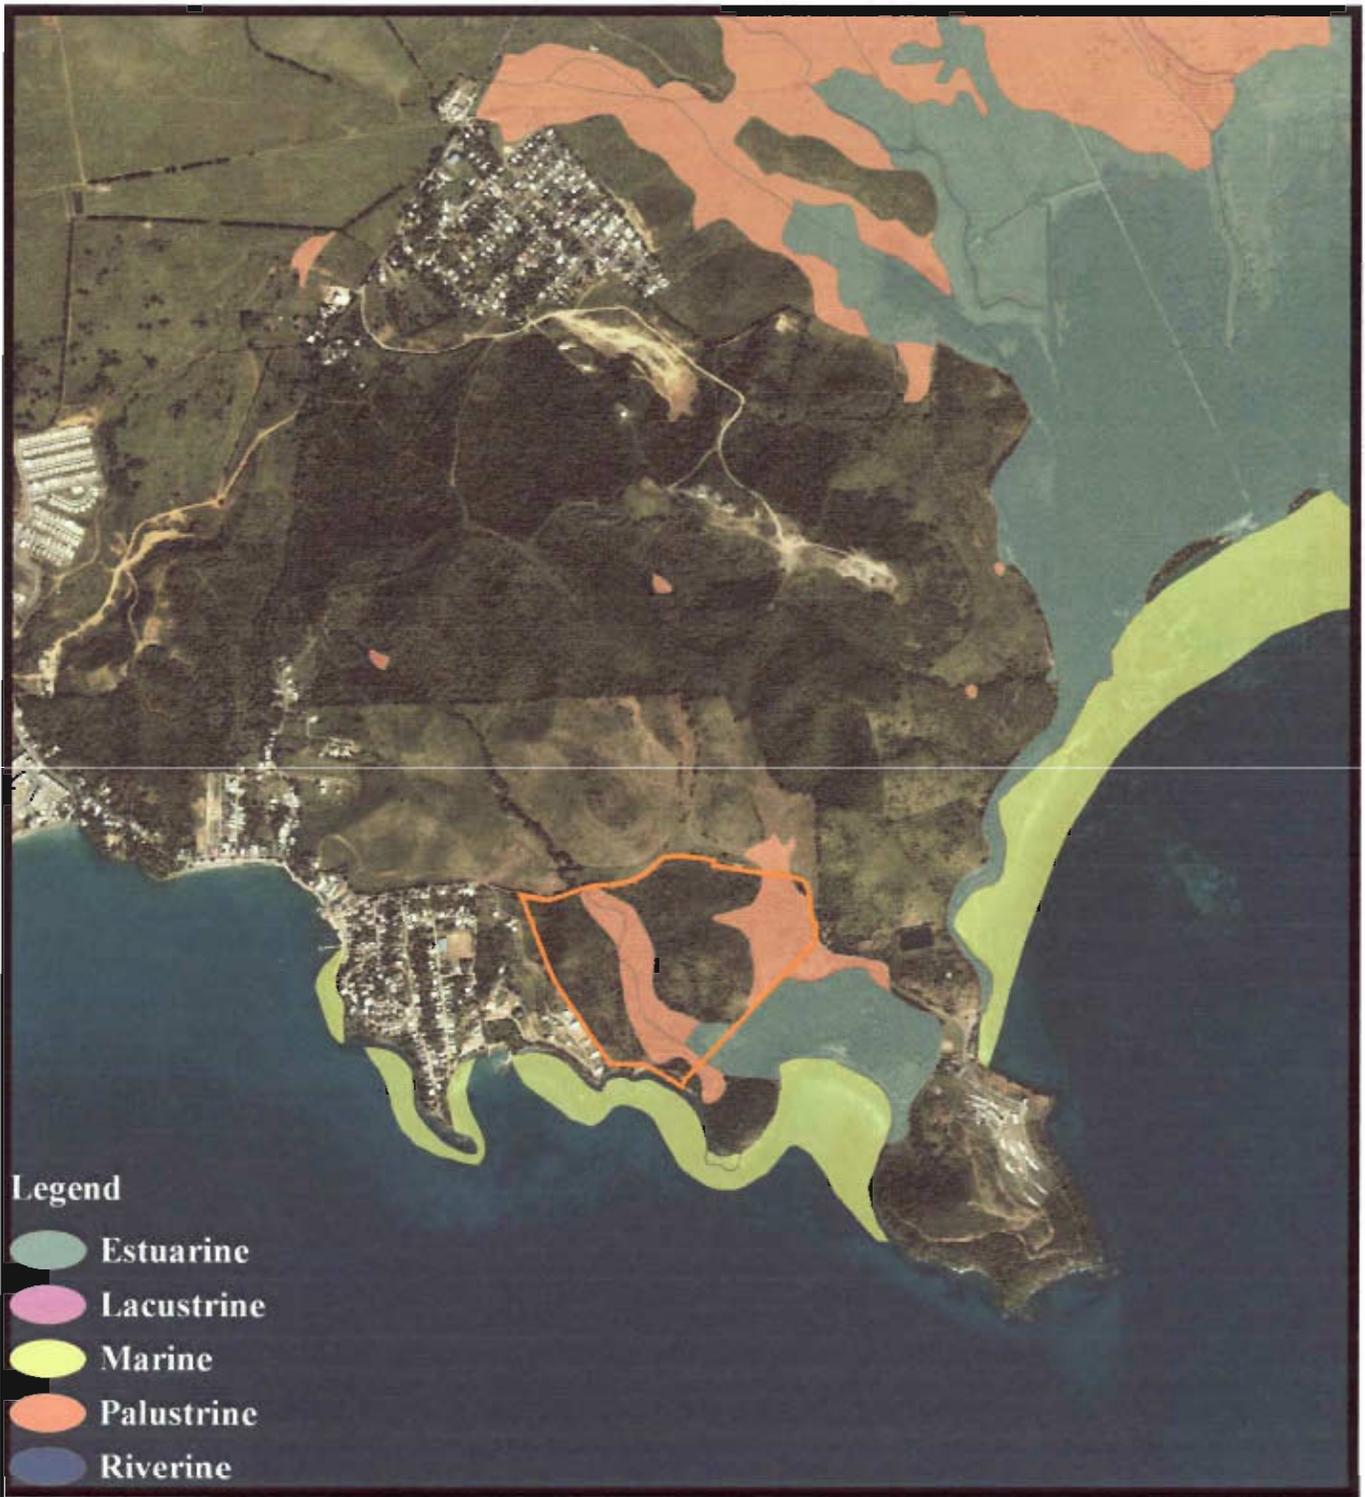
FIGURE 8. NATIONAL WETLAND INVENTORY

illustrated in the National Wetland Inventory Map (see observation points 3 and 4 photographs at Appendix 3).

As a result of this study, wetland areas were confirmed as previously illustrated by the National Wetlands Inventory Map. However, the wetlands were accurately delineated (see figures 9 and 10). The wetland areas identified have an area of approximately 4 acres. Land crabs holes within the wetland areas are an

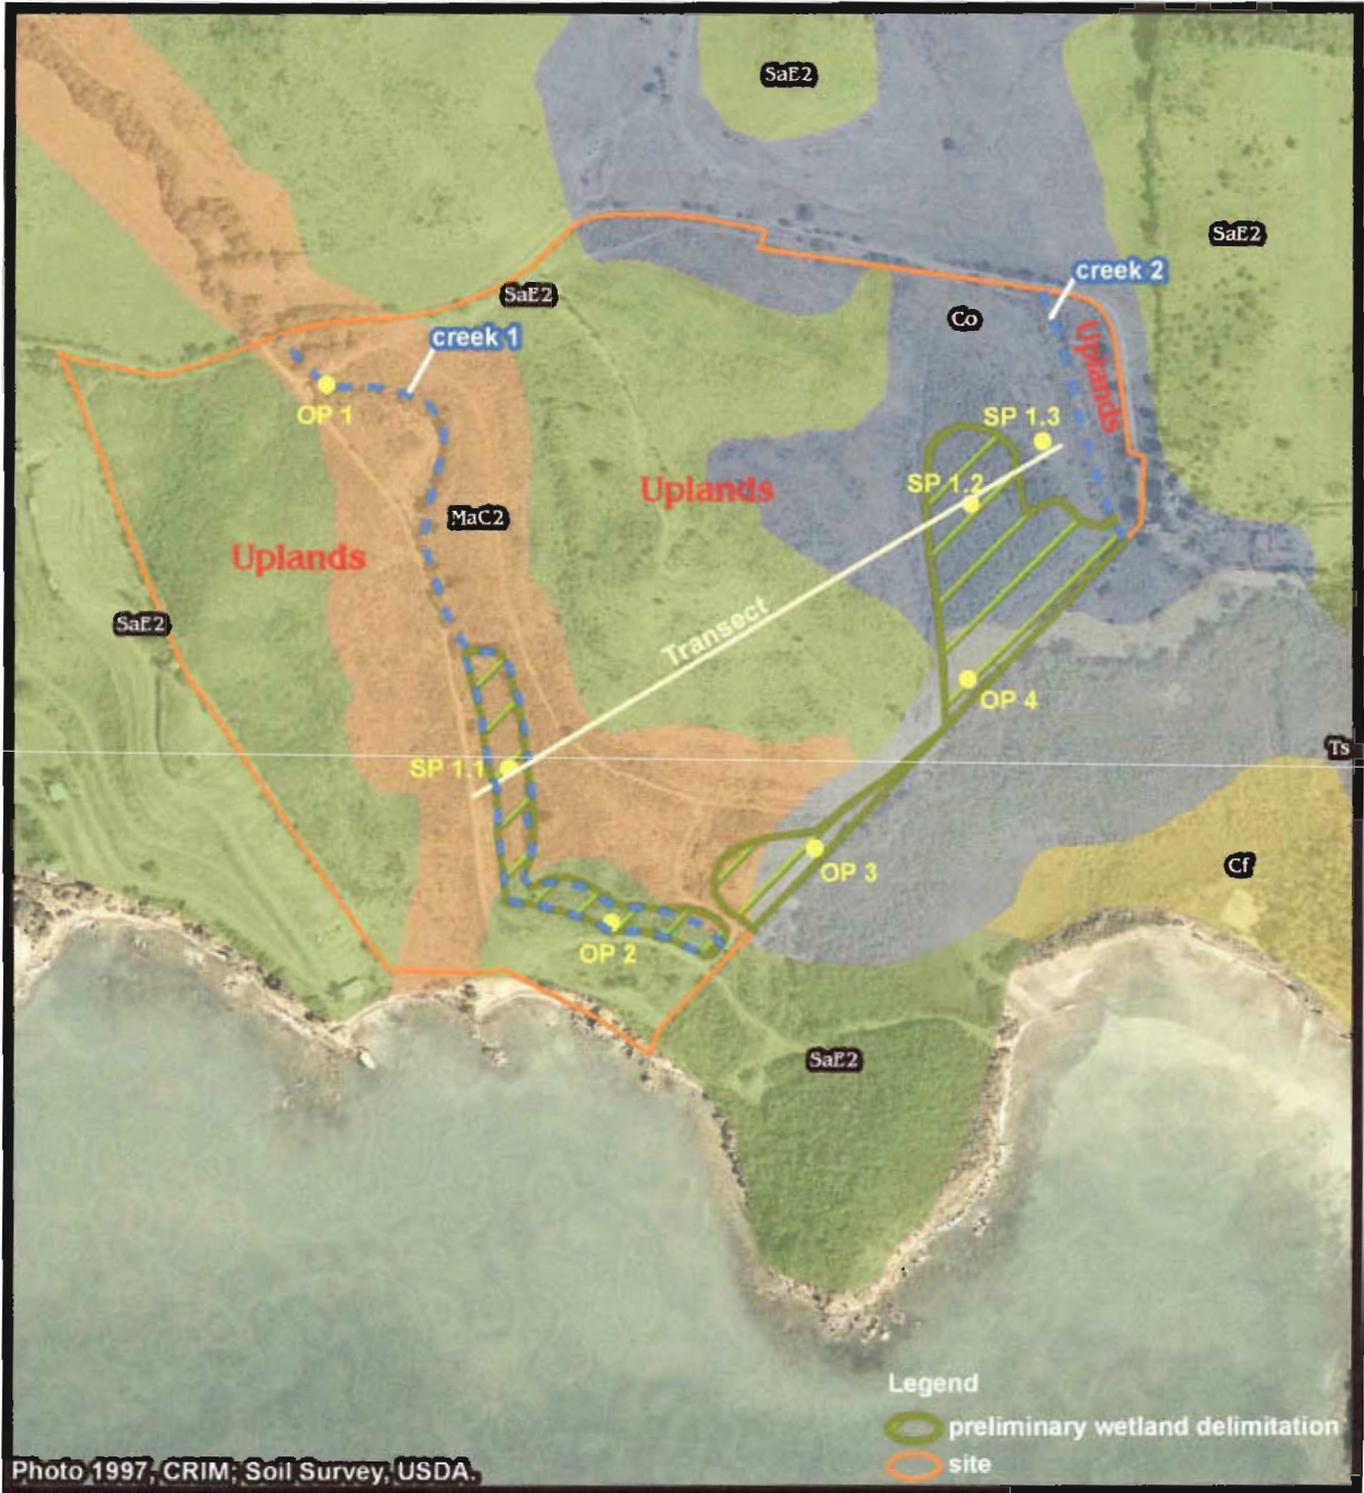
FIGURE 9. TRANSECT AND SAMPLING POINTS LOCATION AND PRELIMINARY WETLAND DELIMITATION

One transects and three sampling points were assessed for vegetation, hydrology and soils. The selected sampling points location was based on the characteristics of the site in such way that the information collected represents the different plants, hydrologic and soils at the nearly level portions of the site. Additional observations along the property were made to accurately define wetland/uplands boundaries (see observation points - OP- location in Figures 9 and 10).

Figures 9 and 10 illustrate transects and sampling points locations. Appendices 2 and 3, respectively, include the field data forms and a photographic record for each sampling point.

Other waters of the United States (two intermittent creeks) previously illustrated on the USGS Topographic Map of the Naguabo Quadrangle and the Soil Survey of the Humacao Area, were confirmed by this study. All the waters of the United States and Wetlands identified at the study area are illustrated on figures 9 and 10 of this report.

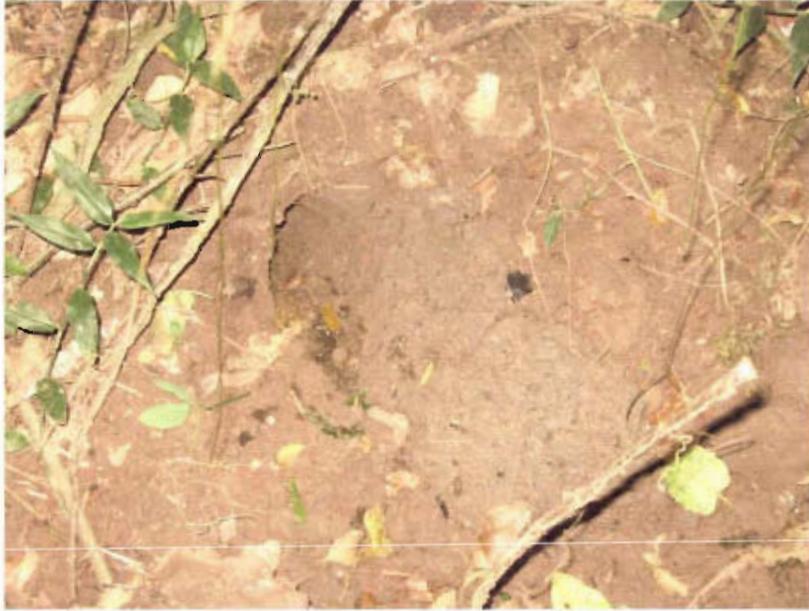
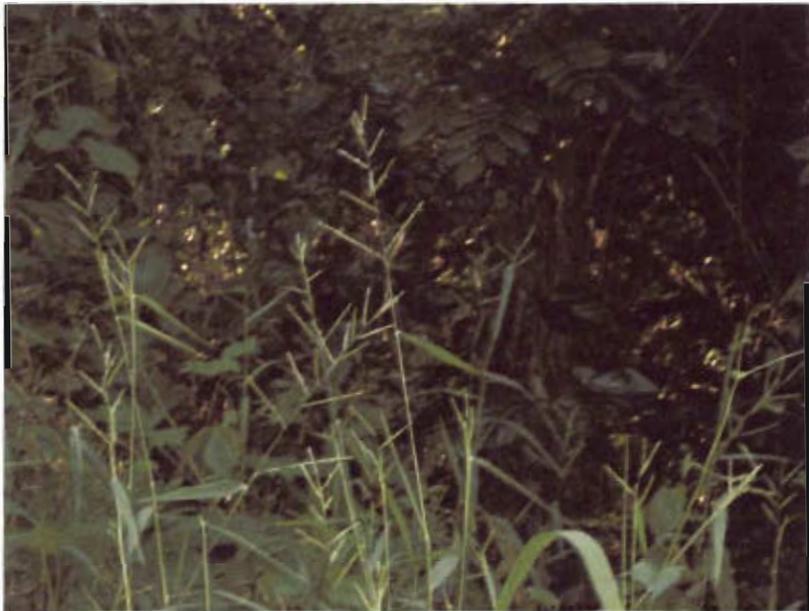
Sampling Point 1.1

Sampling points 1.1 and 1.2 were positive for wetland hydrology indicators (saturation criteria), while sampling point 1.3 was not. Other areas at the south east border of the property were confirmed as wetlands, as previously

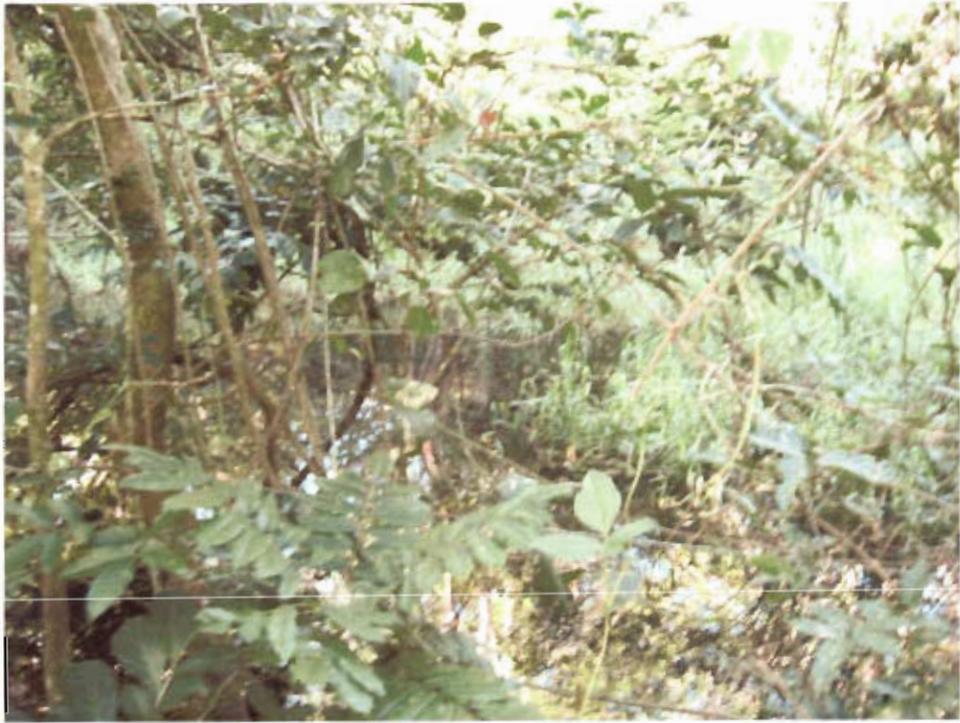
Observation Point 2

In order to determine locations for the soil samplings, a visual assessment of the area was performed with the guidance of the soil map. Soil pits were made on Coloso and Mabi soils. Due to evident presence of wetland indicators, the area with Tidal swamps soils was only observed but not sampled. Even when Mabi soils at the site are not listed as hydric or with hydric inclusions by the Hydric Soils List of the Caribbean Area, we decided to sample it, since it shows potential indicators of positive wetland conditions at a topographic depression on intermittent creek 1 (See sampling point 1 and observation point 2).
