Wetland Delineation Report

**El Nuevo Comandante
Canóvanas, Puerto Rico**

**LAND DEVELOPMENT ASSOCIATES, S.E. (LDA)
SAN JUAN, PUERTO RICO**

**CMA ARCHITECTS & ENGINEERS LLP
San Juan, Puerto Rico**

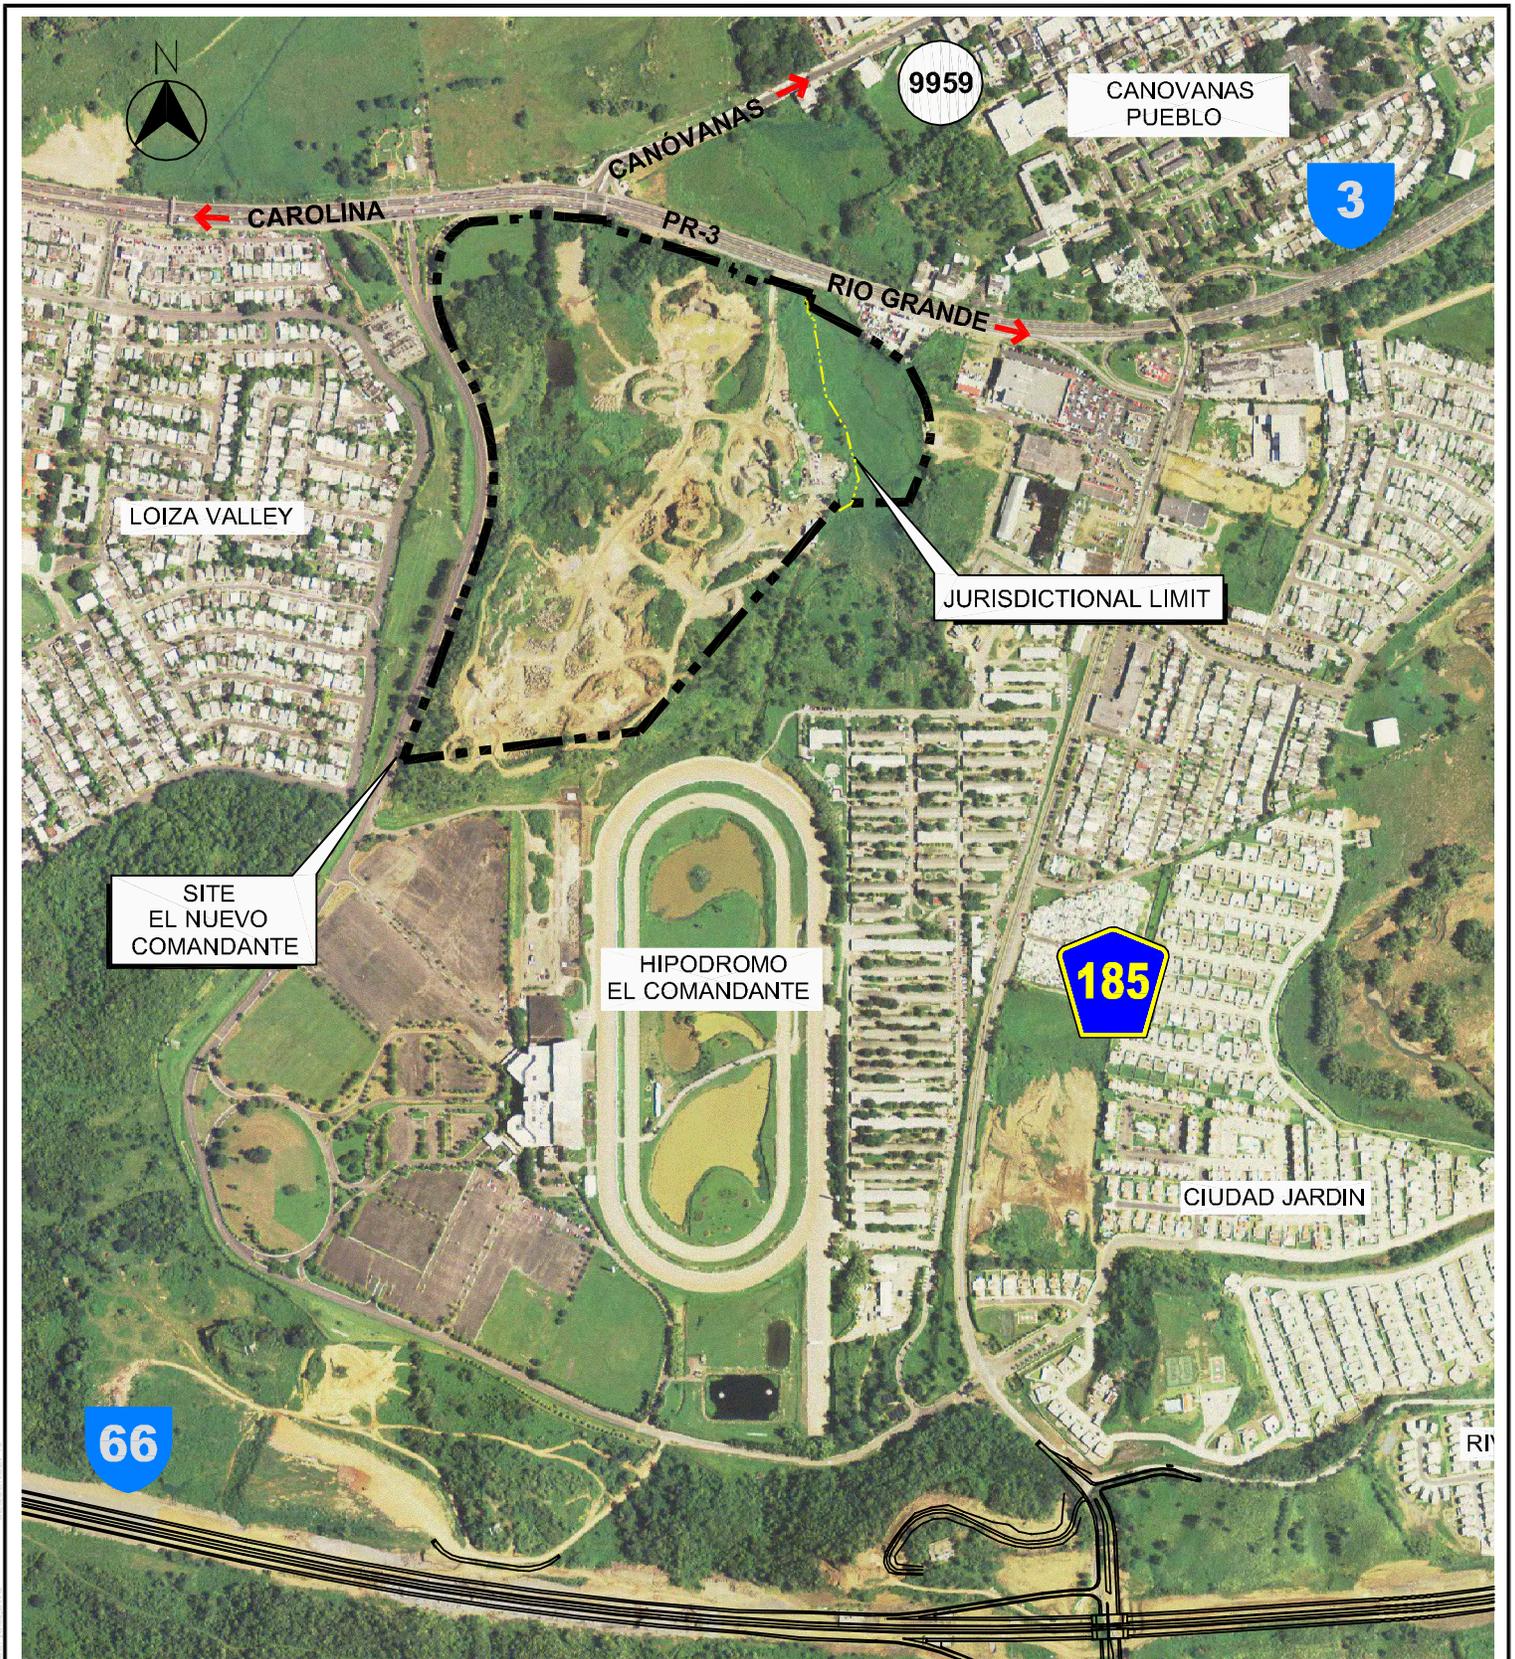
CANOVANAS PUERTO RICO
FIGURE 02 OCT 2, 2006

AERIAL PHOTO (2005)

On year 1981, the construction of El Comandante Race Track modified the southern section of the Bocaforma stream. The quarry activities at the parcel are more intense and by year 1991 more than 90% of the parcel was modified by the earth movement activities. The years 2005 and 2006 aerial photos depict the same area modified by the earth movement activities. Also, some detention ponds were constructed on the parcel for the sedimentation control.

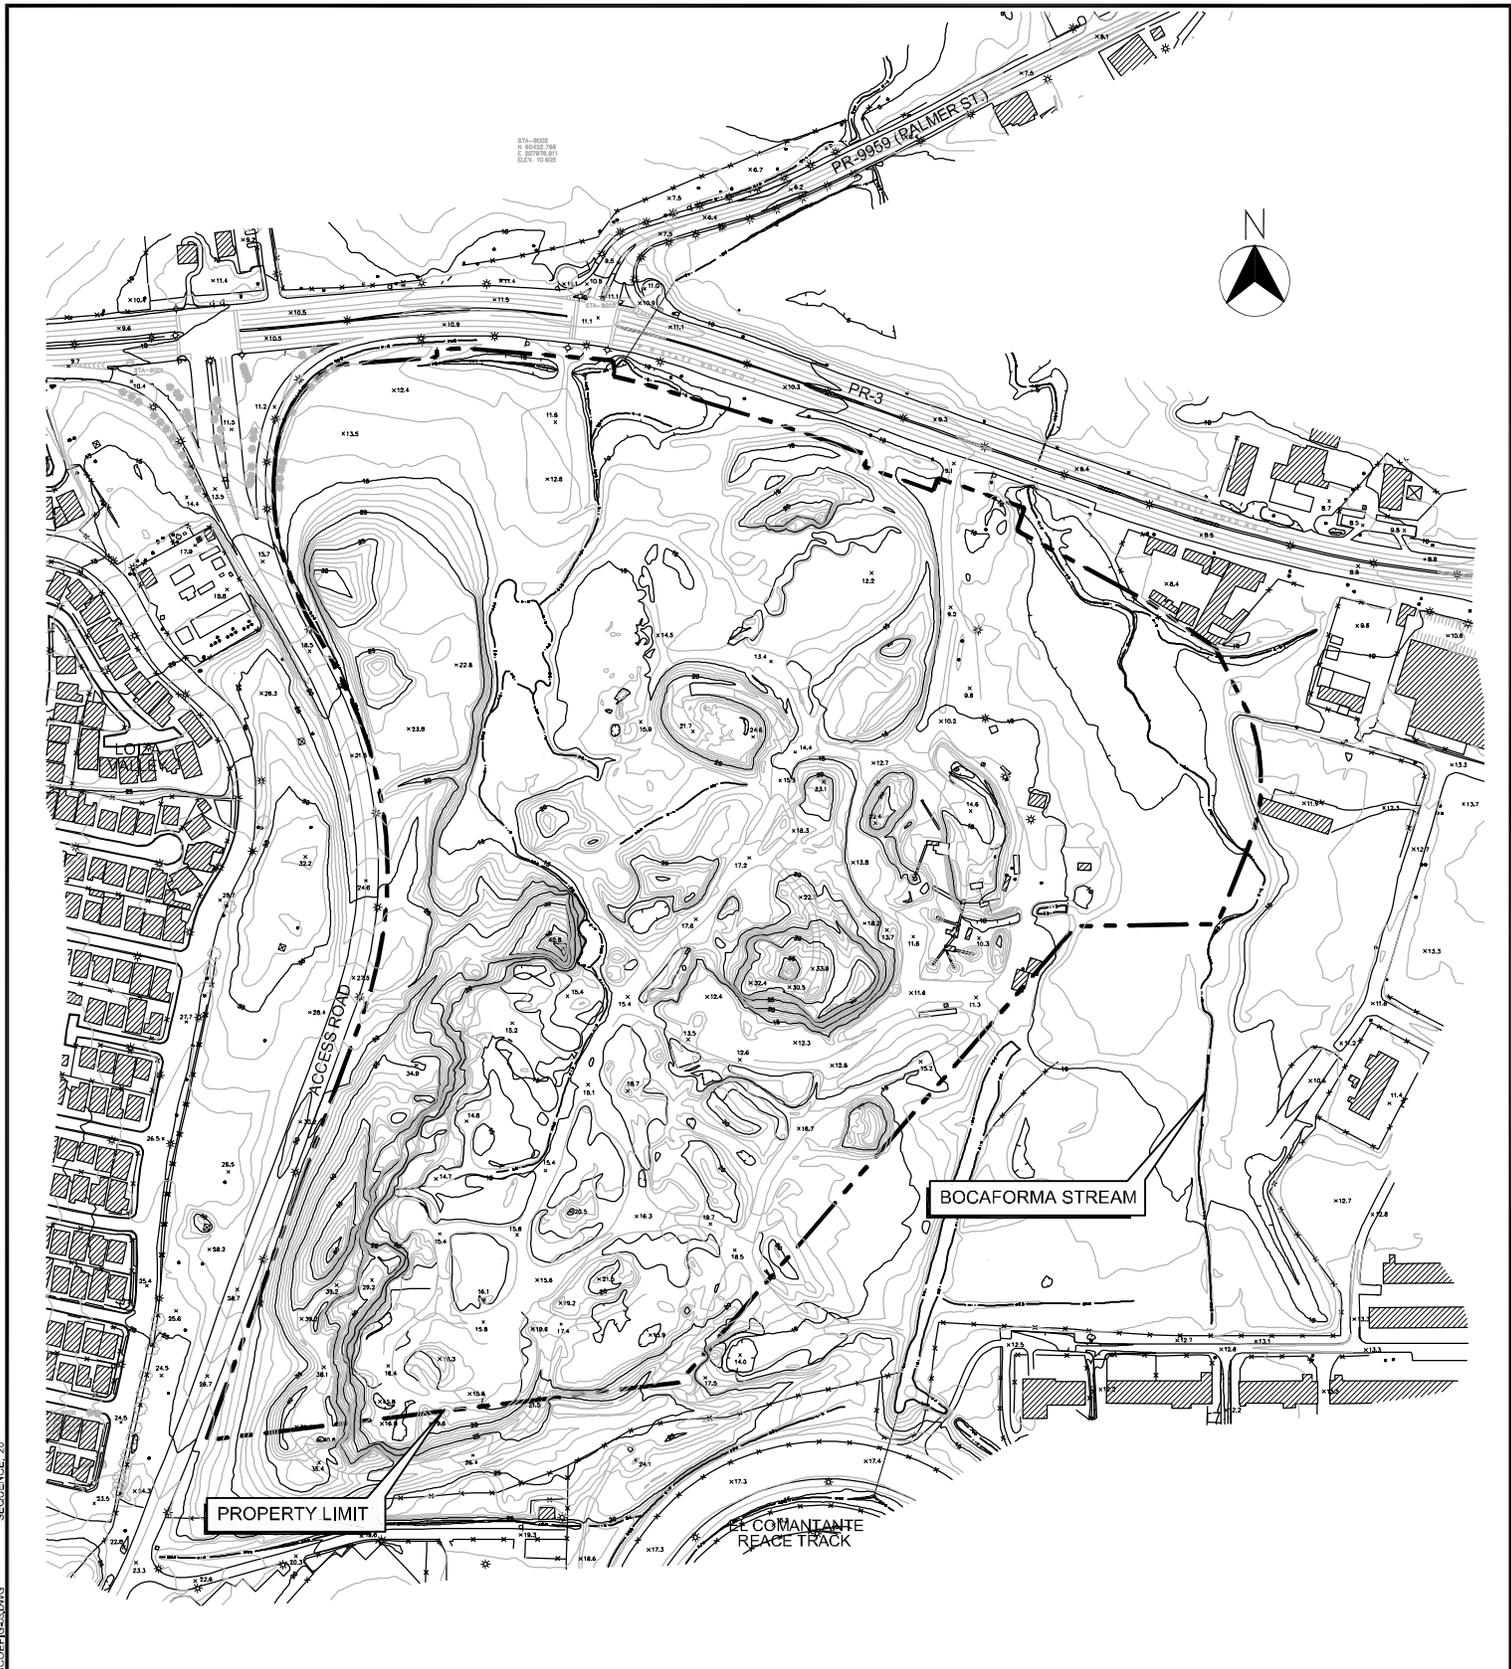
CANOVANAS PUERTO RICO
 FIGURE 03 OCT 2, 2006

TOPOGRAPHIC PLAN

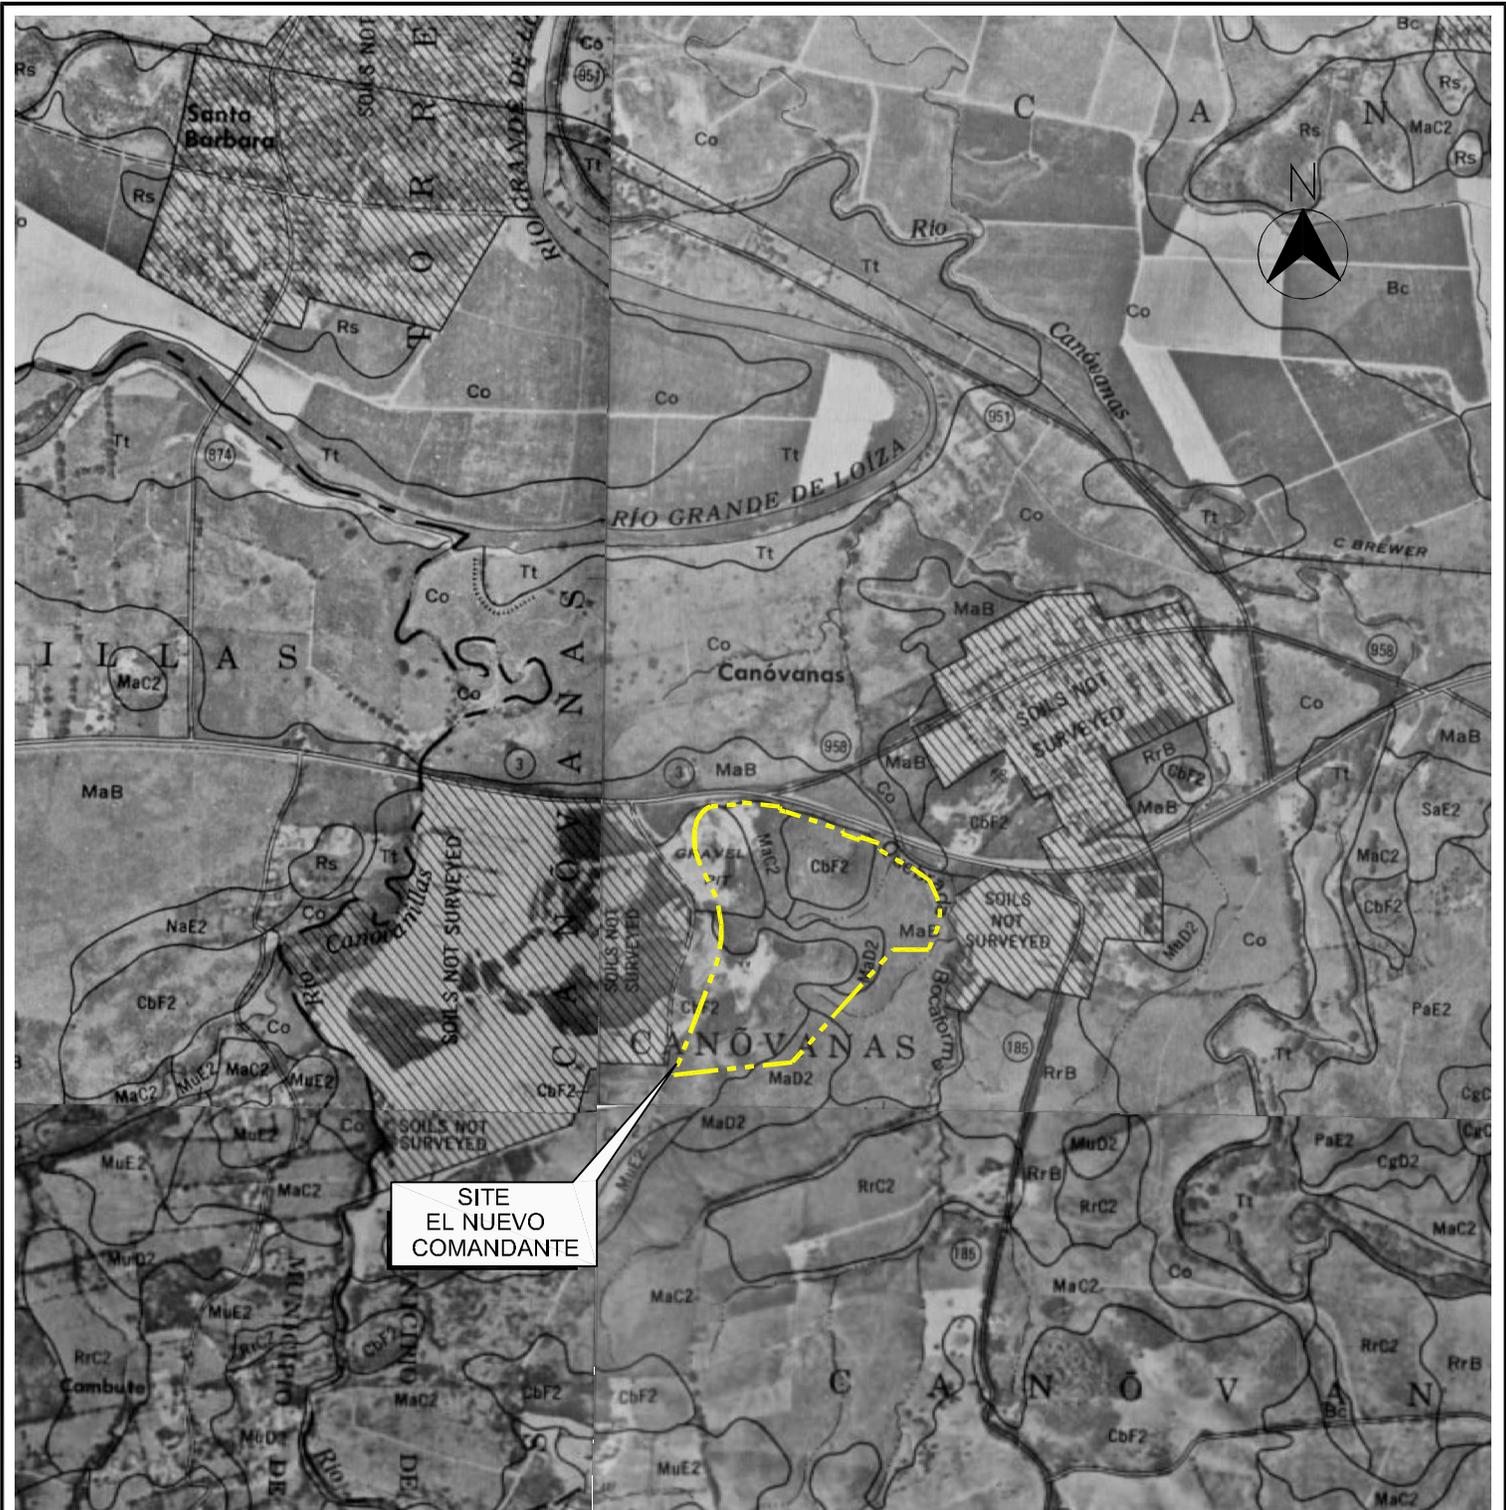
CANOVANAS PUERTO RICO
FIGURE 04 OCT 2, 2006

SOURCE:
USDA-SCS
"SOIL SURVEY OF HUMAÑO AREA OF
EASTERN PUERTO RICO"
SHEET NUM.5 JANUARY 1977

SOIL MAP

According to the Natural Resources and Conservation Service (NRCS), formerly Soil Conservation Service (SCS), the soil types of the area are (CbF2) Caguabo Clay Loam, 20 to 60 percent slopes, eroded, (MaB) Mabí clay, 0 to 5 percent slopes, (MaD2) Mabí clay, 12 to 20 percent slopes, eroded and (MaC2) Mabí clay, 5 to 12 percent slopes, eroded. The Soil Map for the area under study is presented in Figure 3, Soils Map.

The Mabi series (isohyperthermic Aquic Hapluderts) consists of very deep, somewhat poorly drained, slowly permeable soils on alluvial fans and terraces of the Humid Coastal Plains. They formed in sediments of mixed origin. Its typical pedon is:

The Caguabo series (isohyperthermic Lithic Eutrudepts) consists of shallow, well drained, moderately permeable soils on side slopes of strongly dissected uplands. They formed in material that weathered from basalt. Most areas of this soil are used for pasture. A few small areas are planted to woodland. Vegetation consists of native and introduced grasses, shrubs, and trees. Its typical pedon is:
