**Culebrinas River Flood Control Project**

## DETERMINATION OF JURISDICTIONAL AREAS

**Estudio de Determinación de Jurisdicción  
Discovery Bay Resort & Marina,  
Aguada PR**

**DISCOVERY BAY RESORT & MARINA  
FINCA NUEVA  
BARRIO ESPINAR, AGUADA PR**

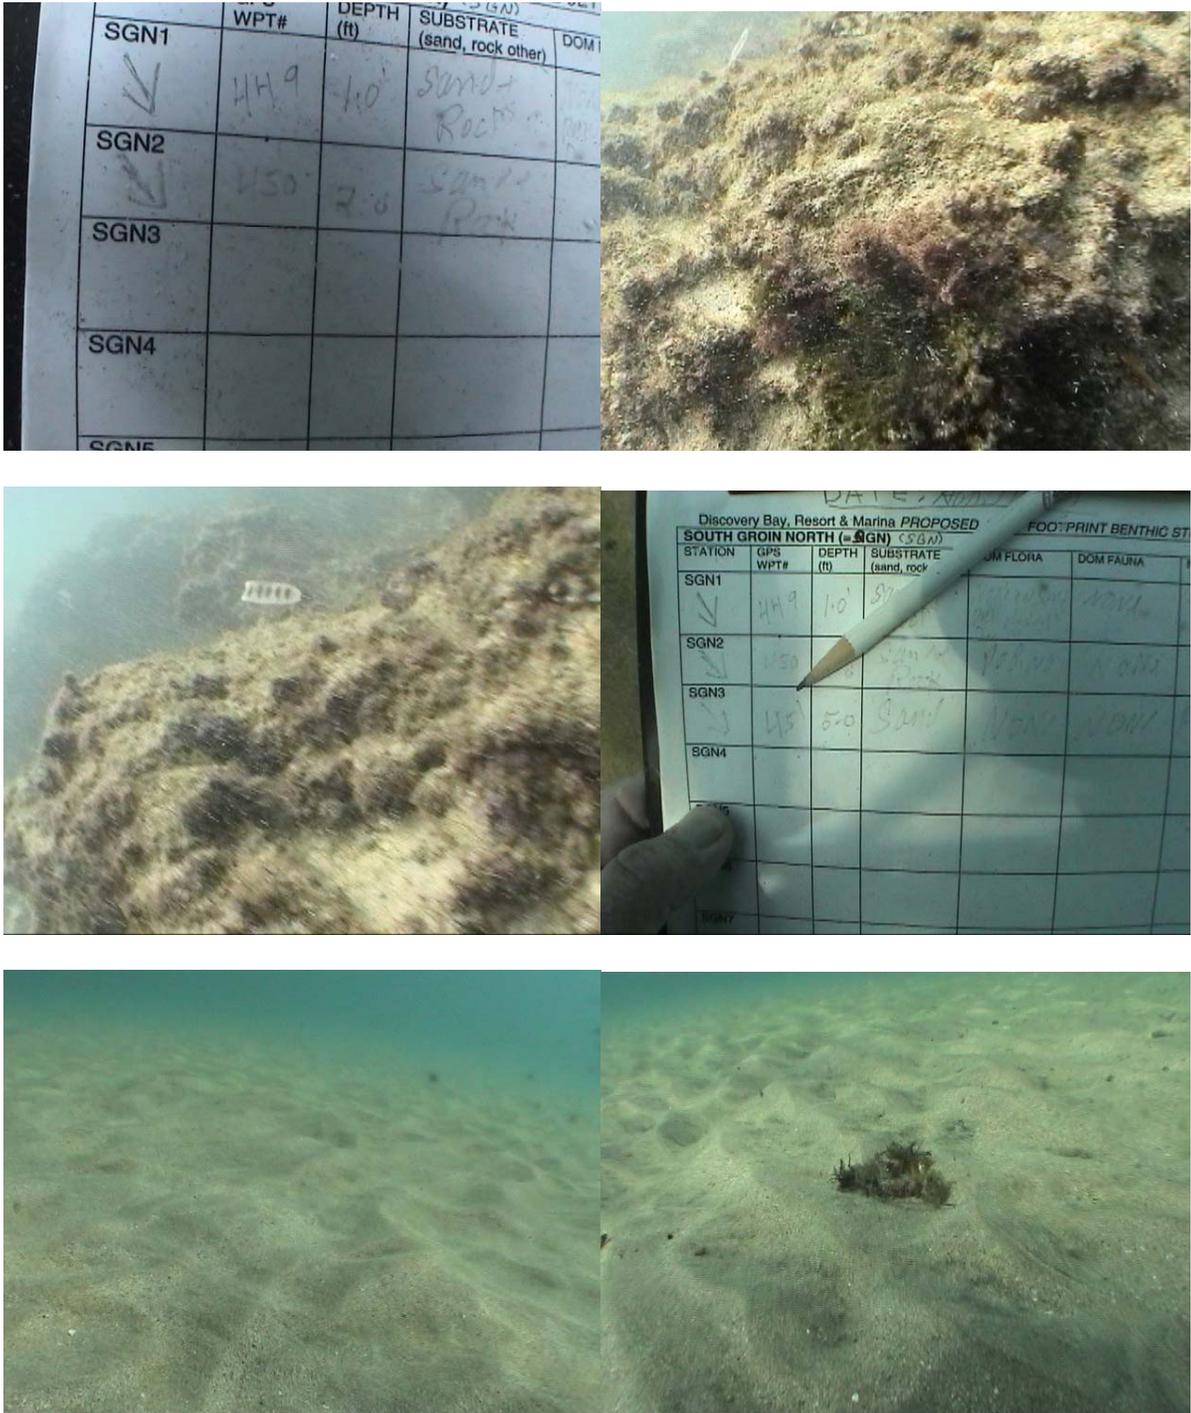
**FIGURE 9.** Selected representative underwater photos taken off the northern side of the SOUTH GROIN, (SGN1 – SGN10) in April 13, 2007 and along the proposed extension of the same.

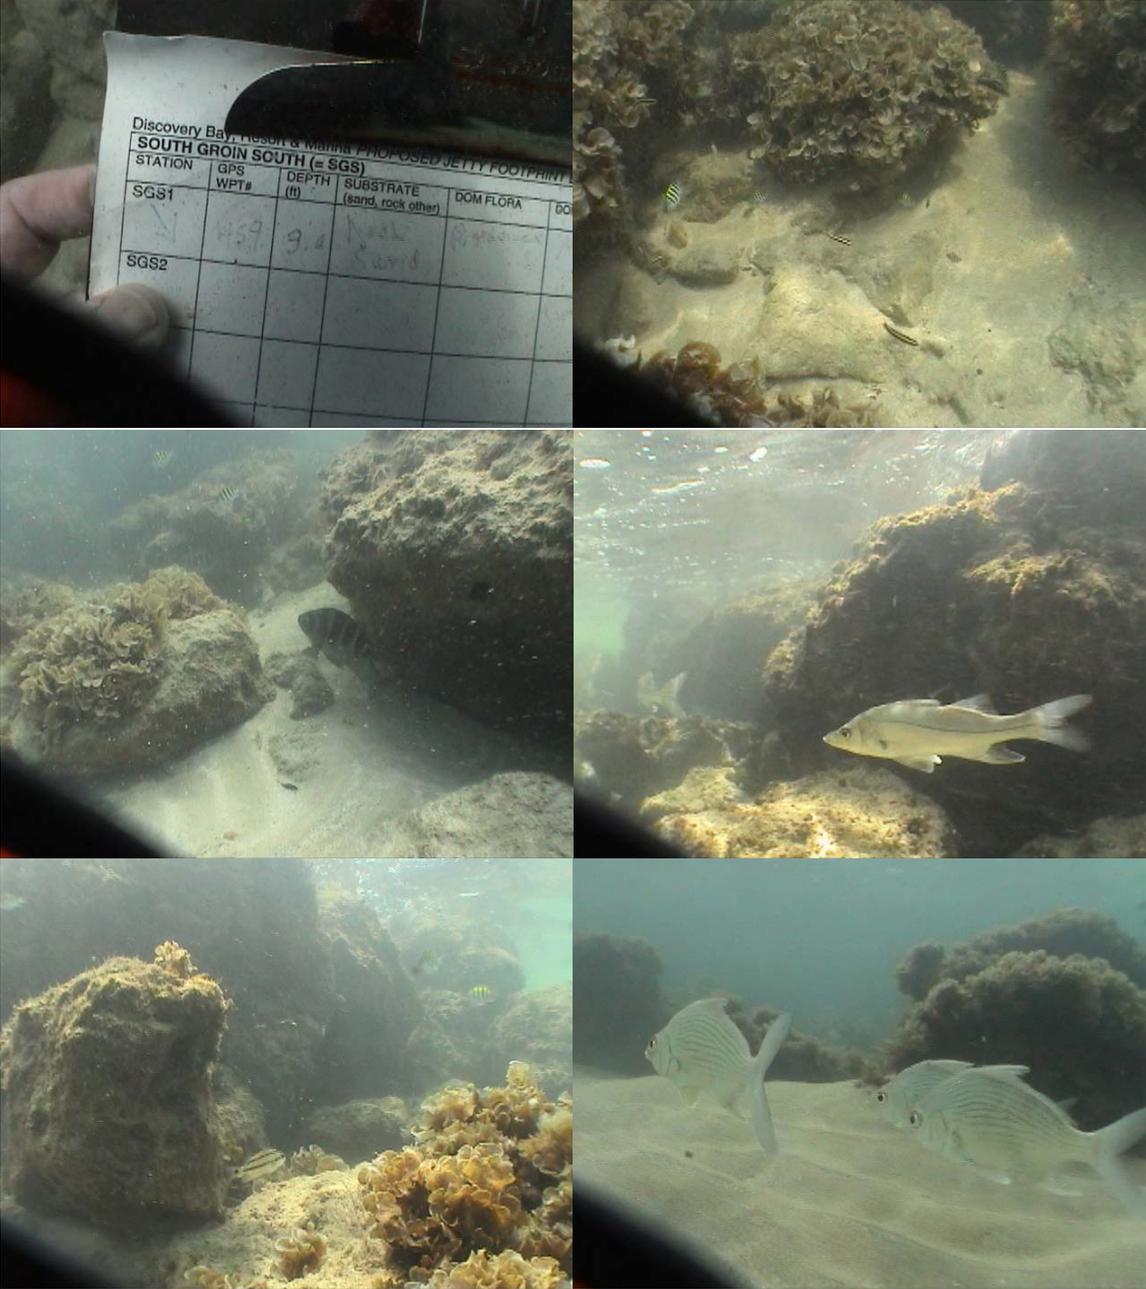
**FIGURE 10.** Selected representative underwater photos taken off the southern side of the SOUTH GROIN, (SGS1 – SGS10) in April 13, 2007 and along the proposed extension of the same.

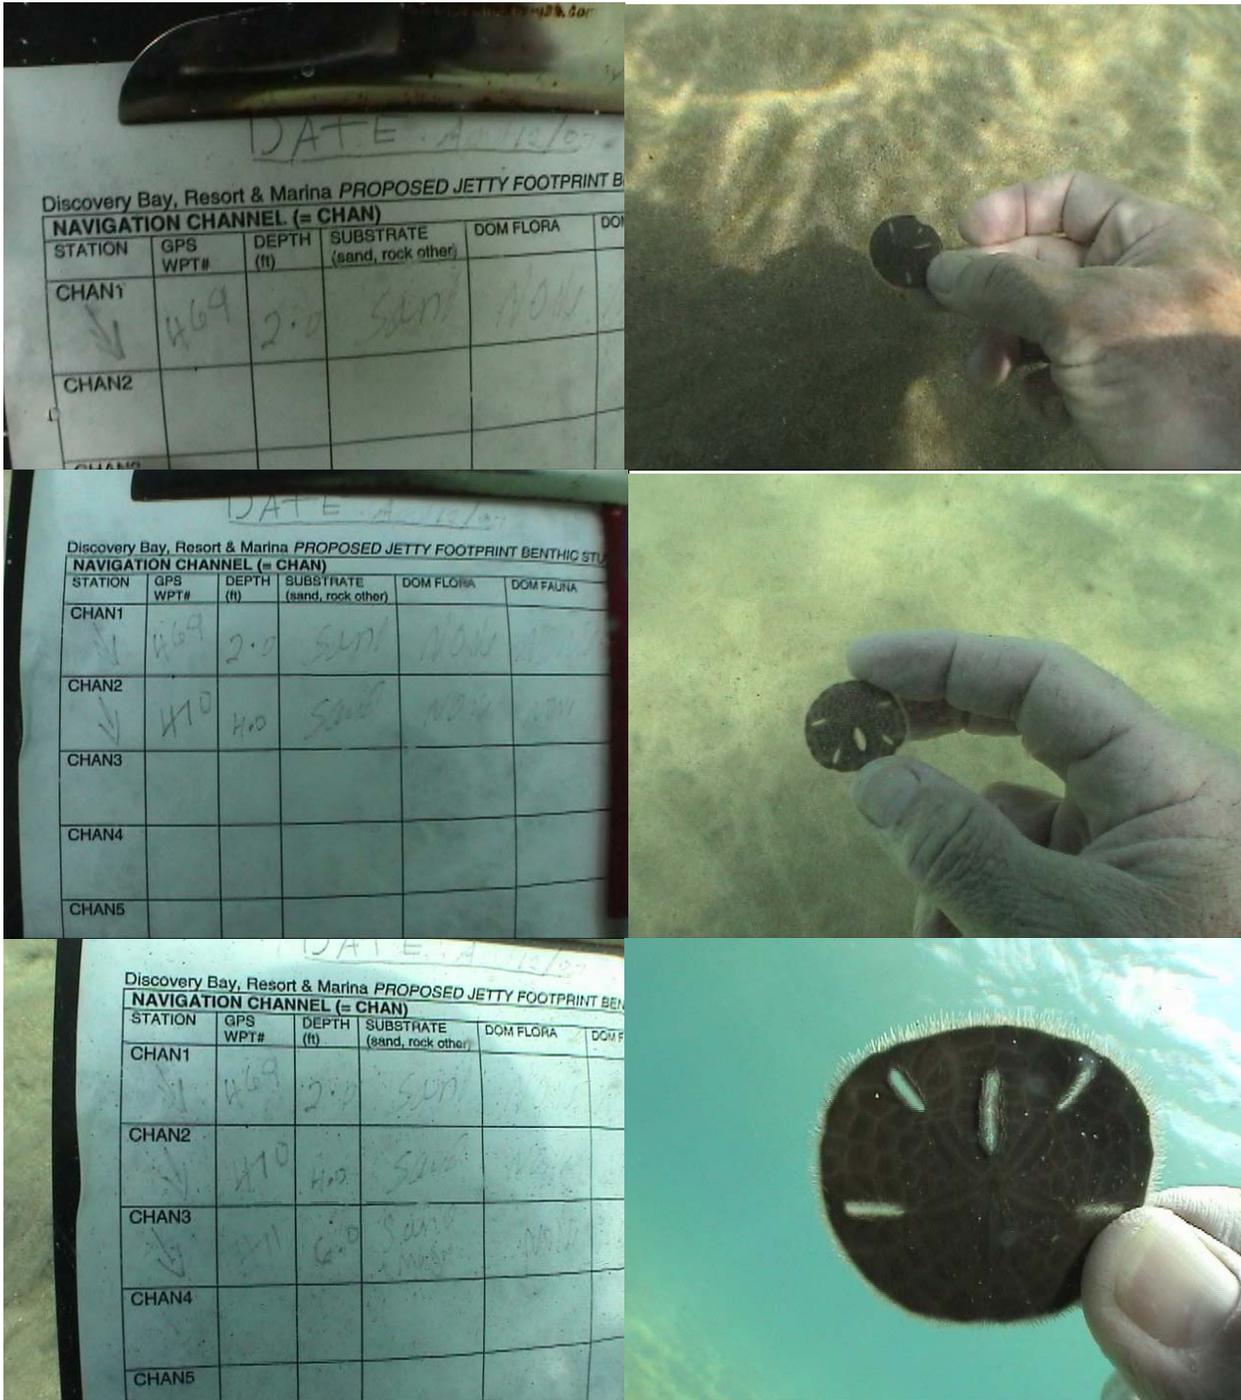
**FIGURE 11.** Selected representative underwater photos taken along the proposed navigation channel (CHAN1 – CHAN11) in April 13, 2007.

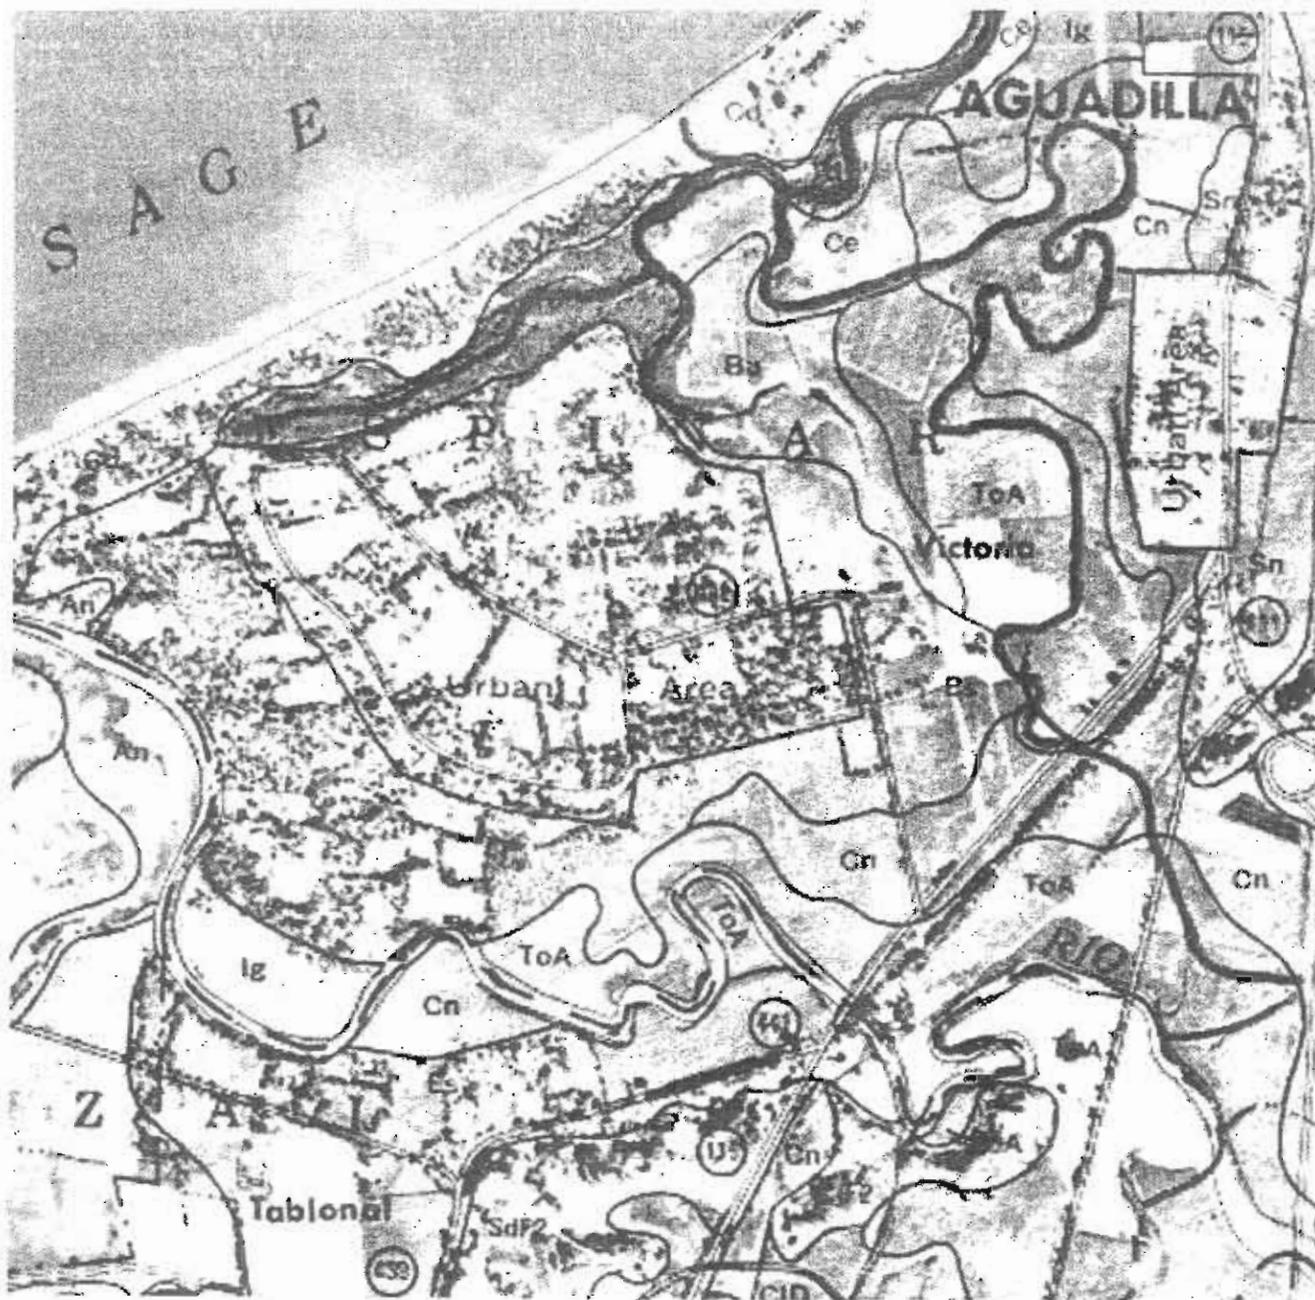
Figure 6. Enlarged soil map showing Caño Madre Vieja.

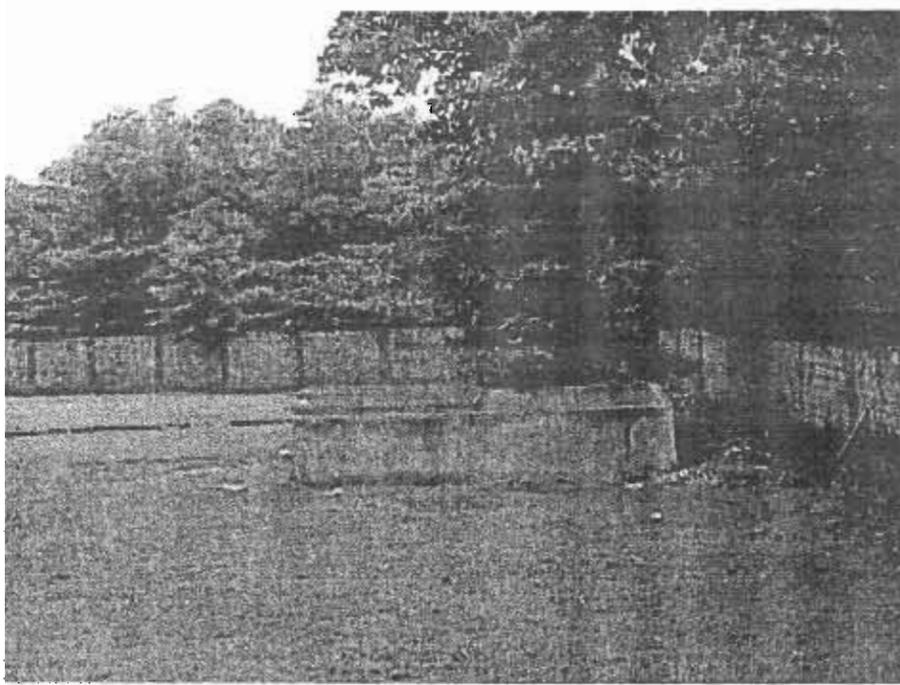
Photo 7. Colegio San Carlos school yard with the forested drainage behind it. The eastern levee would pass through part of the school yard and forest.

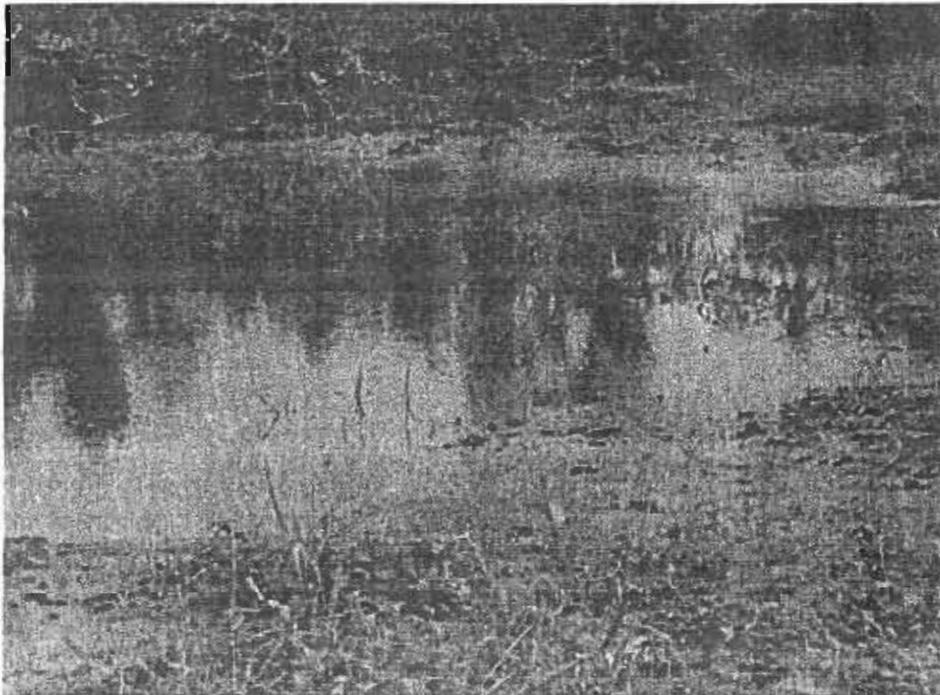
**Photo 10.** Cleared wetland area behind beach berm west of the Caño showing piled debris that includes some trees.

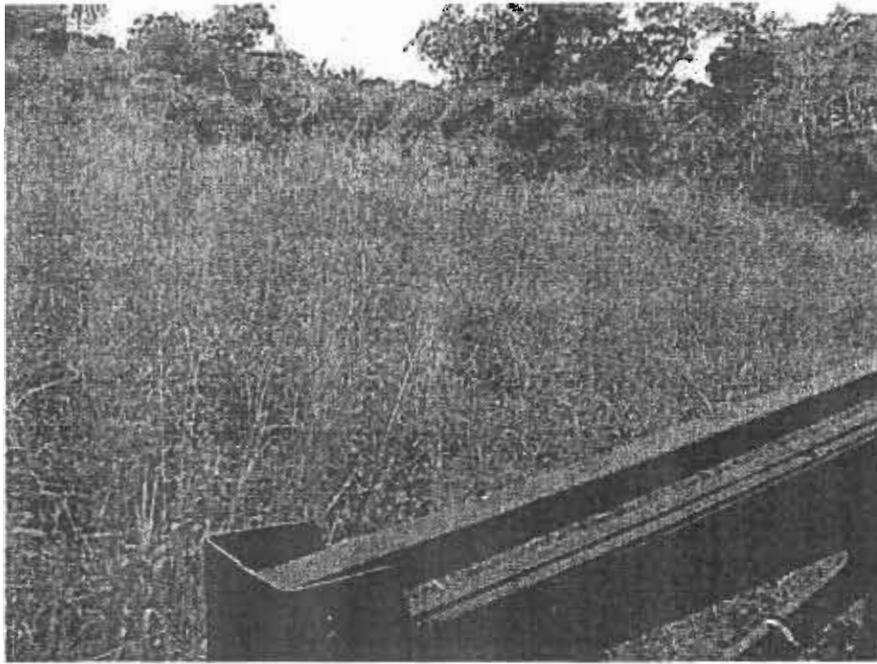
Photo 13. Sedge dominated wetlands on the west side of the Caño, south of the mangrove channel (visible in background). The ground was ponded with several inches of water during this visit.

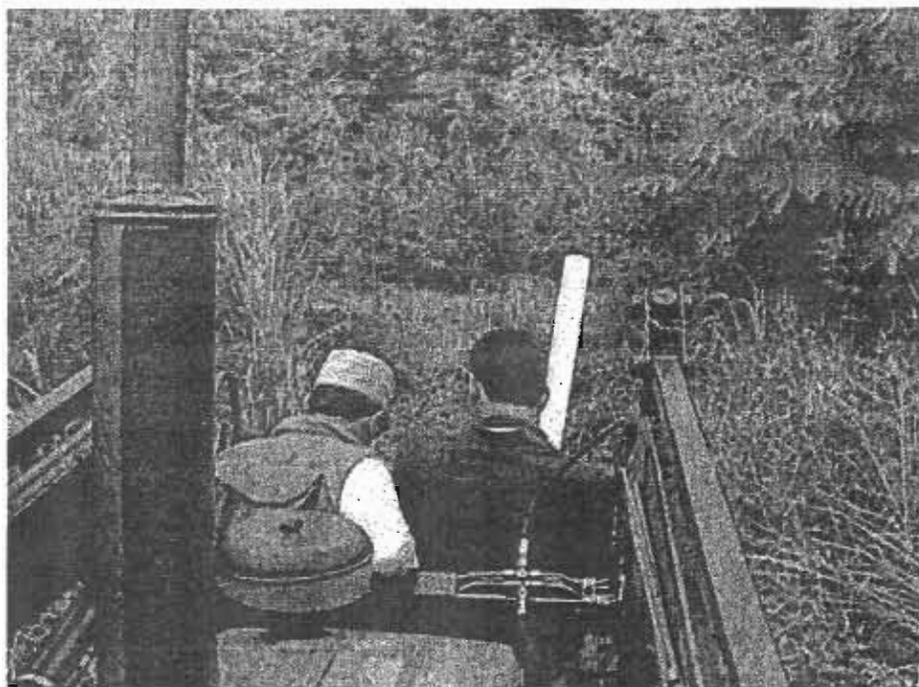
Photo 17. Western side of the Caño, approaching the edge. Note upland trees on the top of the river bank. Many of the grasses are FACW such as *Brachiaria purpurascens* and *Paspalum millegrana*.

Small mangroves still occur on the Caño banks just downstream of the double meander (Photos 17 and 18). The size of the mangroves probably reflect the last time this Caño was mechanically cleaned out. While the Corps does not intend further alteration to the cut-off meander, the hydrology would be highly altered from an estuarine to a fresh-water ponding condition. Some of the trees would be eliminated, though it appears that most would be outside the immediate footprint of the levee.

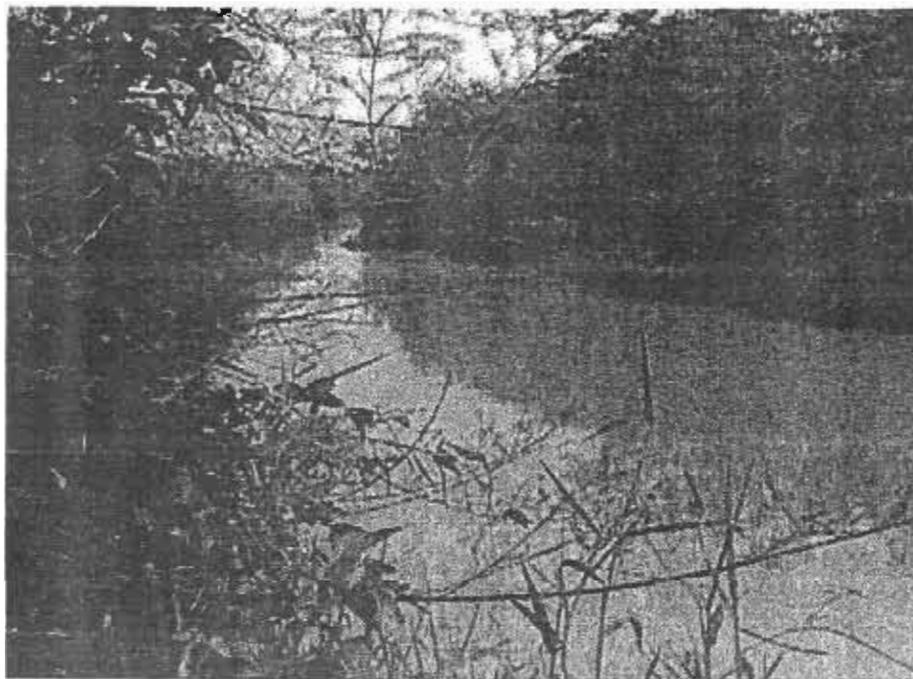
Photo 18. View downstream of the Caño from the west bank just downstream of the meanders. Trees near the water-line are mangroves (red and some white). Most are under 10 feet in height.

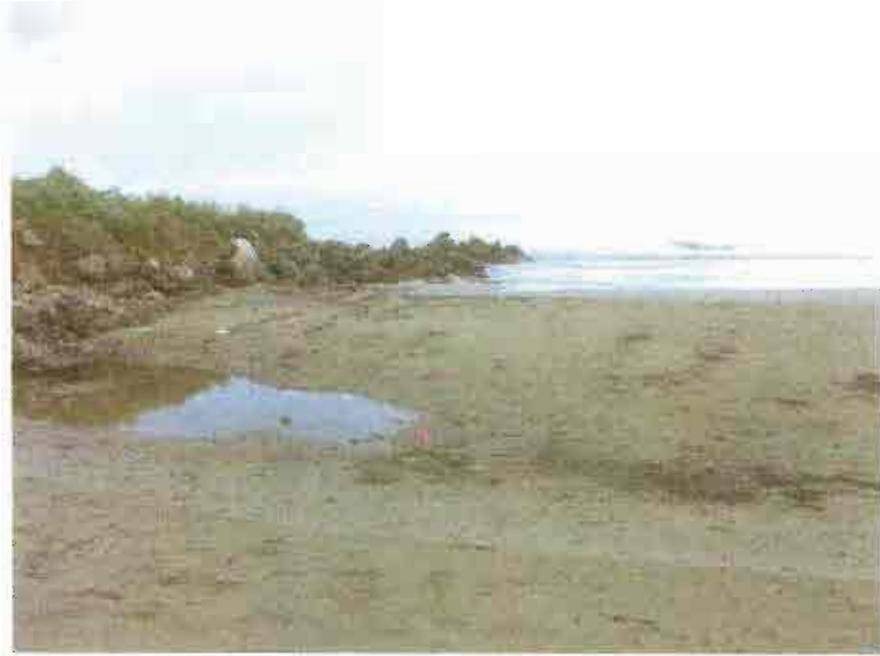
ILLUSTRATION OF THE BORING # 1

Terrestrial maritime zone

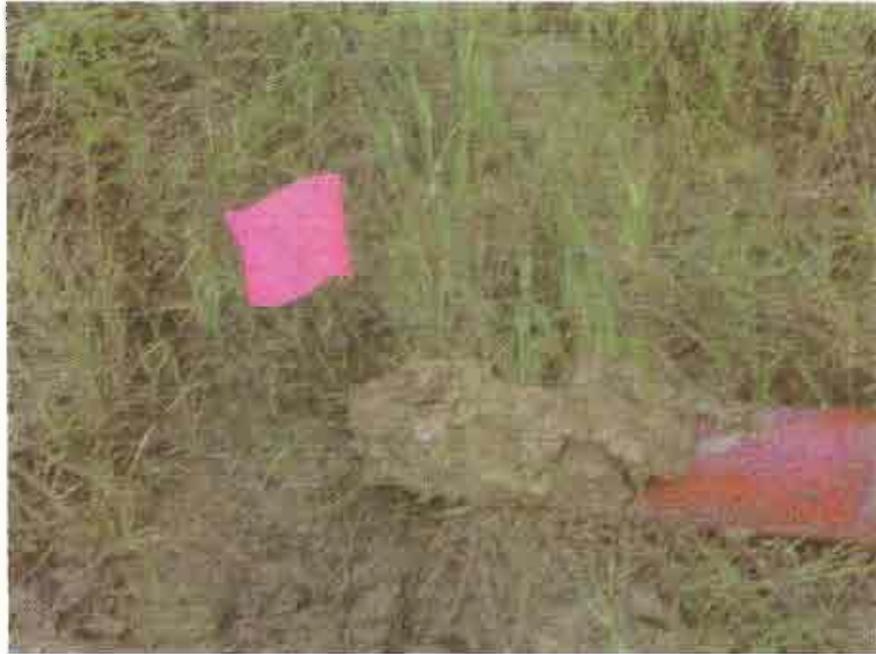
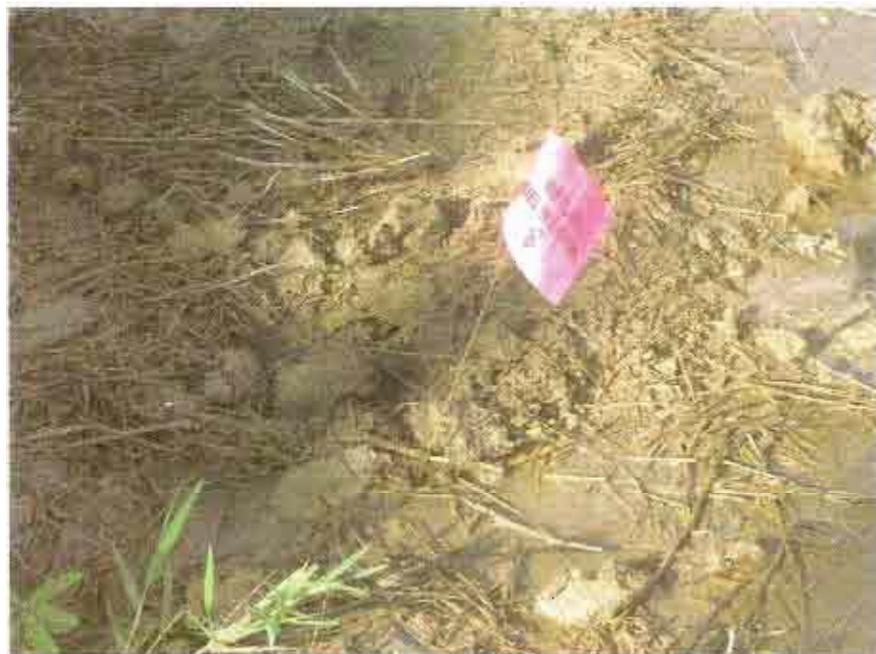
ILLUSTRATION OF THE BORING # 3 & # 8

Positive for wetland area
