# ANEJOS

PROYECTO:  
**PALACIOS DE HUMACAO (ETAPA I)**  
 CASO NUM. 080X2-CET00-04697

**ON THE PRELIMINARY GEOTECHNICAL  
EXPLORATION PERFORMED AT THE SITE  
OF THE PROPOSED PALACIOS DE HUMACAO,  
DEVELOPMENT, BUENA VISTA WARD,  
HUMACAO, PUERTO RICO**

# Estudio de Flora y Fauna

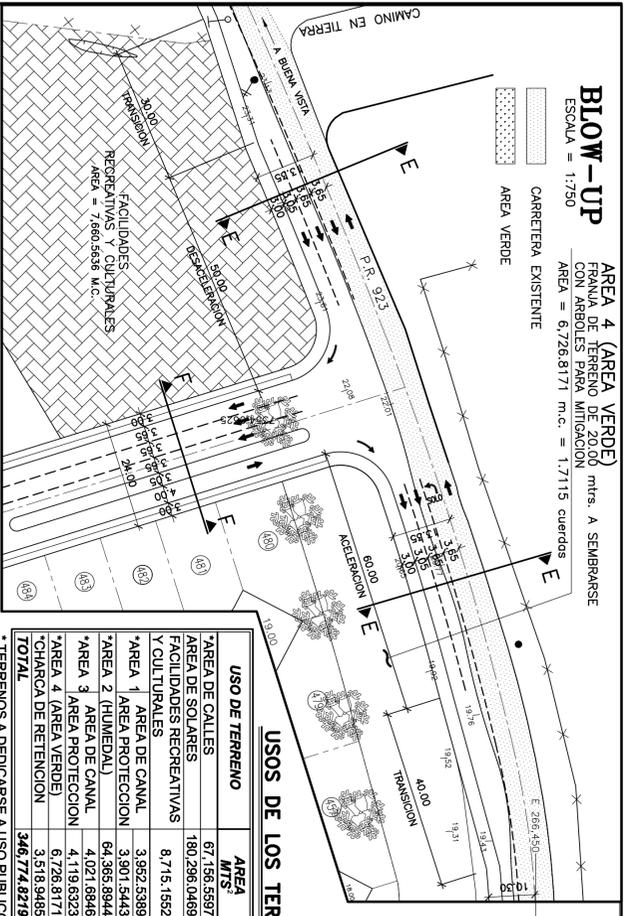
**BLOW-UP**  
 ESCALA = 1:750

AREA 4 (AREA VERDE) mts. A SEMBRARSE  
 FRANJA DE TERRENO DE 20.00  
 CON ABOLLES PARA MITIGACION  
 AREA = 6,726.8171 m.c. = 1,7115 cuerdas

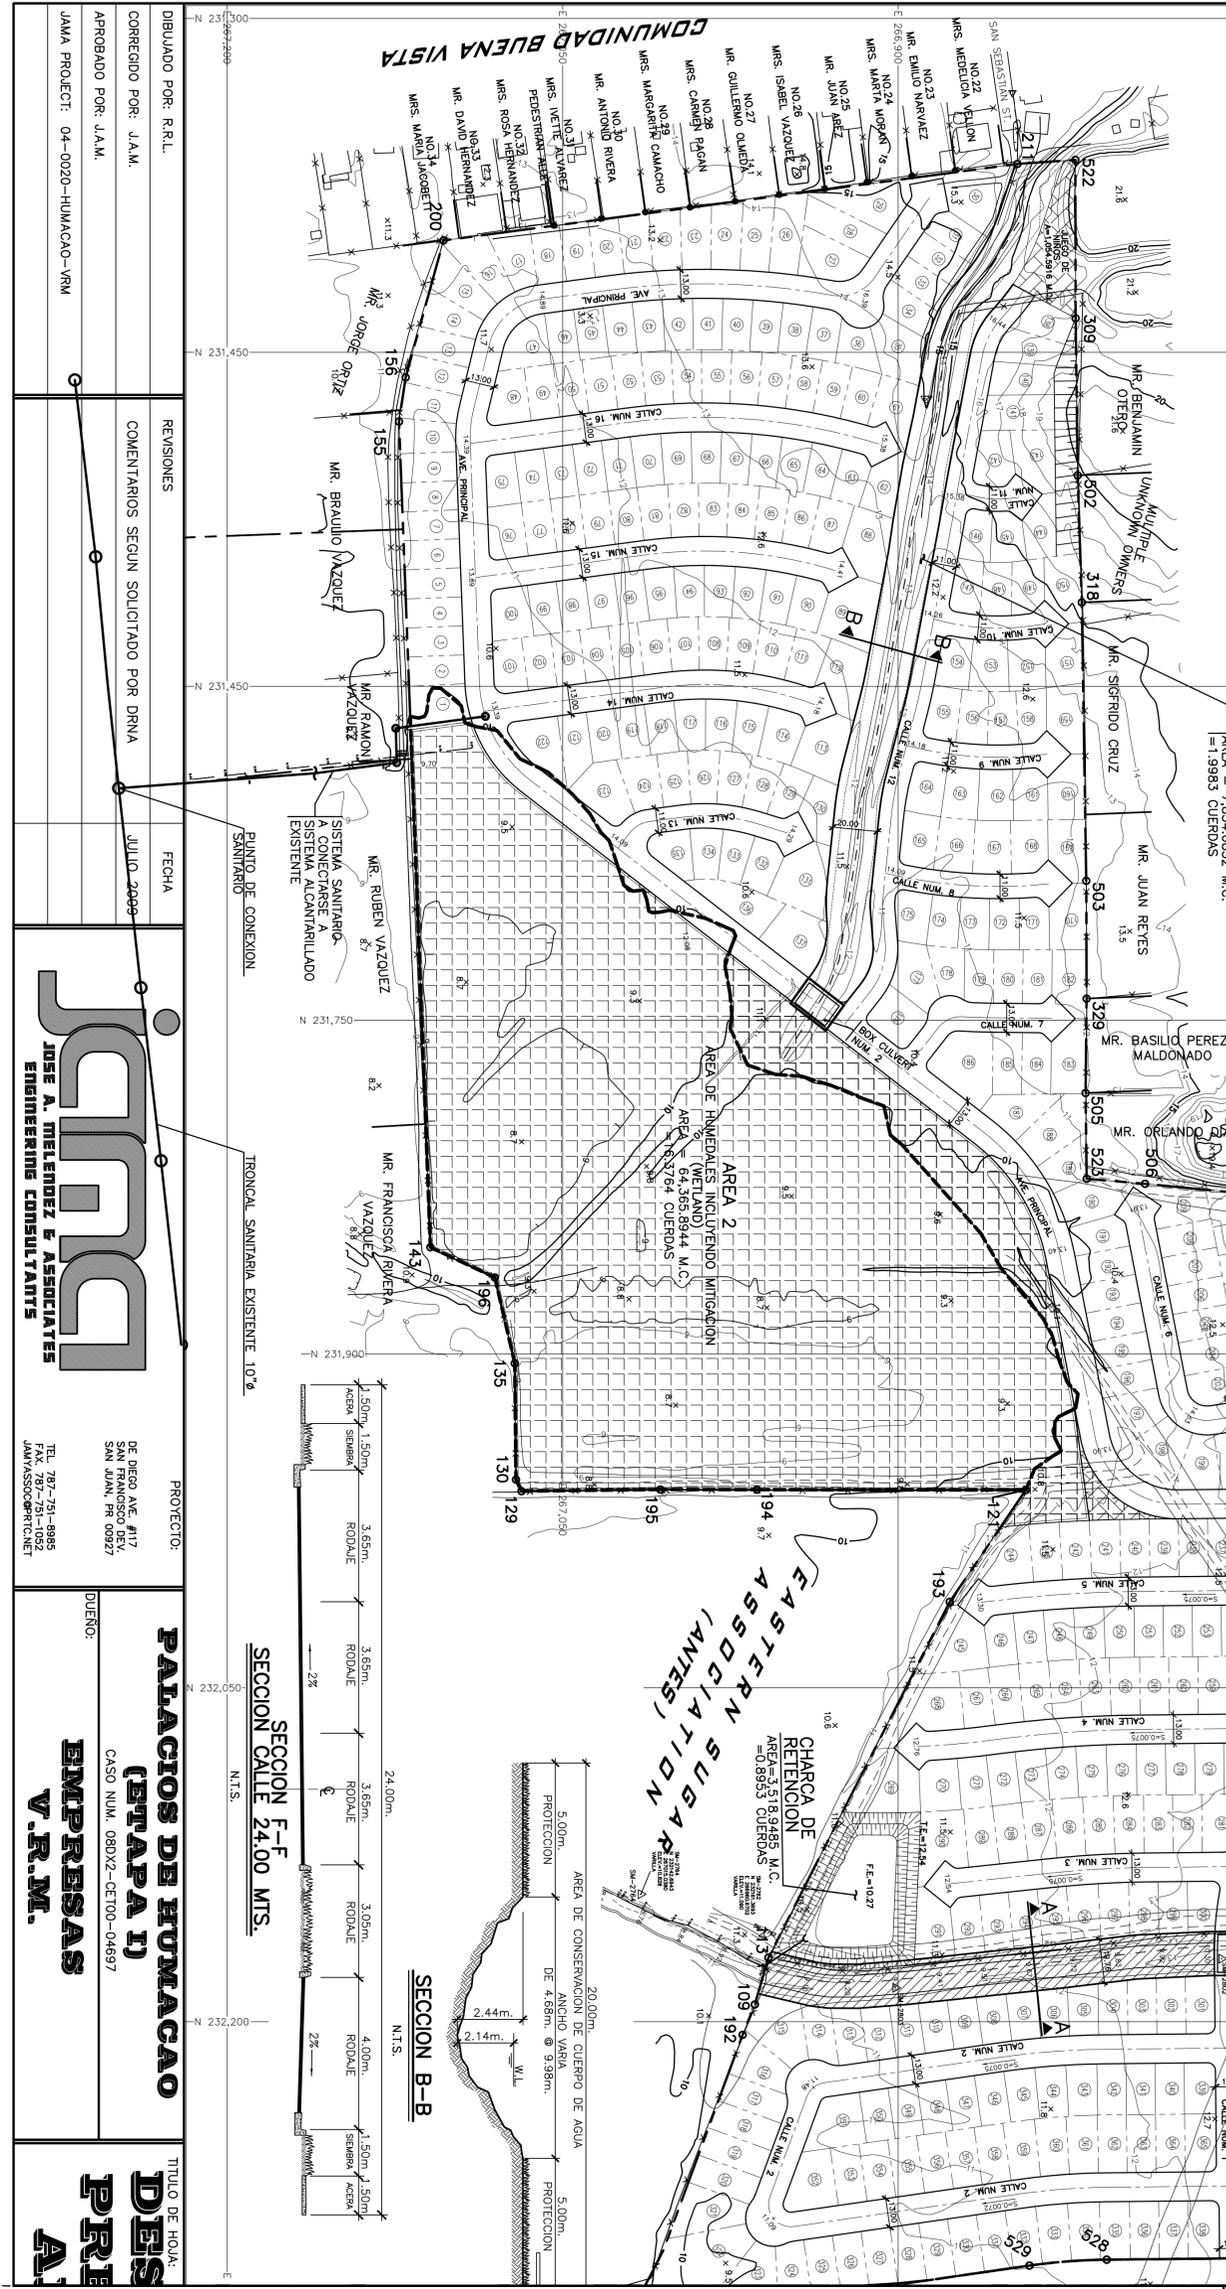
**PLANTA**

USO DE TERRENO	AREA MTS.	AREA CUERDAS	PORCIENTO (%)
*AREA DE CALLES	67,156,5587	17,0865	19.37*
*AREA DE SOLARES	180,280,0469	45,8722	51.99
*FACILIDADES RECREATIVAS Y CULTURALES	8,715,1592	2,2174	2.51
*AREA 1 AREA DE CANAL	3,992,5399	1,0055	1.14*
*AREA 1 AREA PROTECCION (HUMEDAL)	3,901,5443	0,9927	1.13*
*AREA 2 AREA DE CANAL	4,021,8846	1,0232	1.16*
*AREA 3 AREA PROTECCION	4,119,6923	1,0481	1.19*
*AREA 4 (AREA VERDE)	6,726,8171	1,7115	1.94*
*CHARCA DE RETENCION	3,518,9485	0,8953	1.01*
<b>TOTAL</b>	<b>346,774,8219</b>	<b>88,2290</b>	<b>100.00</b>

AREA 3  
 AREA DE CONSERVACION  
 DE CUERPO DE AGUA  
 A DEDICARSE USO PUBLICO  
 AREA = 8,141,3169 M.C.  
 =2,0713 CUERDAS

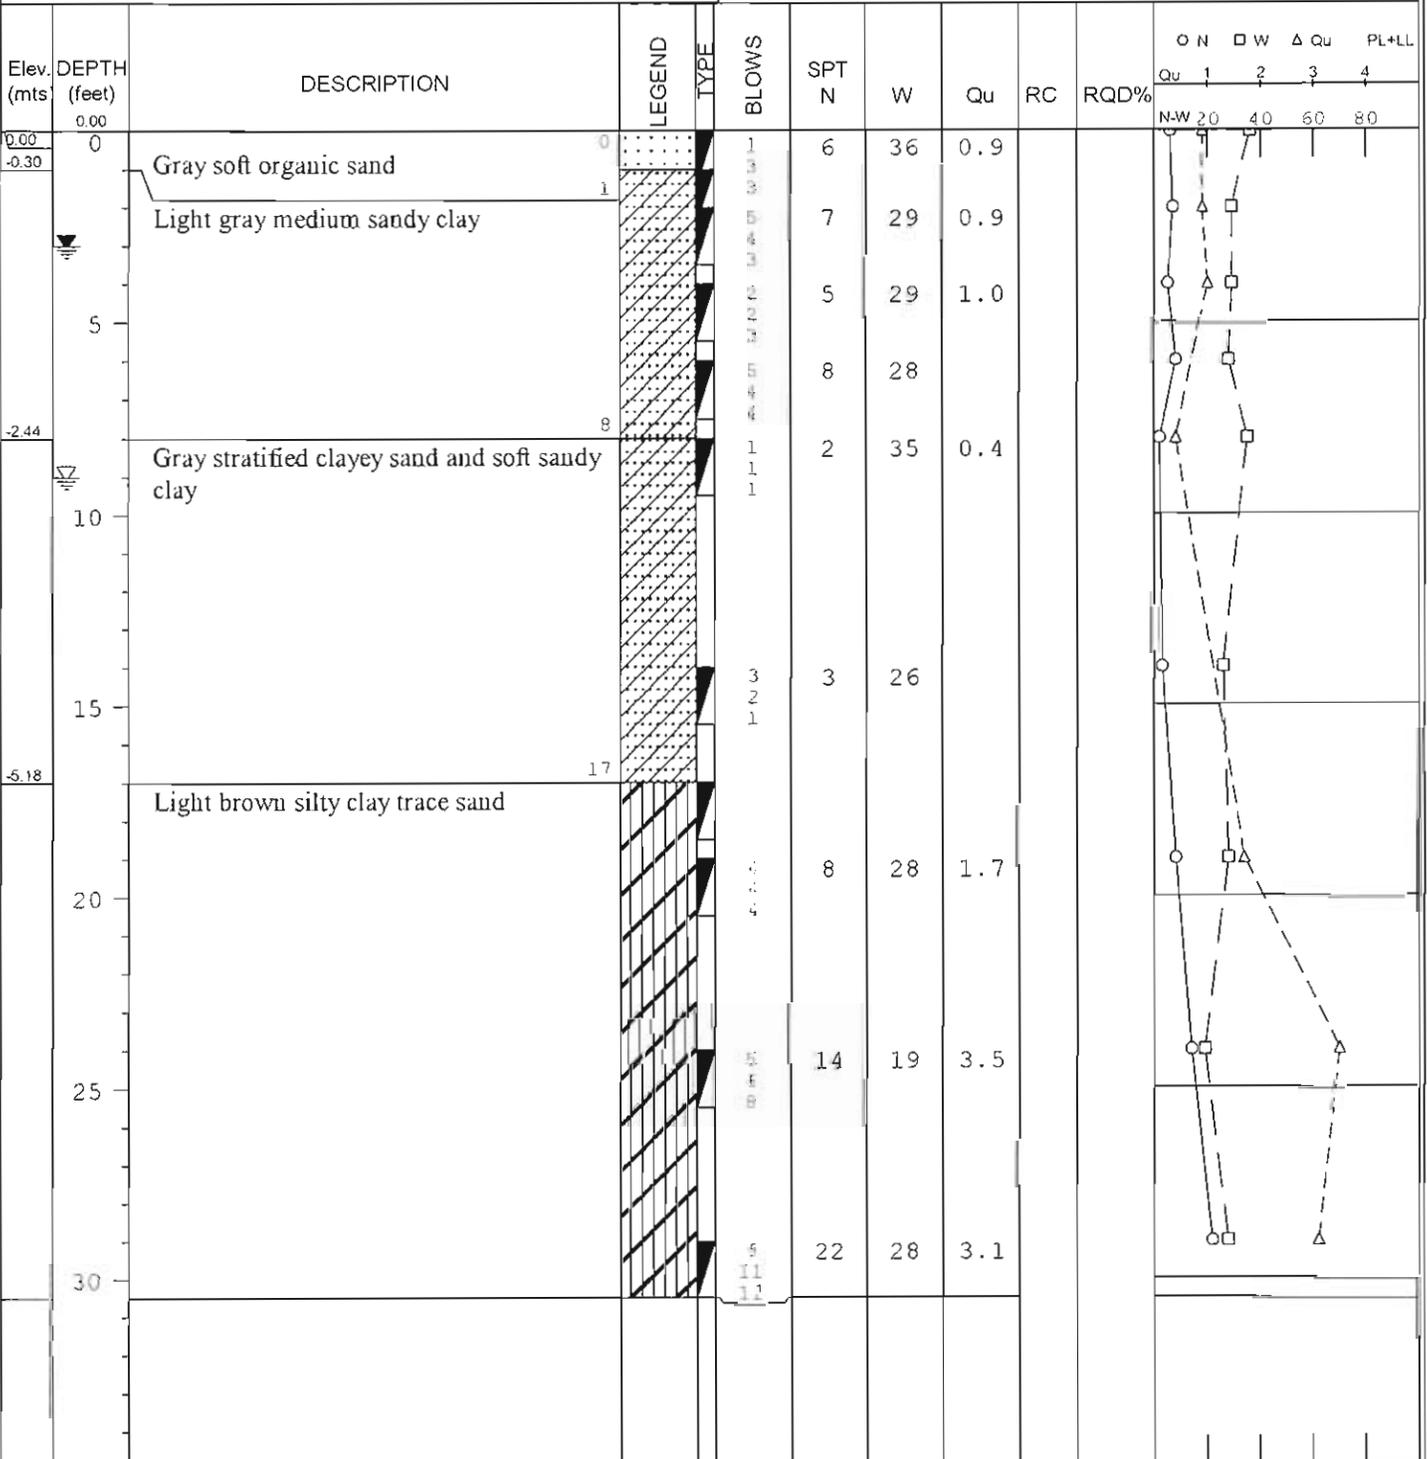
**BORING NUMBER: 21**

<b>DRILLING LOG</b>	PROJECT	PALACIOS DE HUMACAO	JOB	6630	SHEET	1
	OF				OF	1
LOCATION	HUMACAO, PR		DRILLER/DRILL RIG: L. SANTOS / B-45			
DESCRIPTION BY	R. TORRES		DATE HOLE STARTED	10-3-07	COMPLETED 10-3-07	
GROUNDWATER (ft.)	Initial: 9'	Final: 3'	ELEVATION TOP OF HOLE (mts):			
TOTAL DEPTH OF HOLE	30.5'		ENGINEER R. TORRES

"N" - Number of blows required to drive the sampling spoon a distance of 12 in. with a 140 lbs hammer falling 30 in.  
 "W" - Natural Moisture Content in percentage of dry weight. Initial G.W. Depth  
 "Qu" - Unconfined Compressive Strength in tons per square foot. Final G.W. Depth  
 "Rc" - Core recovery in percent for each successive run. "Rqd" - Rock quality designation.  
 "WH" - Sample was recovered by advancing the sampler with the weight of the hammer.  
 "P" - A "P" in the Unconfined Compressive Strength test indicates the use of the pocket Penetrometer.

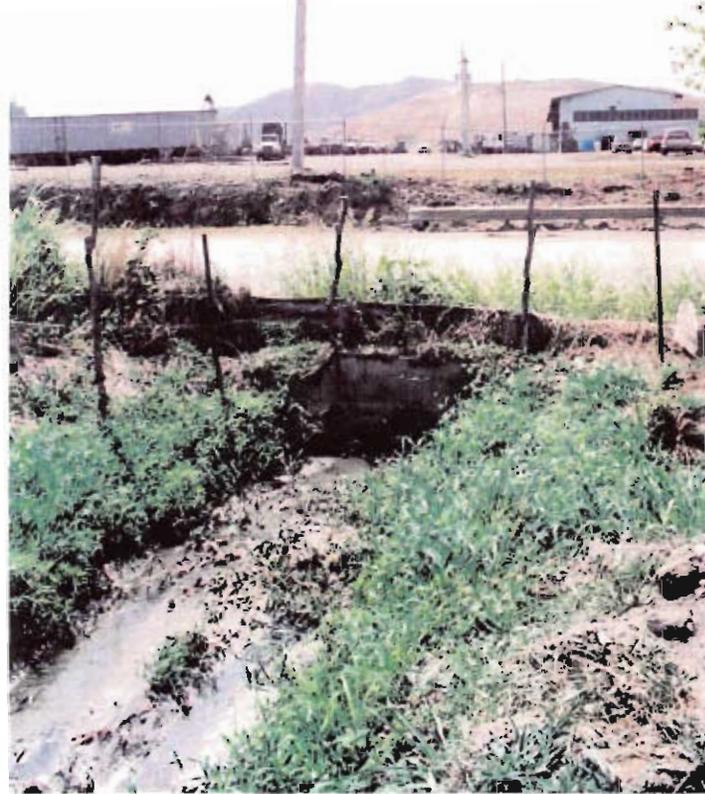
Foto 7: Vista del caño formado por las aguas que se originan en el Vertedero de Humacao, las cuales corren a lo largo de la Parcela 1

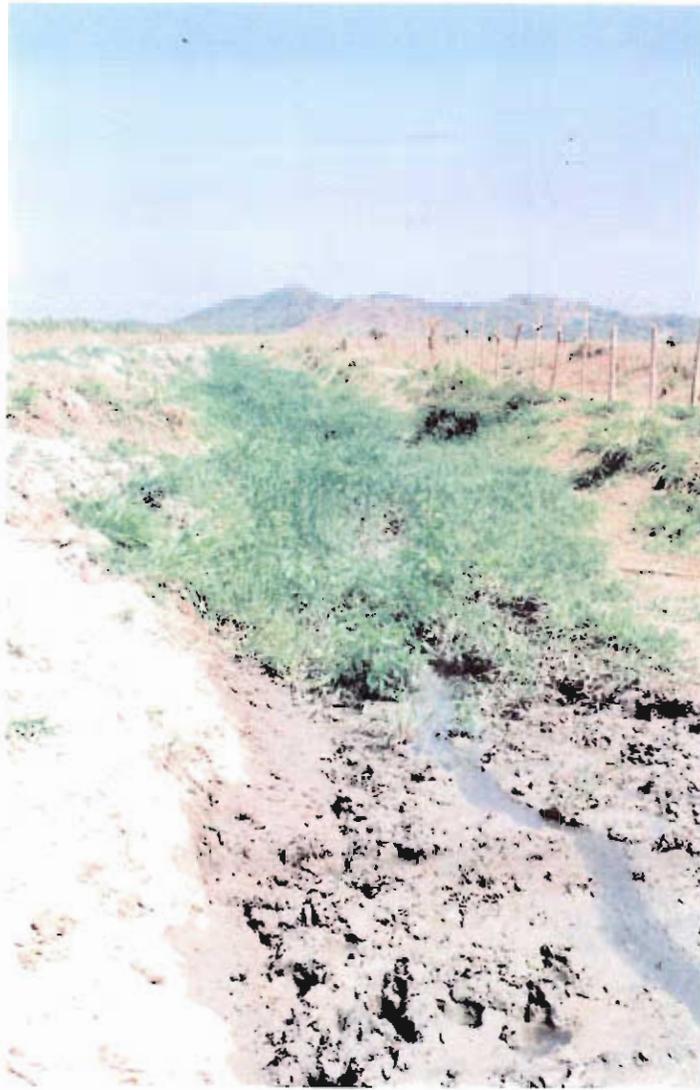
Foto 8: Vista de la parte del caño que pasa a través de la Parcela 1. Nótese la veta de agua y las pisadas de ganado vacuno

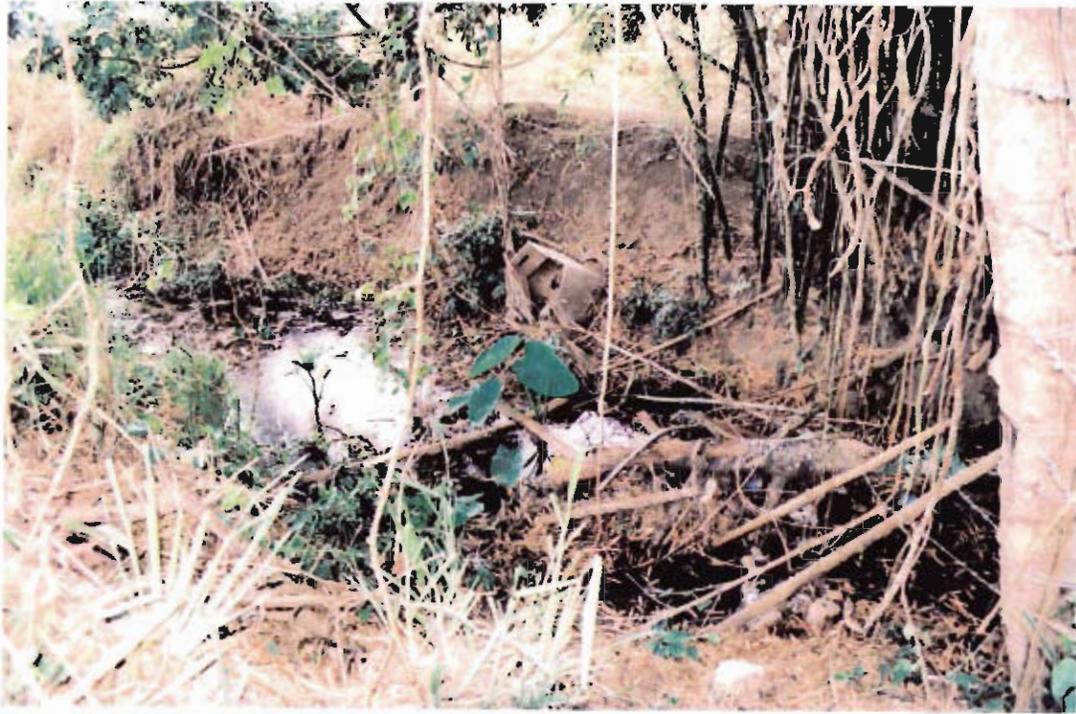
Foto 3: Entrada de la quebrada a la Parcela 2. Nótese a la extrema derecha la verja de alambre estriado que marca la colindancia de la propiedad.

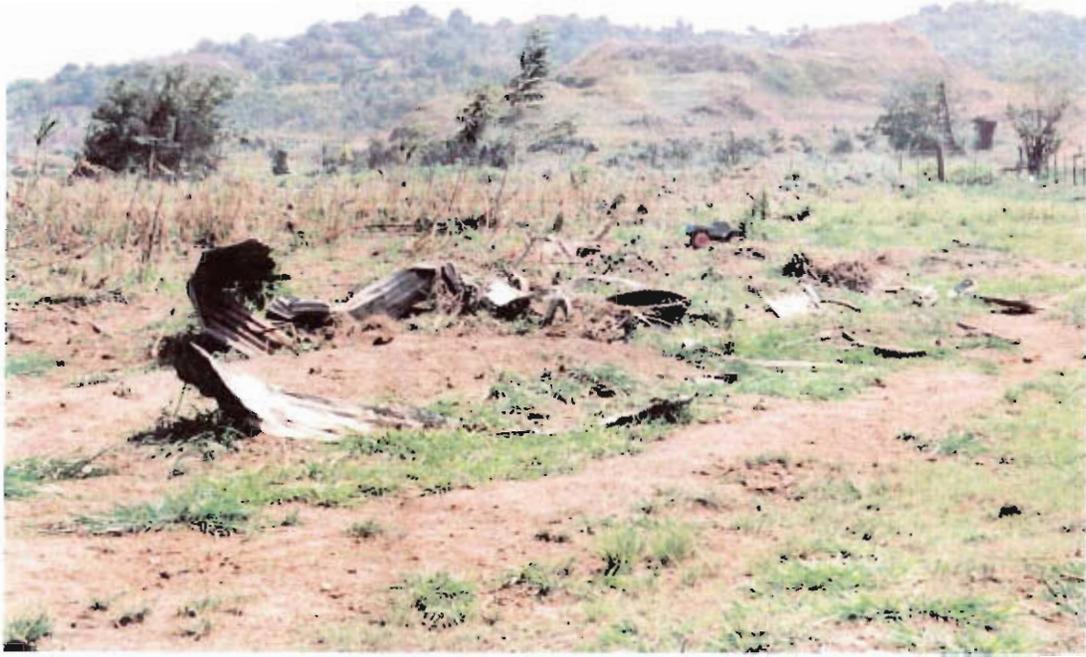
Foto 17: Vertedero clandestino en la Parcela 1

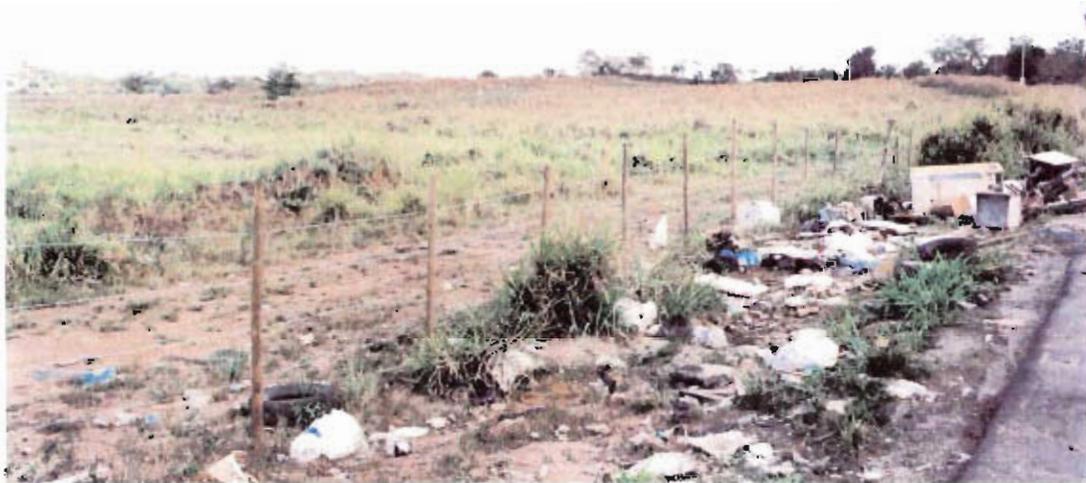
Foto 18: Vertedero clandestino en la colindancia de la Parcela 2
