AUGUST 24, 2002

**PRELIMINARY REPORT NO. 1: FIELD STUDIES OF**

**MARINE RESOURCES ASSESSMENT: MARINA  
PUERTO REAL, FAJARDO, PUERTO RICO**

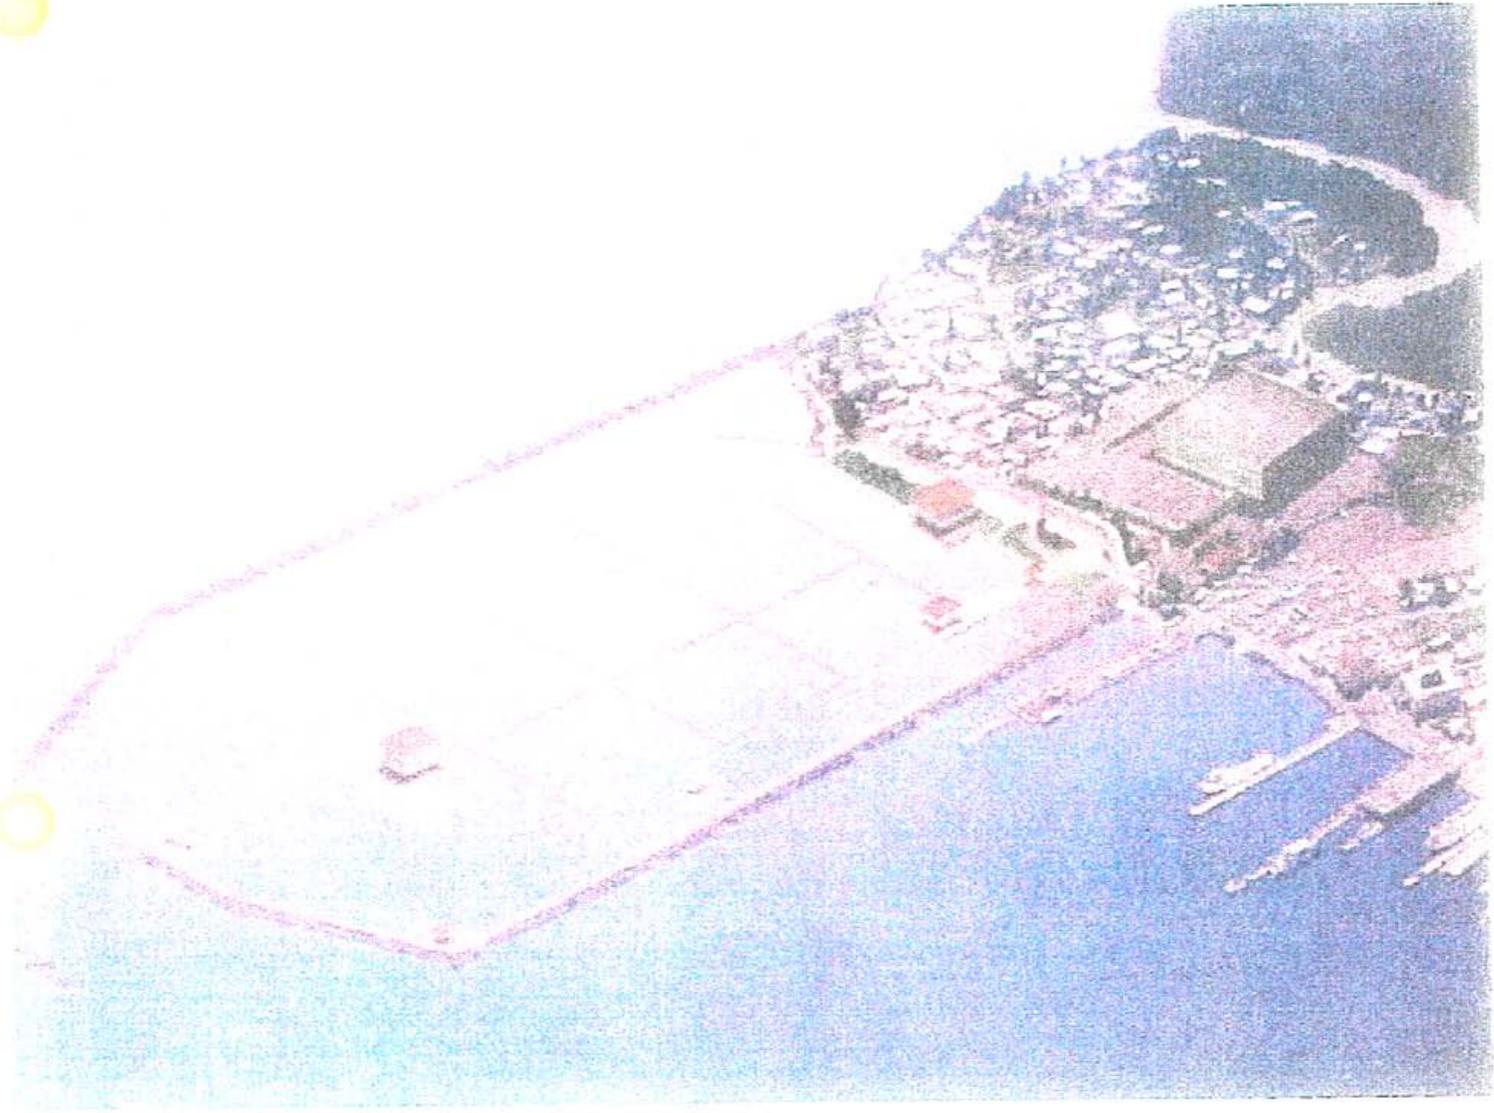
**FIGURE 1**

Project location. The proposed project, which consists of the construction of a marina (Marina Puerto Real) would be located at the Maternillo Sector, Puerto Real Ward, Fajardo, and east coast of Puerto Rico. This figure is derived from NOAA, Chart#U25663.

The proposed project consists of the construction of a marina (Marina Puerto Real), which would be located at the Maternillo Sector, Puerto Real Ward, Fajardo, east coast of Puerto Rico (FIGURE 1).

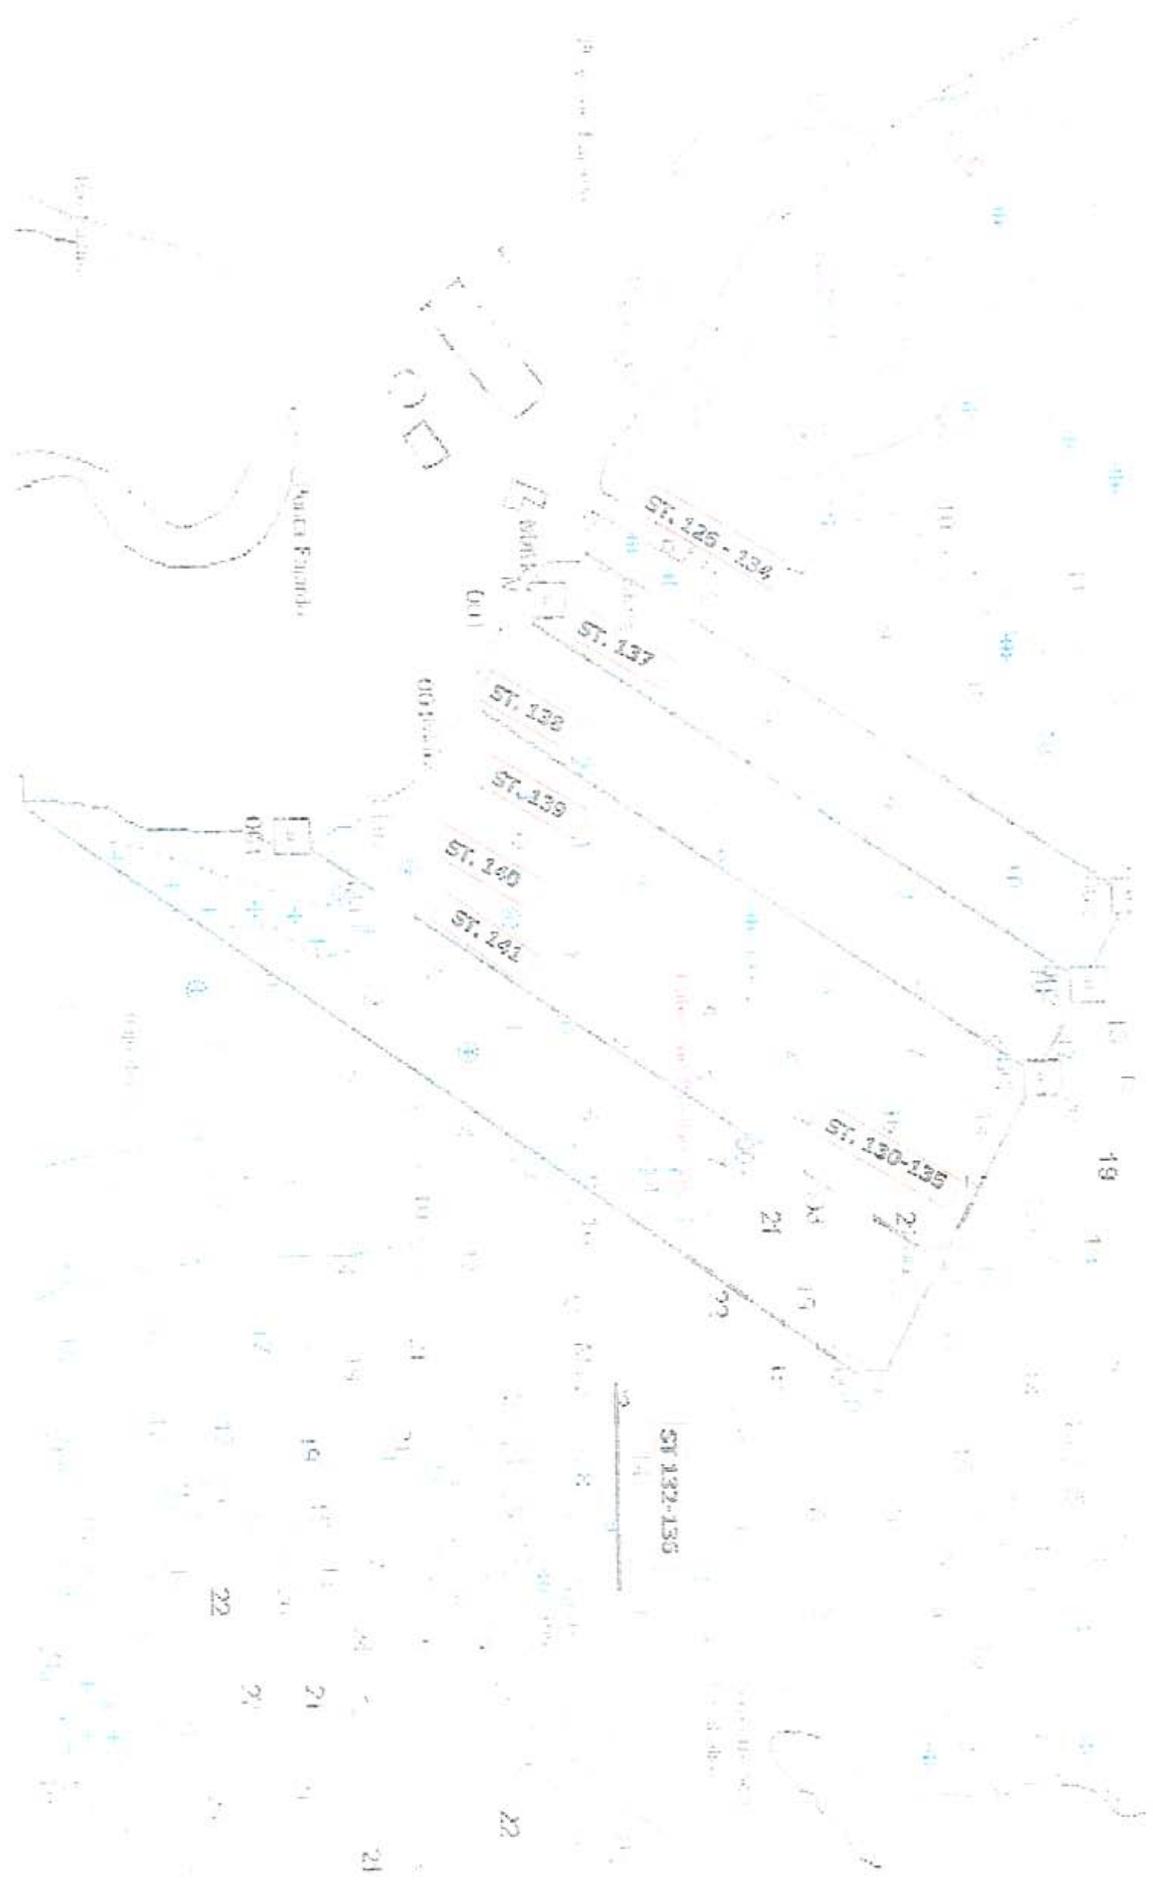
**FIGURE 2**

The location of the three transects performed (ST. 126-134) and the five point near shore inspections (ST. 137, ST. 138, ST. 139, ST. 140, ST. 141) conducted in July 24, 2002 by V&A, Inc.

Three transects, and five point inspections (their locations are shown in FIGURE 2) were conducted. The point inspections, all in very shallow water, were conducted by wading, due to the very poor water quality conditions found near shore. The location of each of the five (5) point inspections were registered with the V&A/GPS#2, which is a 12 channel global positioning instrument with an EPE of 10-20-ft. At each inspection point, notes on the depth, substrate, and of the flora and fauna were taken *in situ*.

The transects consisted of implementing the 20m-U/W video-transect technique as outlined below. The locations and extents of the three transects are shown in FIGURE 2. One of the transects (ST. 126-134) is an inshore transect. The other two transects (ST. 130-131, and ST.132-136) are located offshore but close to the proposed project location. The beginning and end points of each transect were also registered with a GPS 48, 12 channel global positioning instrument. Marking the beginning and end points of the transects will help in the monitoring process, which is a process often required by the agencies.
