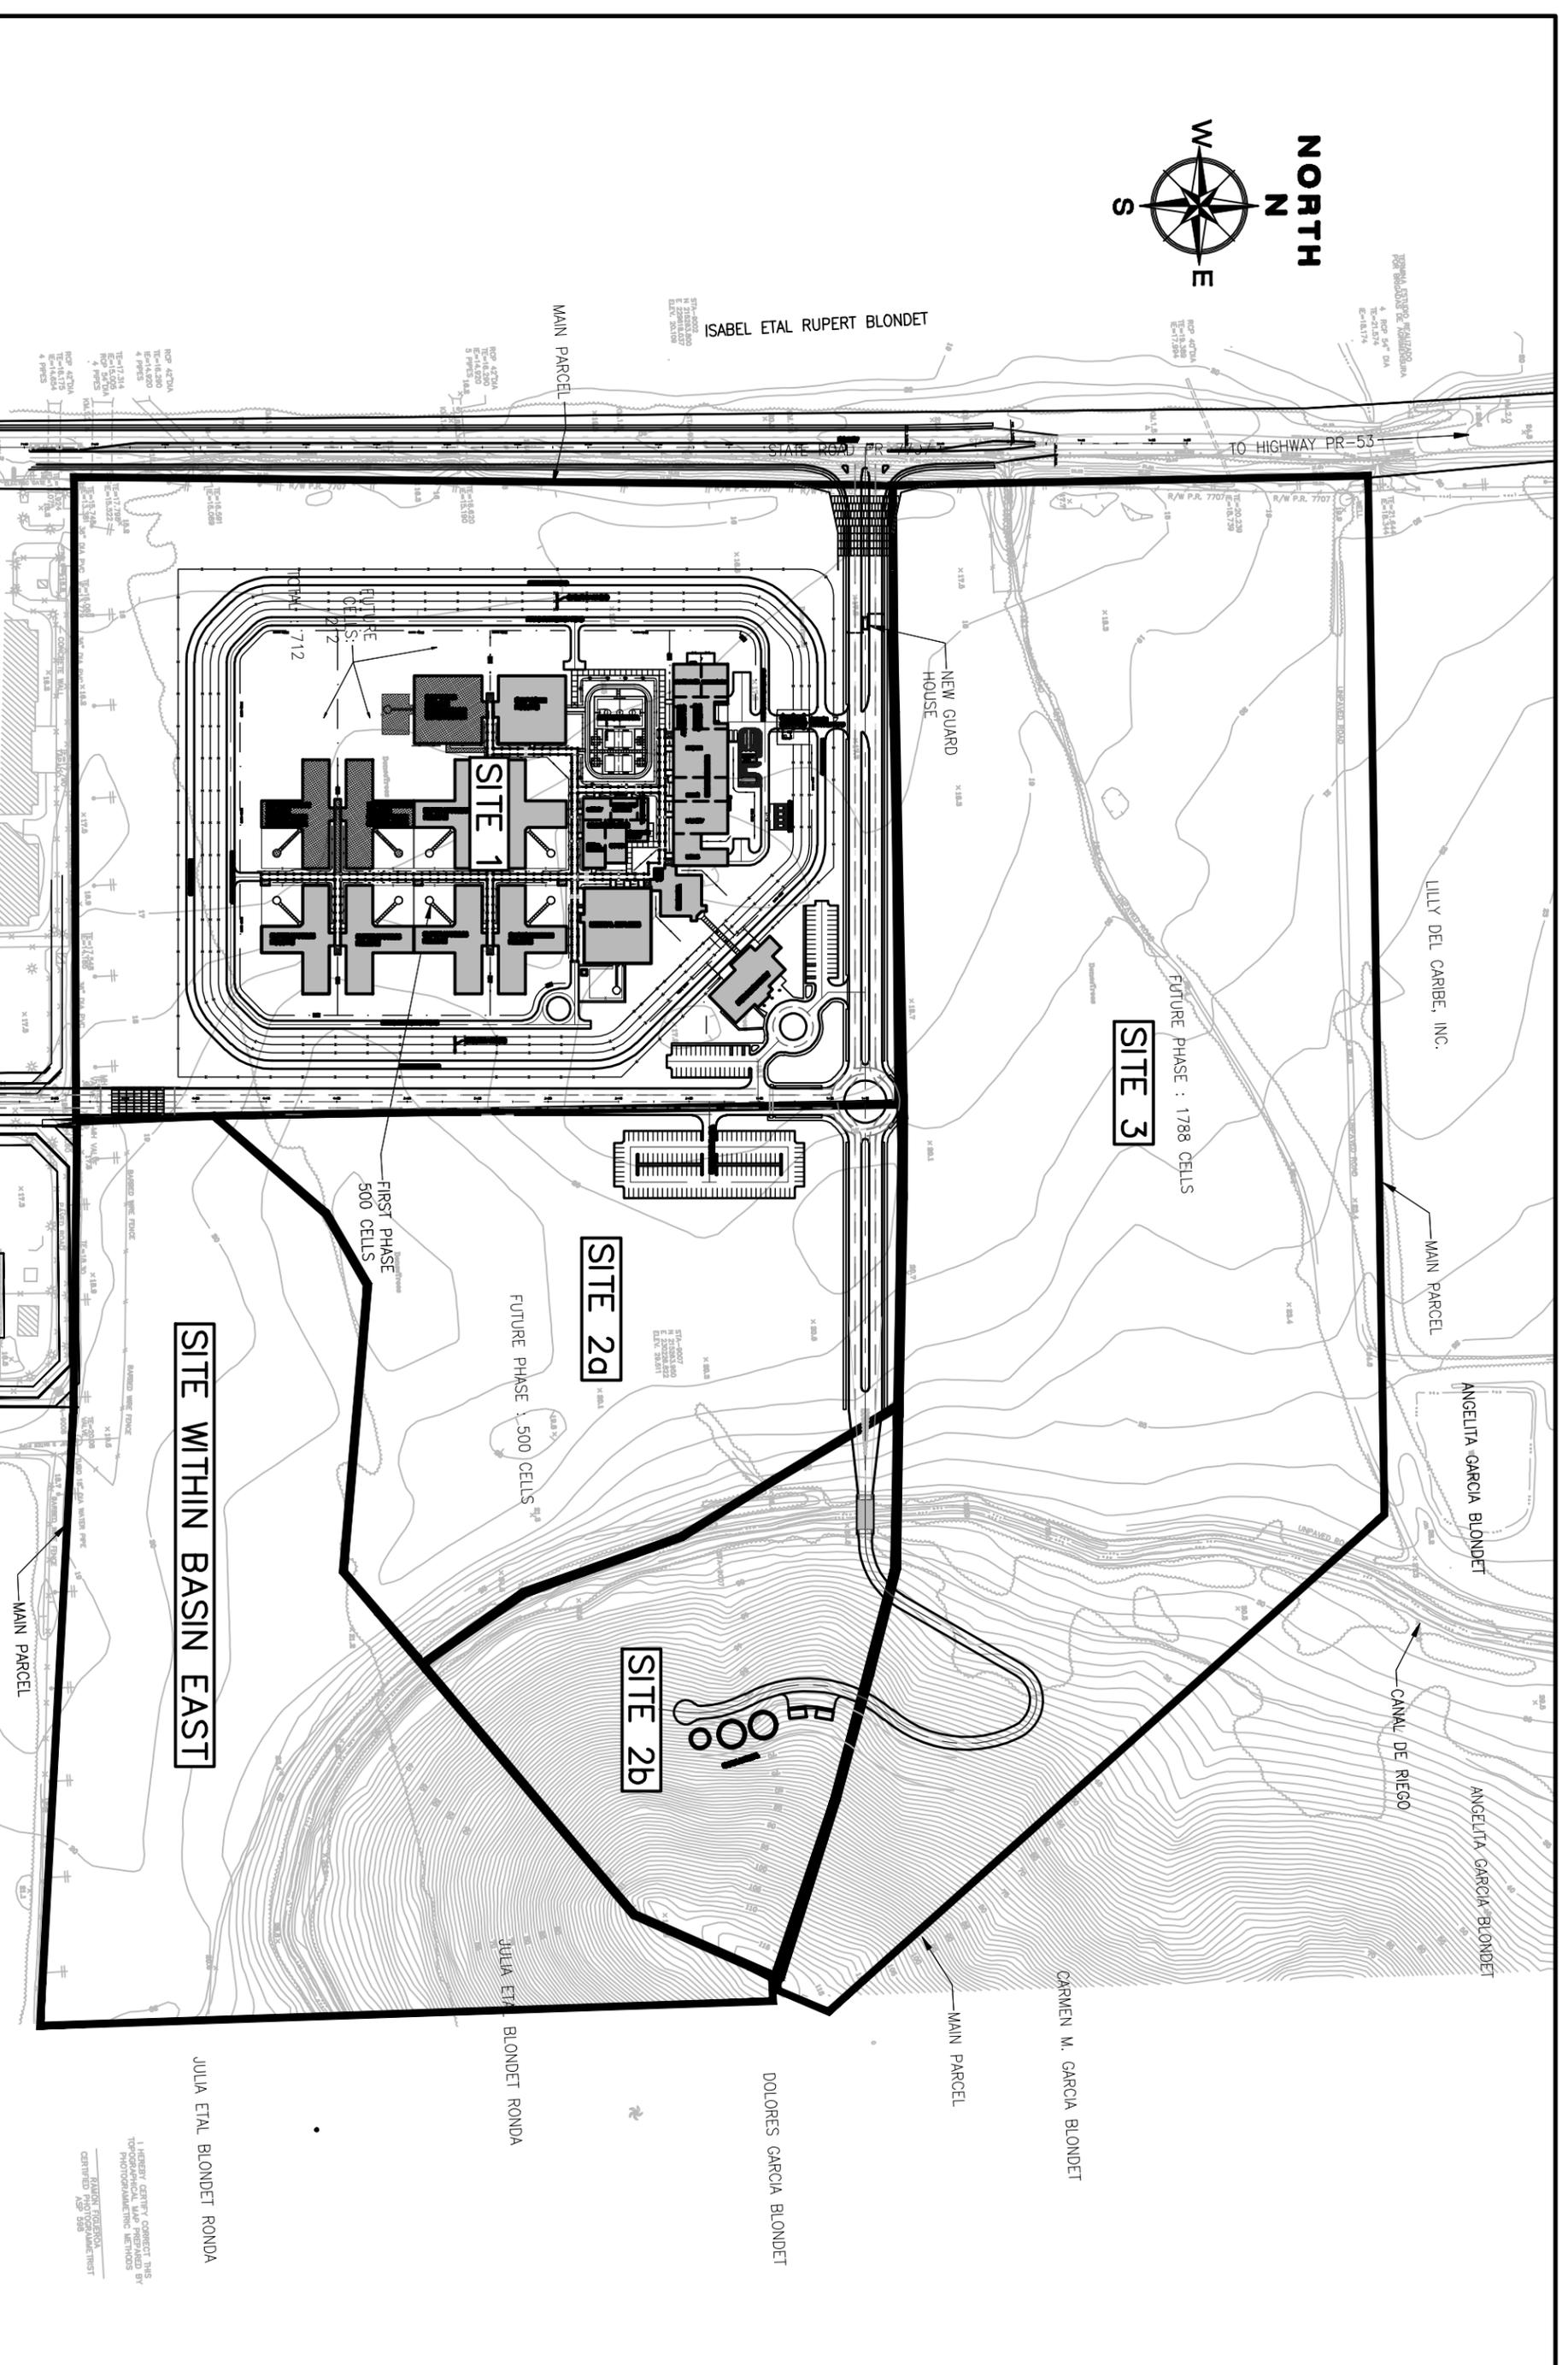
Figure 9: Watershed Limits within Project Site for Proposed Condition

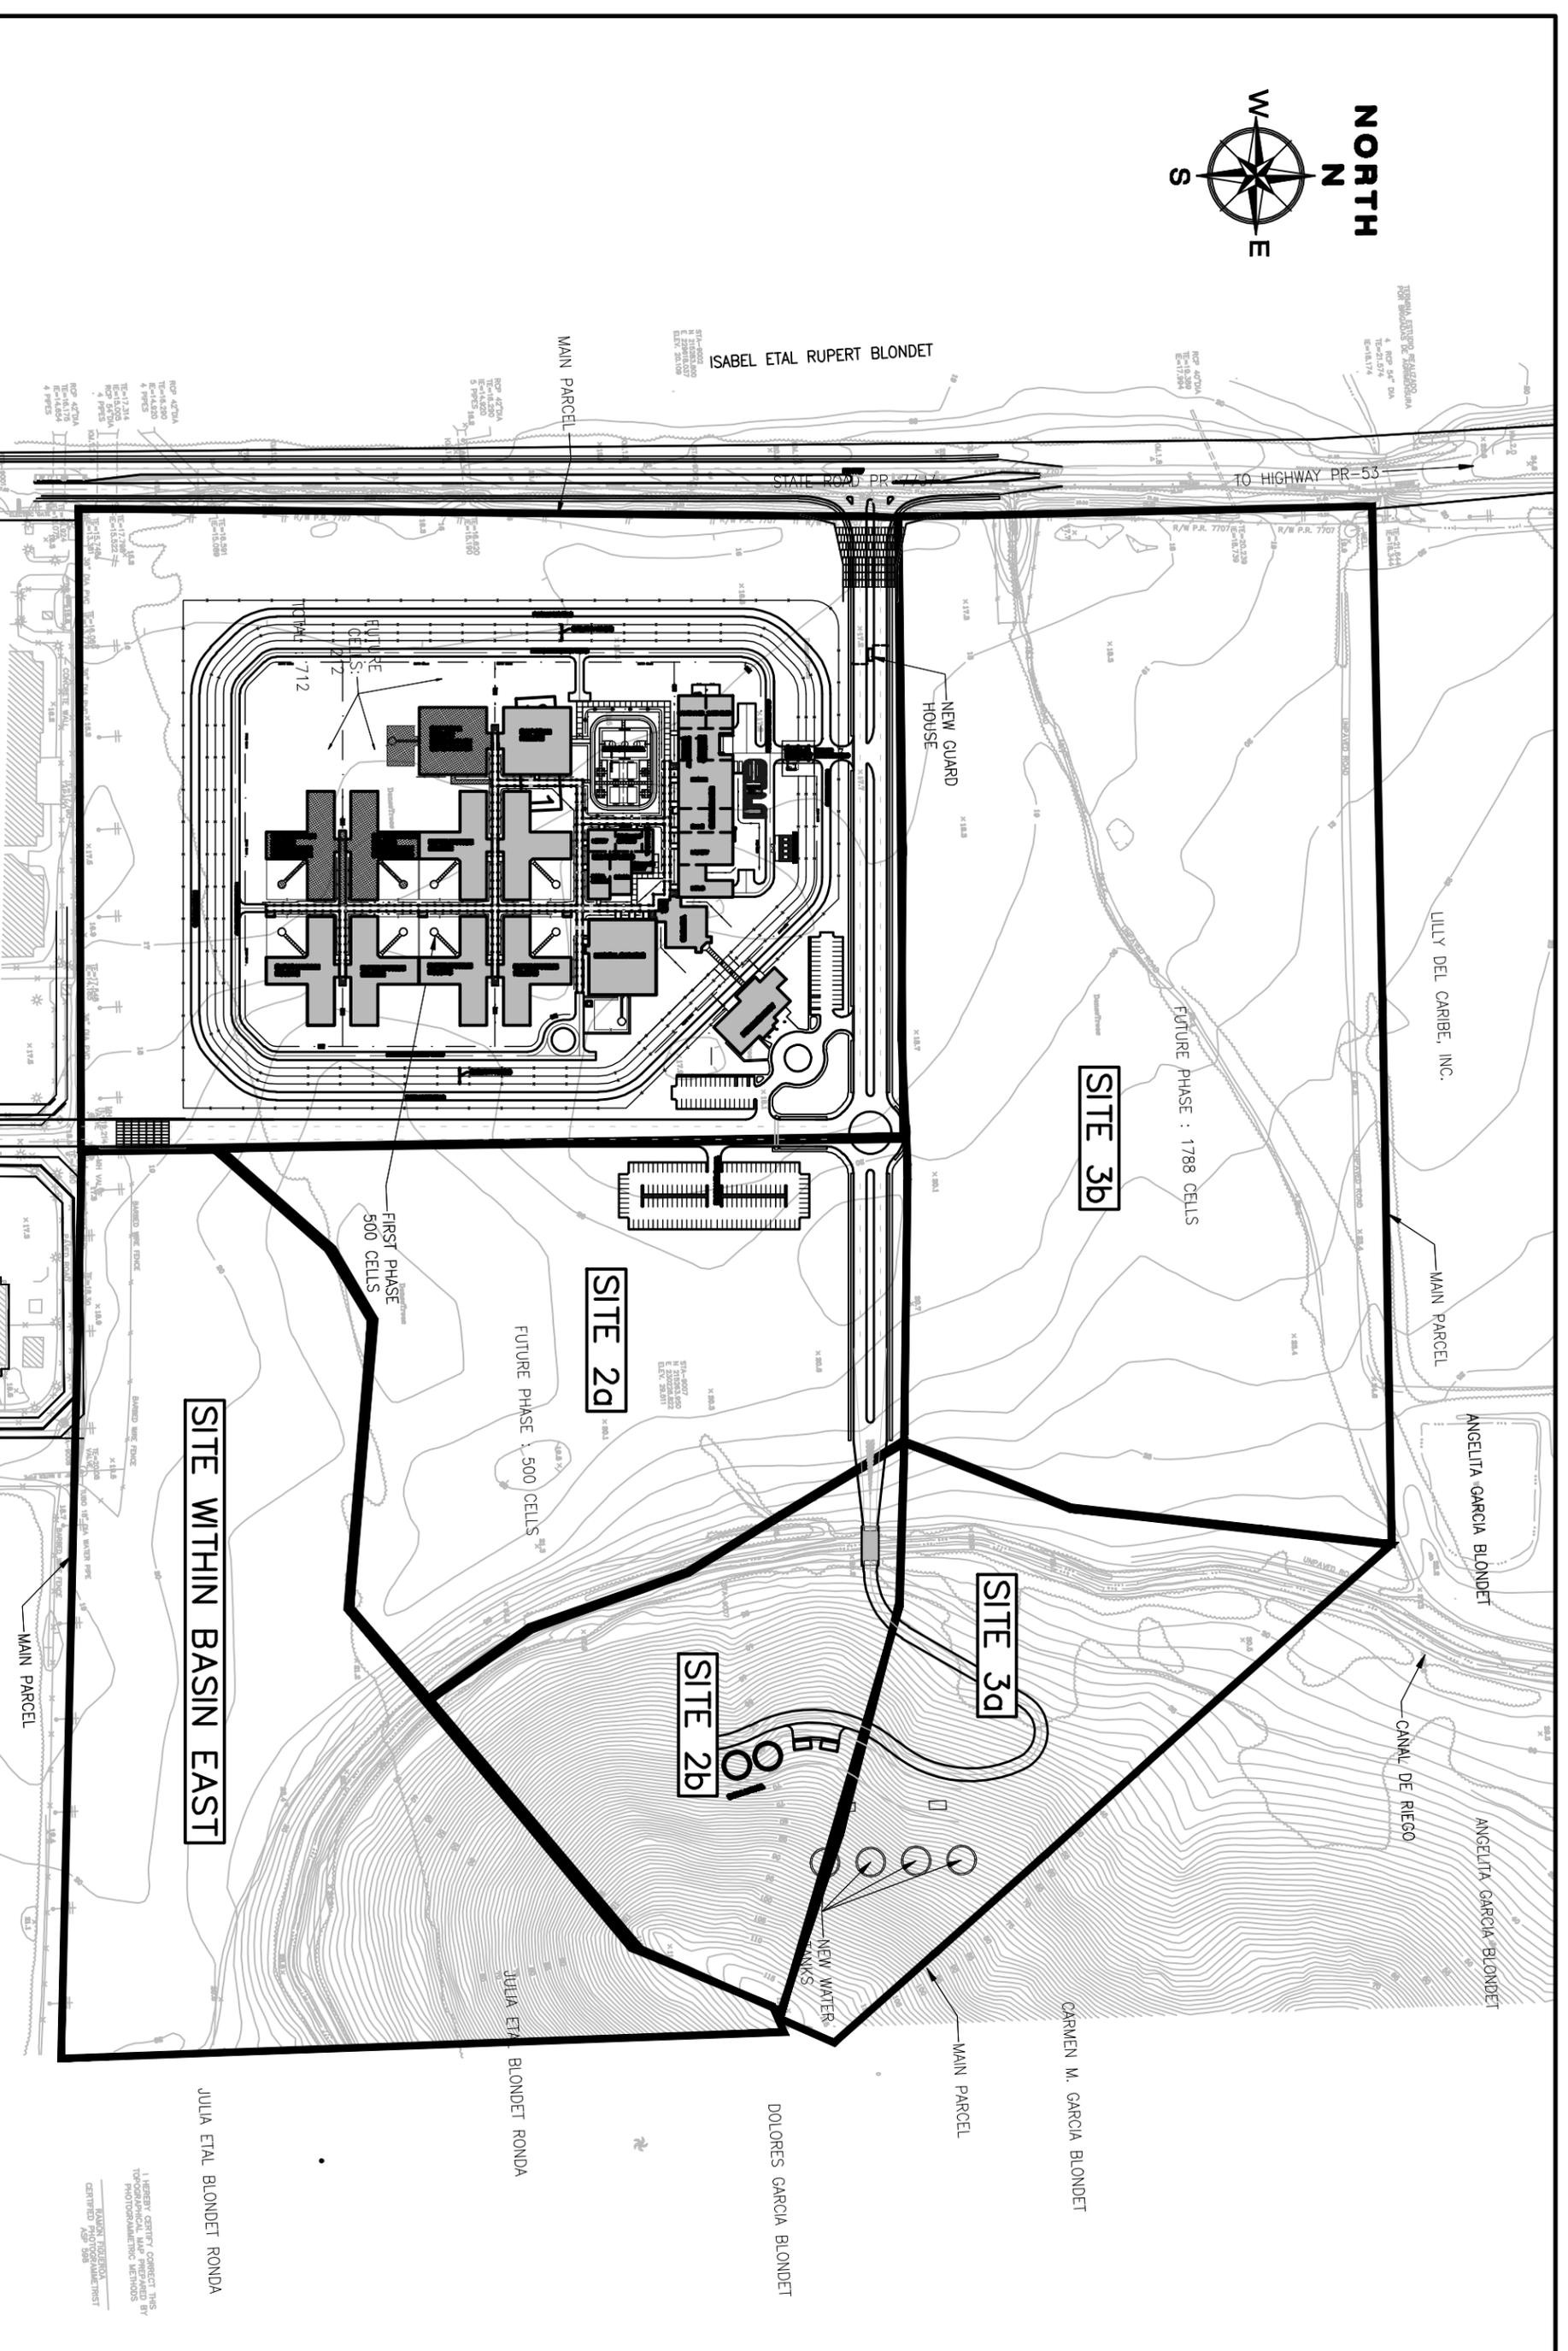
Figure 10: Watershed Limits for Future Condition

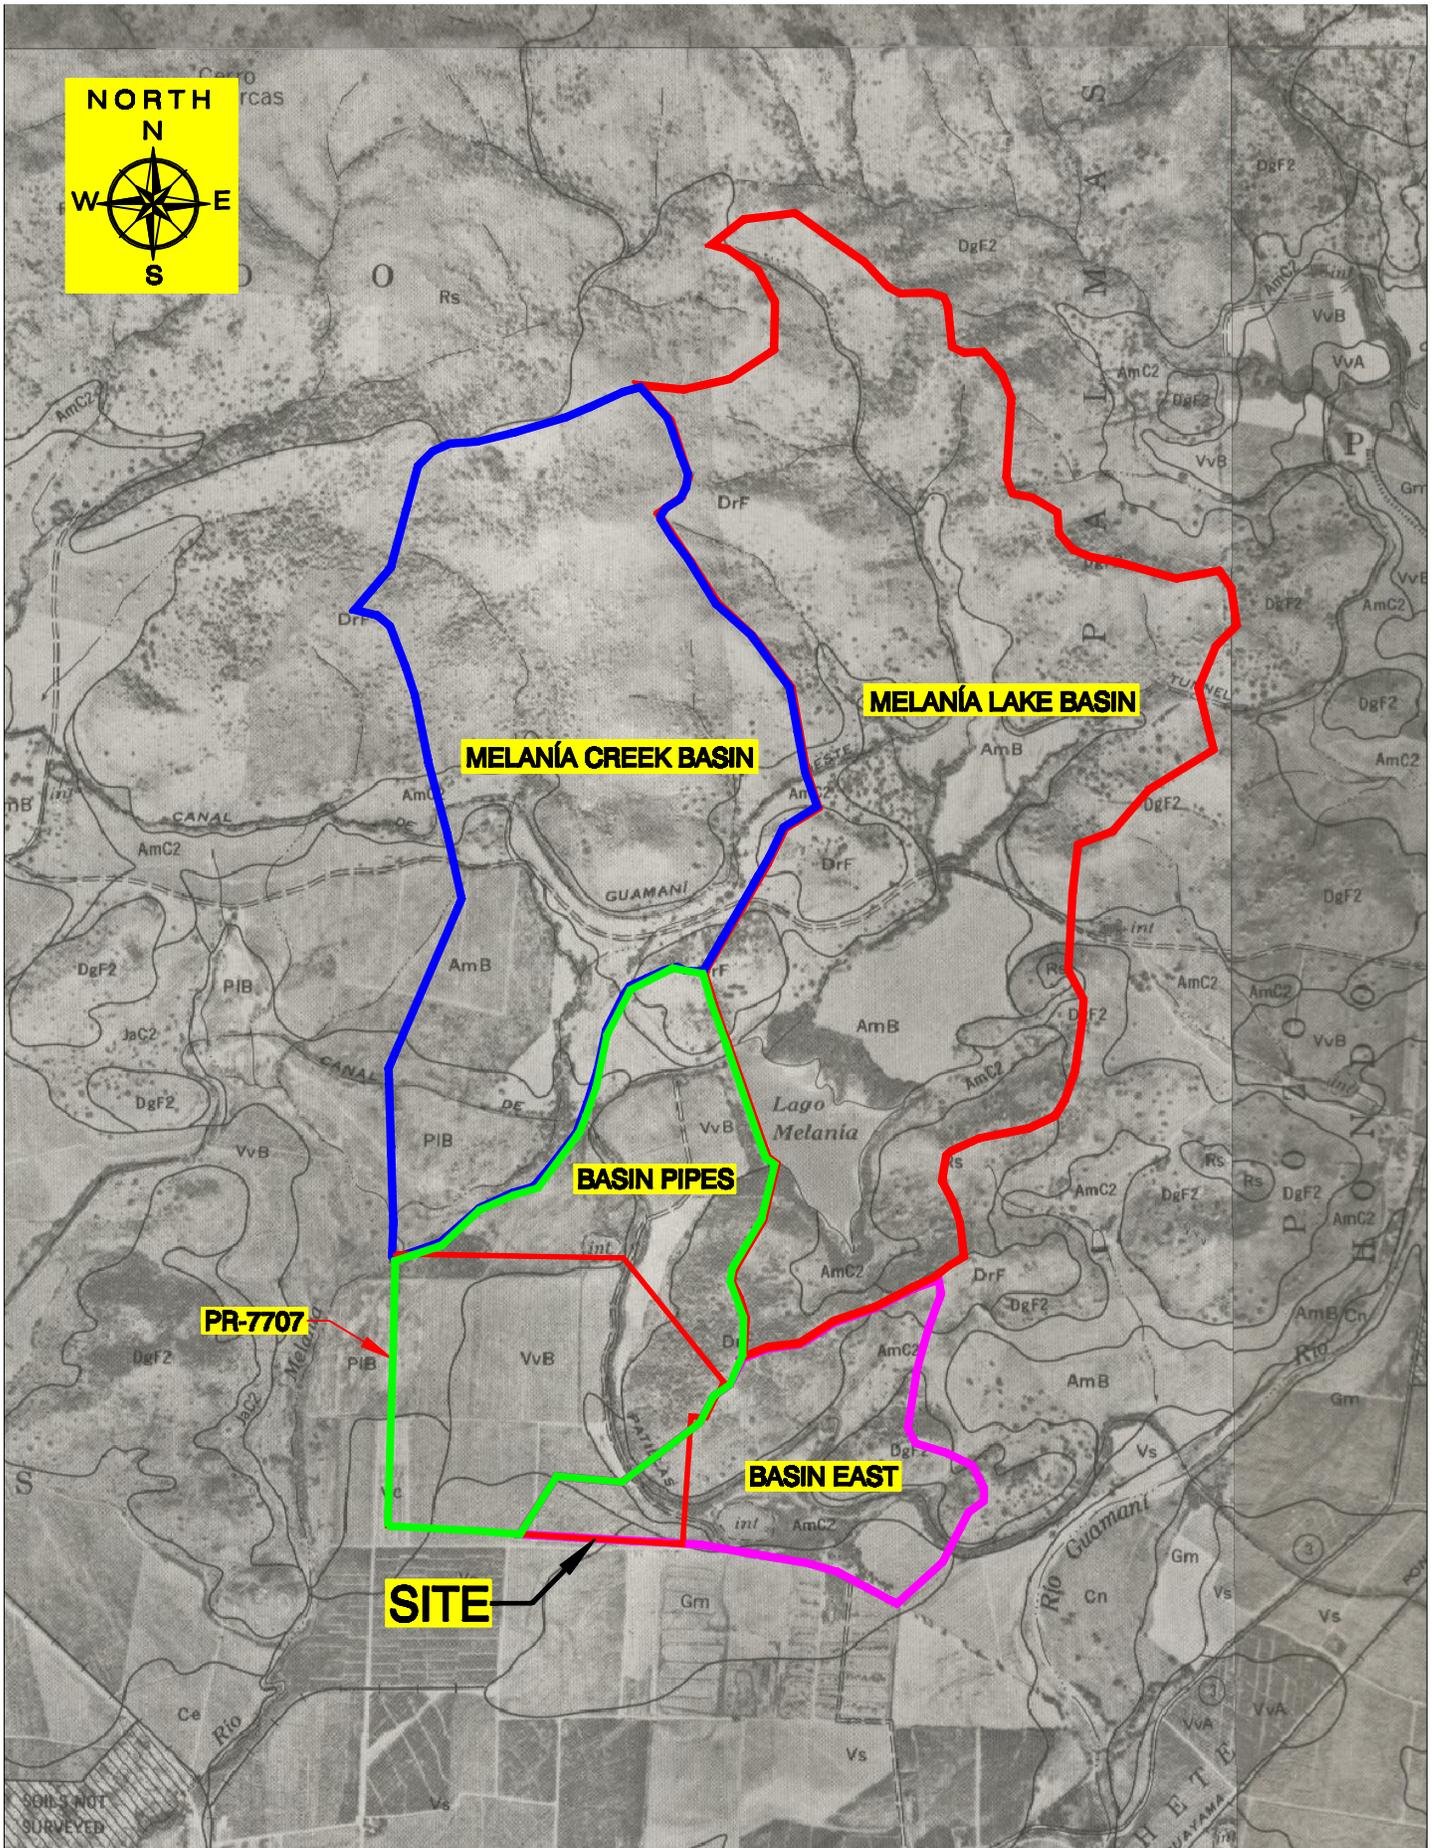
Figure 11: Project Location on a Partial Reproduction of Soil Survey Map of Humacao Sheet # 50
 Scale 1: 20,000

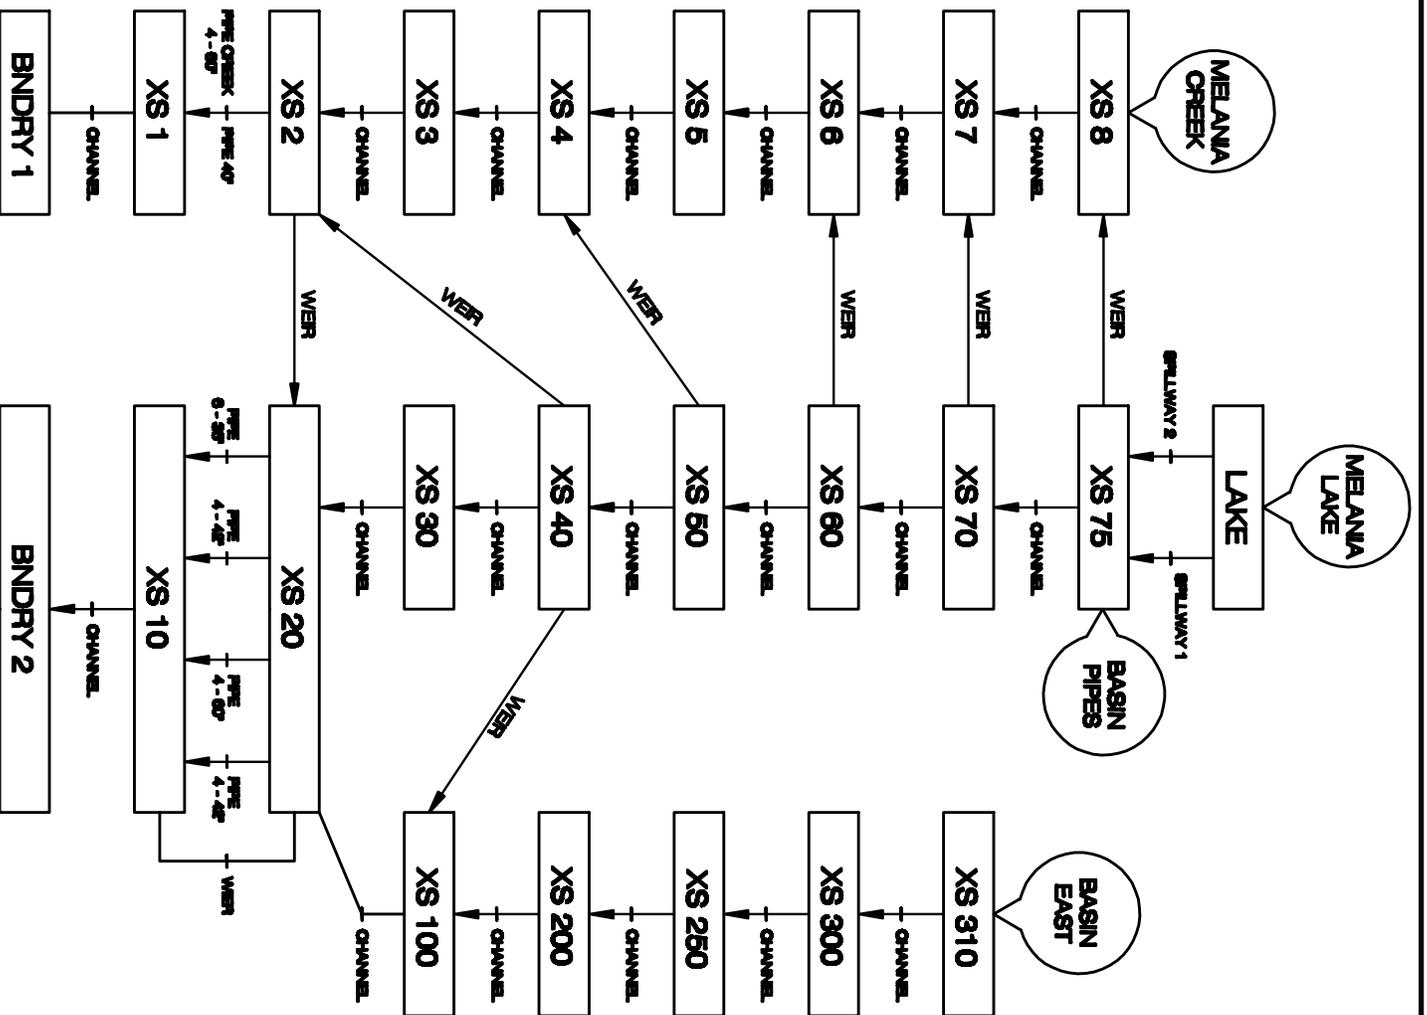
Figure 12: Schematic Link-Node Diagram for Existing Condition

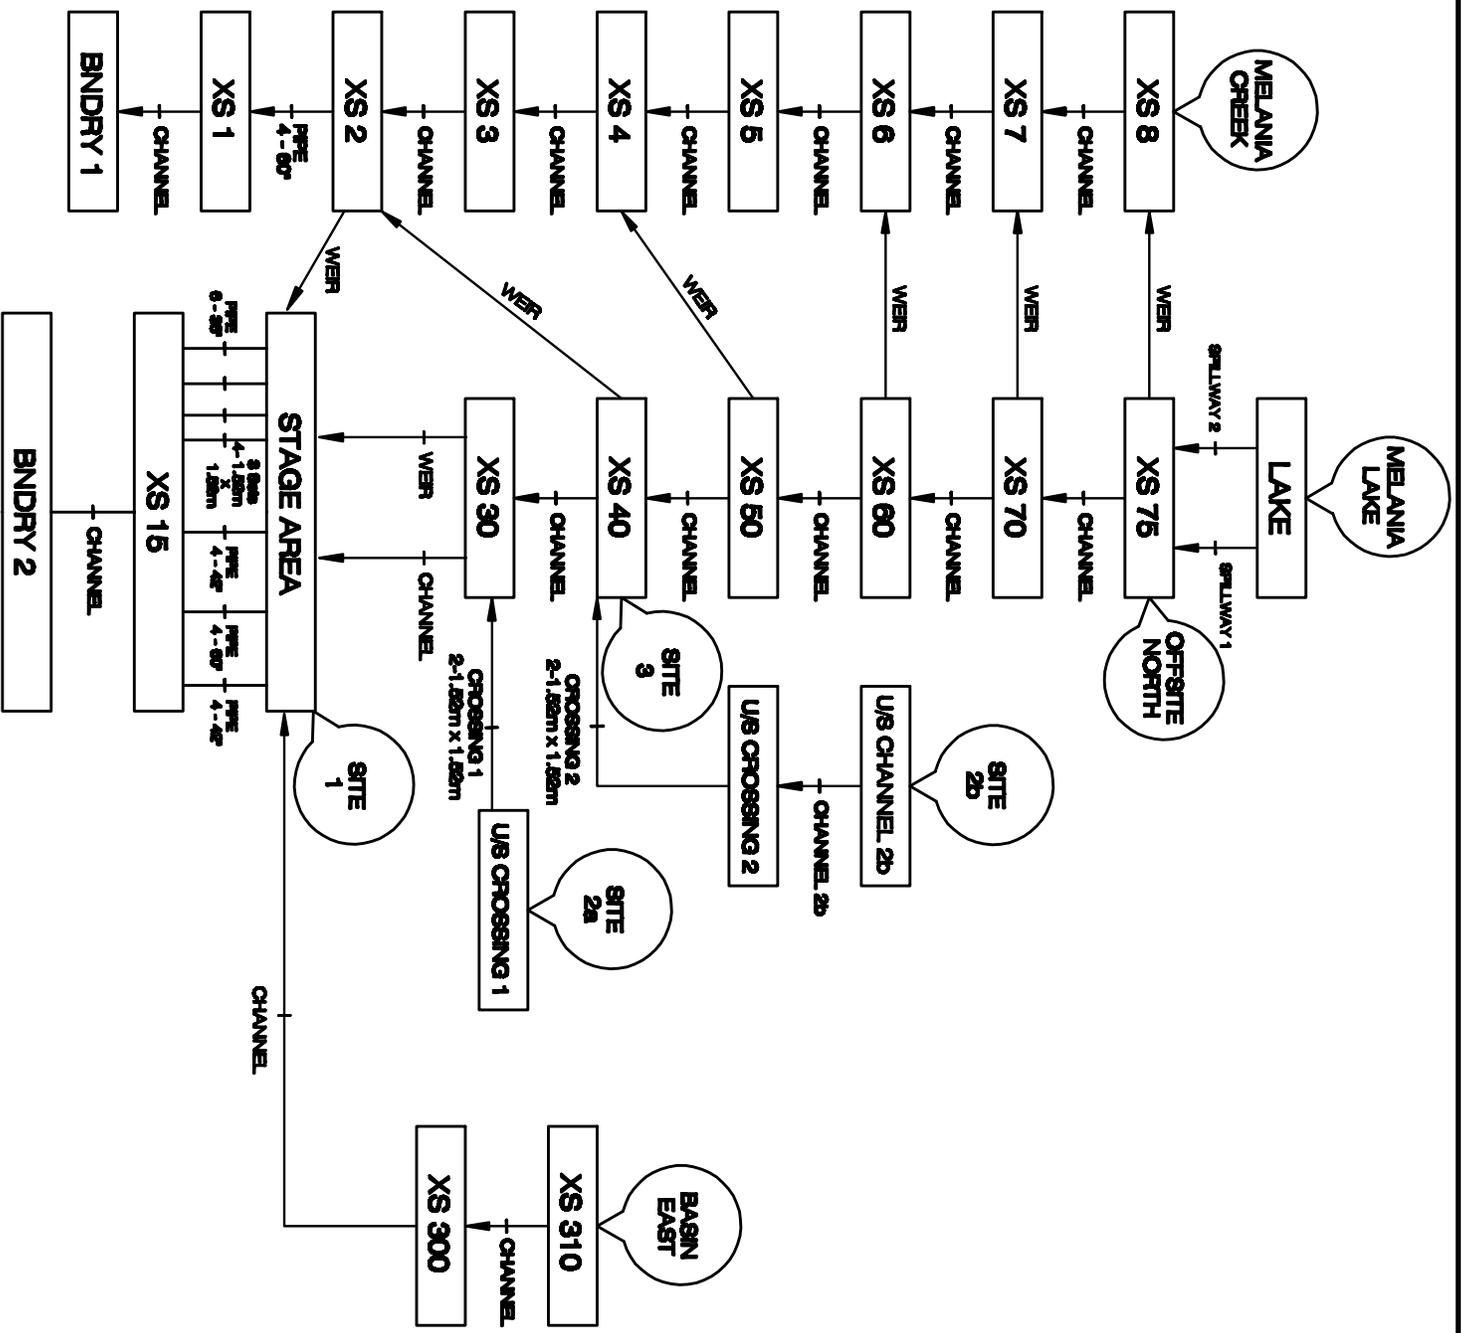
Figure 19: Schematic Link-Node Diagram for Proposed Condition
