**Preliminary Jurisdictional Determination
for the proposed project
Urbanización Monte Sierra
Barrio Caracoles
Mayagüez, Puerto Rico**

Prepared for
CGM. Environmental Consultant Inc.
Caguas, PR 00725

Prepared by
Iván Ruiz & Associates

April 2007

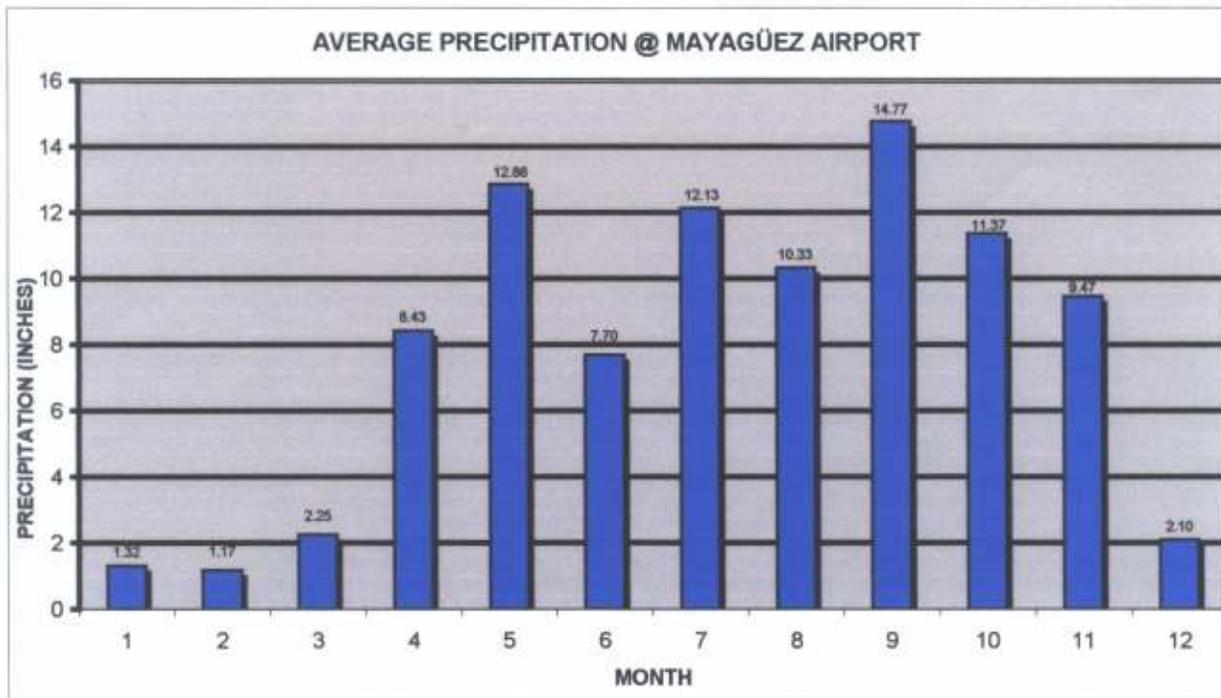
**Figure 2: Annual Precipitation Data from the Mayagüez Airport
(Based on data for the period of 1998-2005)**

Much of the rainfall is orographic and is produced by the lifting of moist trade winds over interior ridges. The rainfalls as brief showers that are frequently moderate to heavy, especially in the period May through November, being the period between December thru April the driest (Figure 2). The average precipitation ranges from 1.17 inches in February to 14.77 inches in September, averaging 65.9 inches. The dry season occurs during the period of December through March. Precipitation data for the central northern coast of Puerto Rico are given on Table 1.

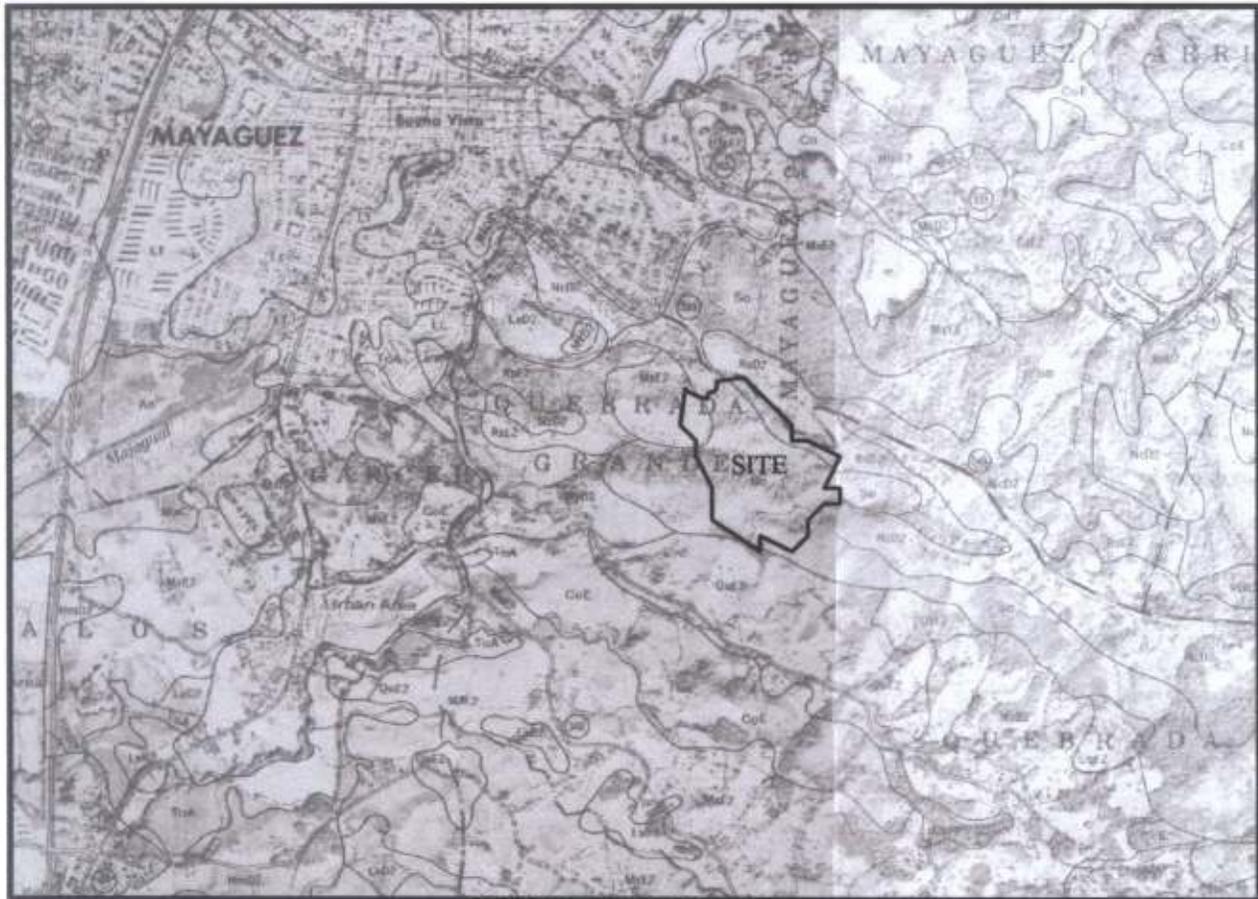
FIGURE 3: SOIL MAP

According to the Soil Survey of Mayagüez Area of Western Puerto Rico (Sheet No. 46), do not indicate a particular type or association of soils for the site. Instead indicates that the site soils are classified as “**Serpentinite outcrop (So)**”, which are areas where 75 to 100 percent of the soil surface are cover by a serpentinite outcrops. The slope ranges from 0 to 60 percent. In accordance to the Natural Resources

Conservation Service, 80% of the proposed area is of this type of soil. See **Figure 3**.

Some irregularly shaped areas not covered by the outcrop, which consist of gravelly or cobbly soil materials are five inches (5) thick and soil color are red, black, or reddish brown. In few places there are pockets of red or black soils between the outcrops. This type of soil was particularly observed on the intermittent riverbed.

Other types of mapped soil unit are found on lesser amount were **Mucara clay**, 20 to 40% slopes, eroded (**MxF2**) and **Rosario clay**, 20 to 40% slopes, eroded (**RsE2**). Mucara soil series consist of moderately deep, well drained, and moderately permeable. These soils are found on strongly dissected side slopes and narrow ridgetops throughout volcanic uplands.

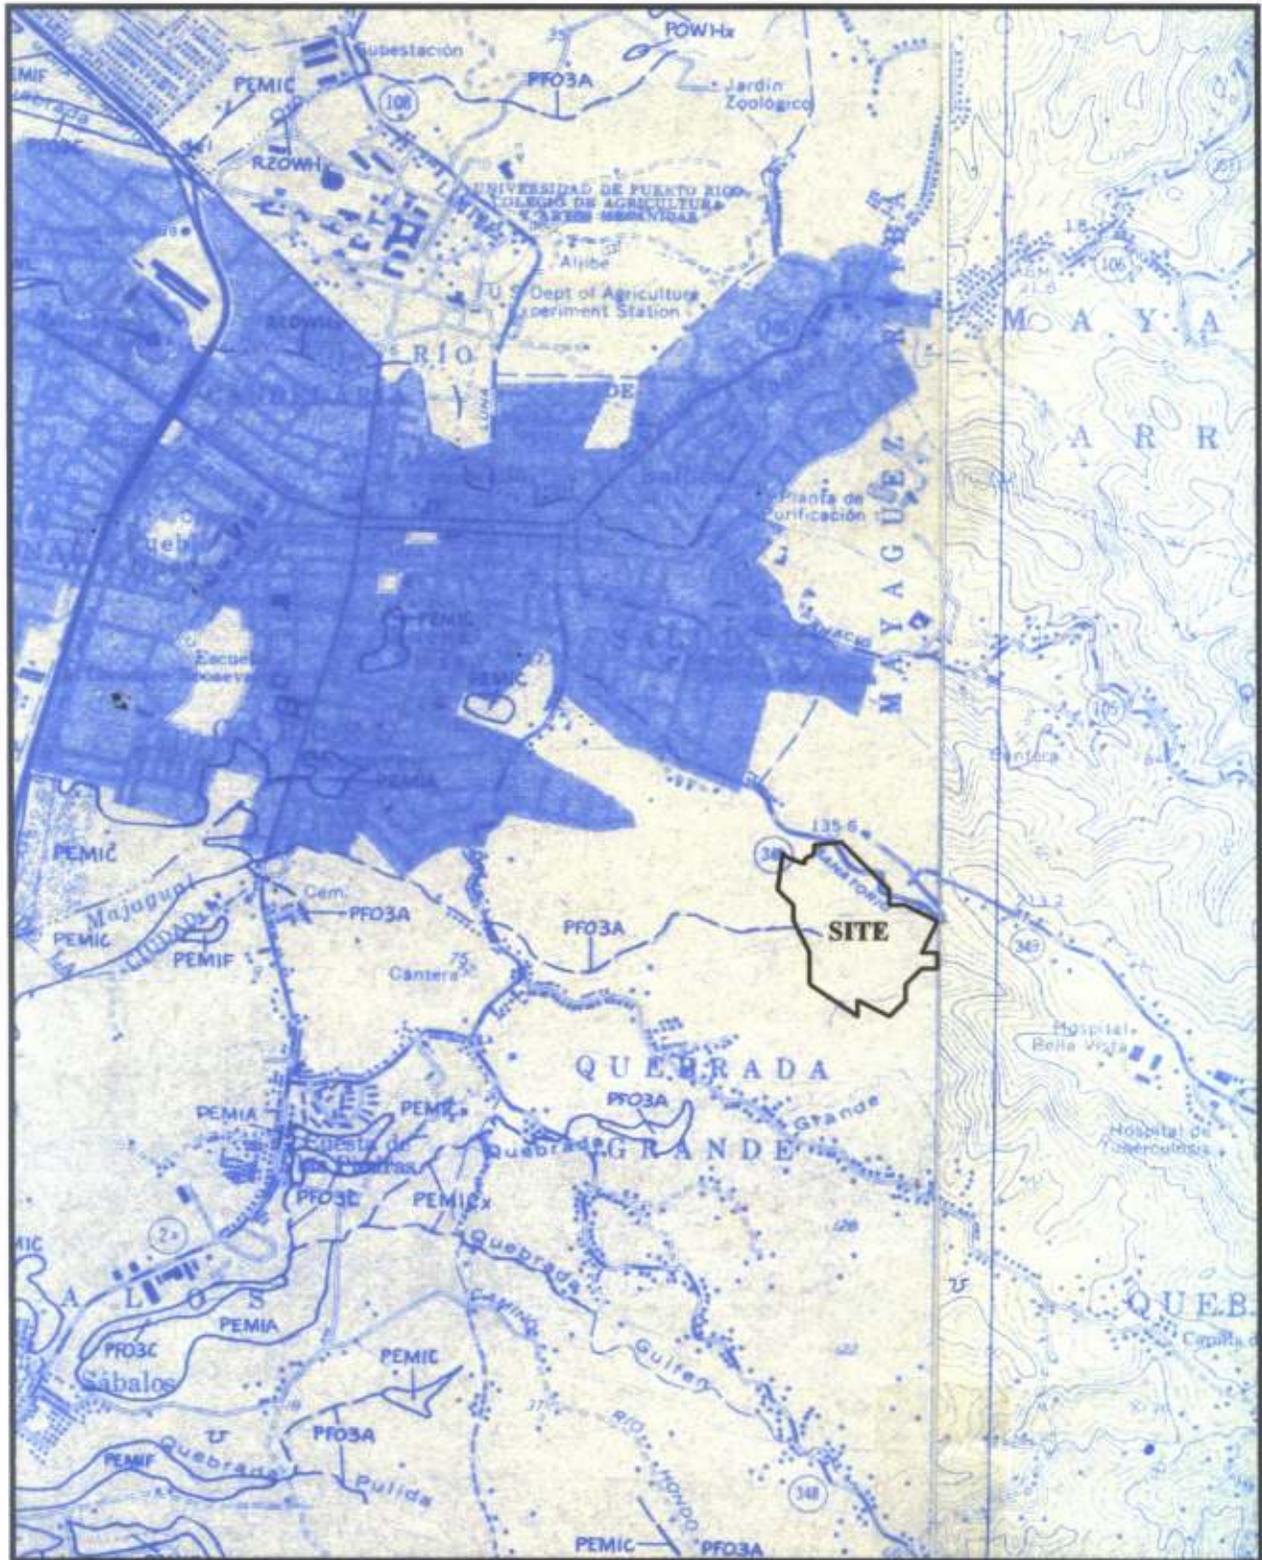
Figure 4: Wetland Inventory Map.

Site wetland hydrology is limited to the intermittent creek channel. It is strongly influenced mainly by the surface flow. Other factors such as precipitation, and groundwater discharge may contribute to the wetland hydrology. The wetland hydrologic characteristic is that of a riverine wetland, which intercept the water table so it receives groundwater in addition to precipitation and headwater flooding.

The proposed project site contains two (2) unnamed creeks, which flow from east to west, have a well-characterized stream channel corridor with a shallow riverbed. Parts of these creeks have an intermittent flow in the higher elevations and an upper perennial flow in the lower elevations, with a high gradient and the velocity of the water is high.

On both riverine subsystems, the streambed is largely composed of cobbles and gravel. Although, some part where flow is cause by ground water intersections the streambed bed are vegetated.

For the purpose of Section 404 of the Clean Water Act, field inspection for hydrophytic vegetation, wetland hydrology and hydric soils indicates the existence of an upland area within a intermittent unnamed creek that has jurisdiction. Field inspection and the preliminary jurisdictional determination coincide with the Fish and Wildlife Service Inventory Map (Mayagüez Quadrangle). According to the FWS Inventory Map, one wetland area is occasionally flooded by headwaters. Water from this creek ultimately ended on the Mayagüez Bay, through the Majagual Canal. (See Figure 5: Wetland Inventory Map)

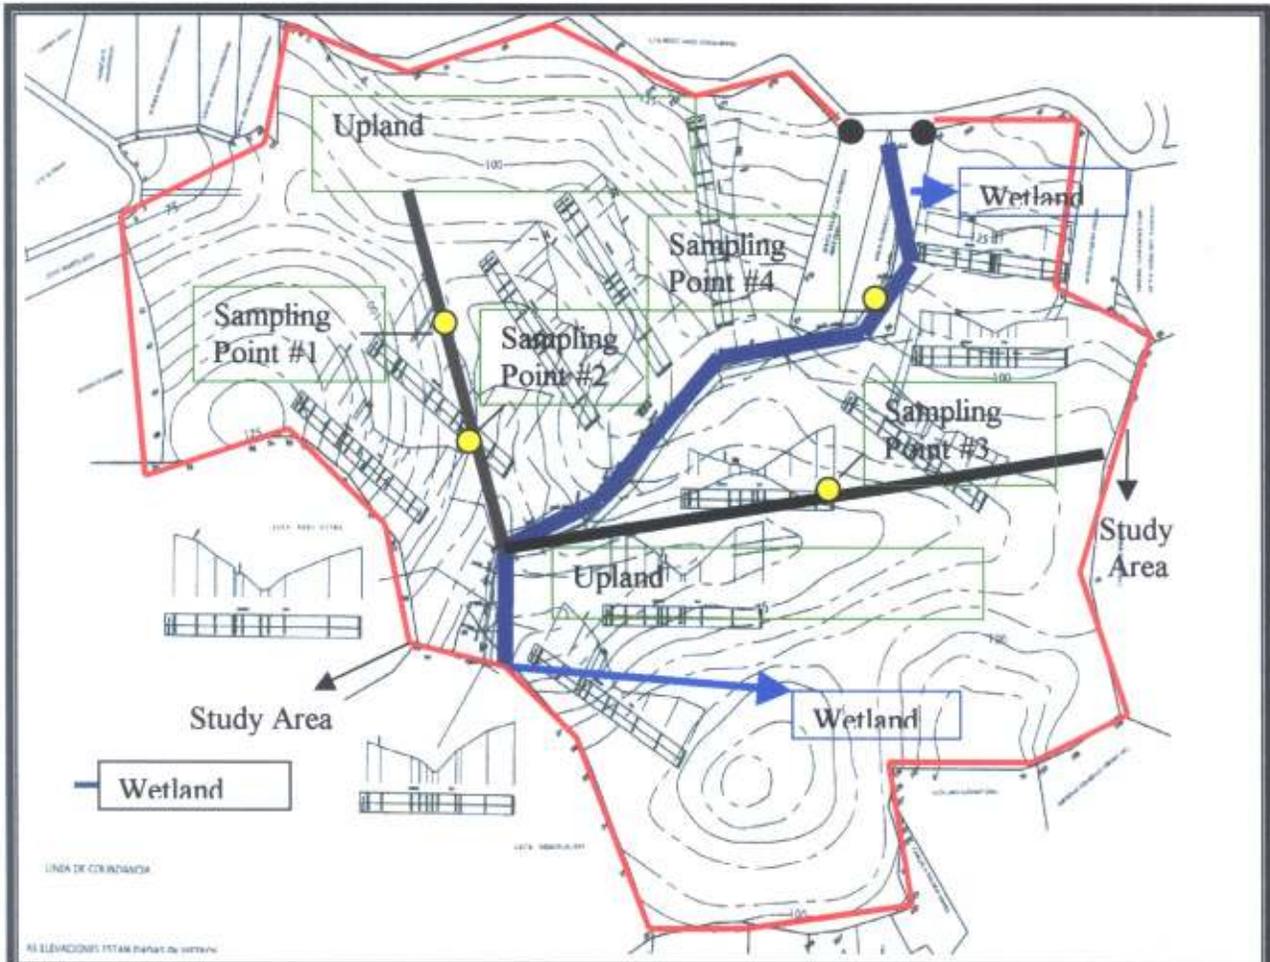
**PRELIMINARY
WETLAND
DELINEATION**
marzo, 2007

These jurisdictional wetlands are depicted in the enclosed Preliminary Wetland Delineation.

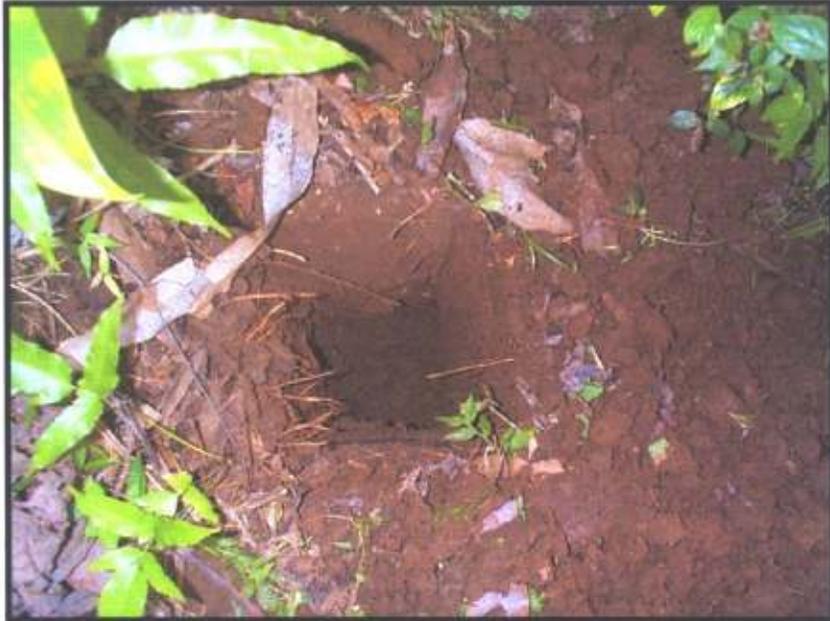
Photo 1: View of Sampling Point 1 pit.

Remarks: Sampling point located on an open area, near Municipal pave road.

Remarks: <u>No wetland hydrology indicators were observed at this sampling point.</u>

Remarks: <u>No hydric soil indicators were observed at this sampling point.</u>

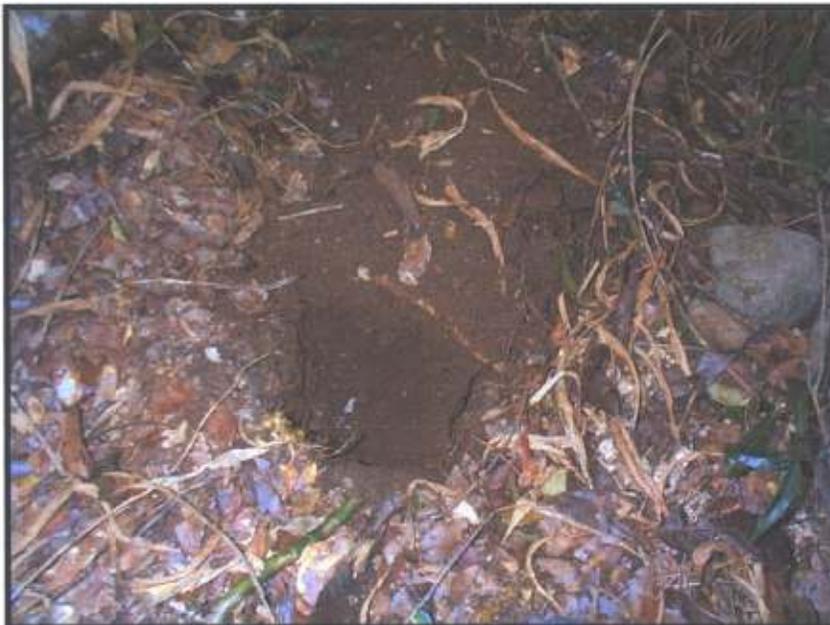
Photo 2: View of Sampling Point 2 pit.

Remarks: No hydric soil indicators were observed at this sampling point.

Remarks: Sampling point located on a dry gully.

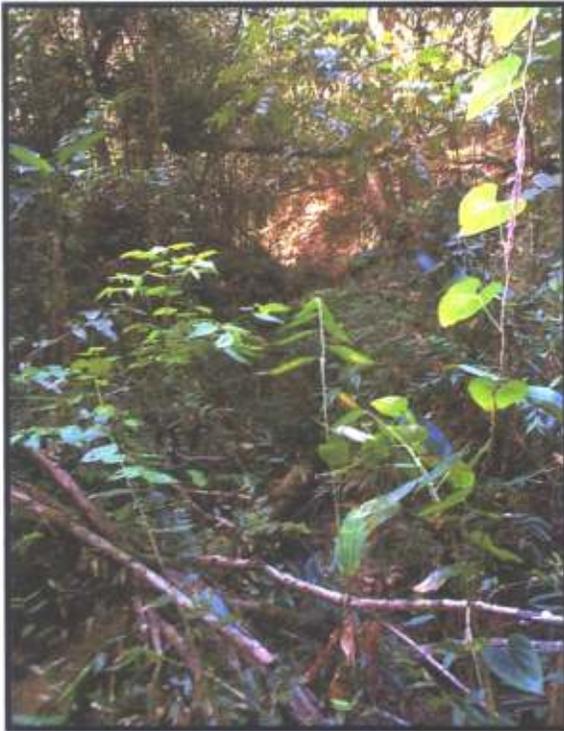
Photo 3: View of vegetation on SP 2.

Percent of Dominant Species that are OBL, FACW or FAC (excluding FAC-). 3/5 - 60%

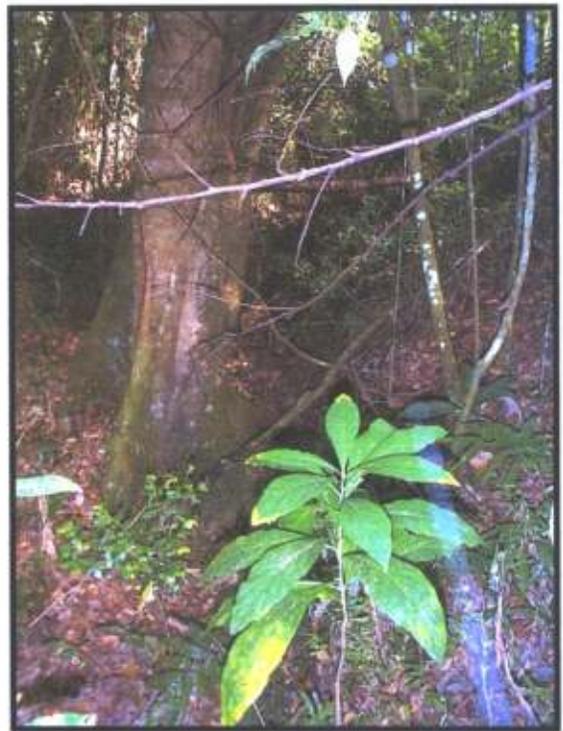
Photo 4: View of vegetation on SP 3.

Percent of Dominant Species that are OBL, FACW or FAC (excluding FAC-): 3/4 - 75%

Remarks: No hydric soil indicators were observed at this sampling point.

Hydrophytic Vegetation Present? <input checked="" type="radio"/> Yes <input type="radio"/> No (Circle) Wetland Hydrology Present? <input type="radio"/> Yes <input checked="" type="radio"/> No (Circle) Hydric Soils Present? <input type="radio"/> Yes <input checked="" type="radio"/> No (Circle)	Is this Sampling Point Within a Wetland? Yes <input type="radio"/> No <input checked="" type="radio"/> (Circle)
Remarks: Sampling point located on a dry gully.

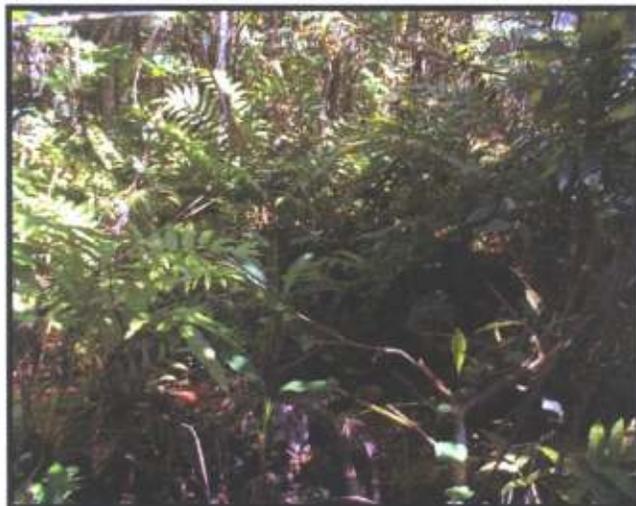
Photo 5: View of vegetation on SP 4.

Percent of Dominant Species that are OBL, FACW or FAC (excluding FAC-): 4/4 = 67%

___ Recorded Data (Describe in Remarks): ___ Stream, Lake, or Tide Gauge ___ Aerial Photographs ___ Other X No Recorded Data Available	Wetland Hydrology Indicators: Primary Indicators: ___ Inundated X Saturated in Upper 12 Inches ___ Water Marks ___ Drift Lines ___ Sediment Deposits X Drainage Patterns in Wetlands Secondary Indicators (2 or more required): ___ Oxidized Root Channels in Upper 12 Inches X Water-Stained Leaves ___ Local Soil Survey Data X FAC-Neutral Test ___ Other (Explain in Remarks)
Field Observations: Depth of Surface Water: <u>N/A</u> (in.) Depth to Free Water in Pit: <u>5</u> (in.) Depth to Saturated Soil: <u>0</u> (in.)	
Remarks: <u>Sampling point located on the basin of an intermittent creek.</u>

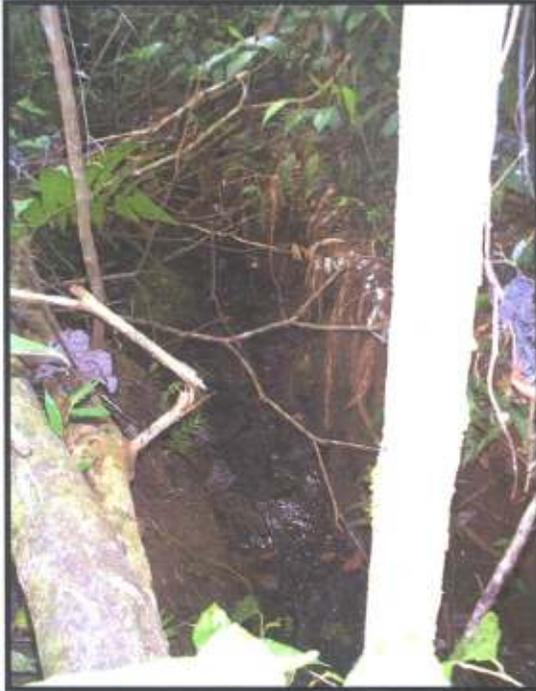
Photo 6: View of upper perennial unnamed creek.

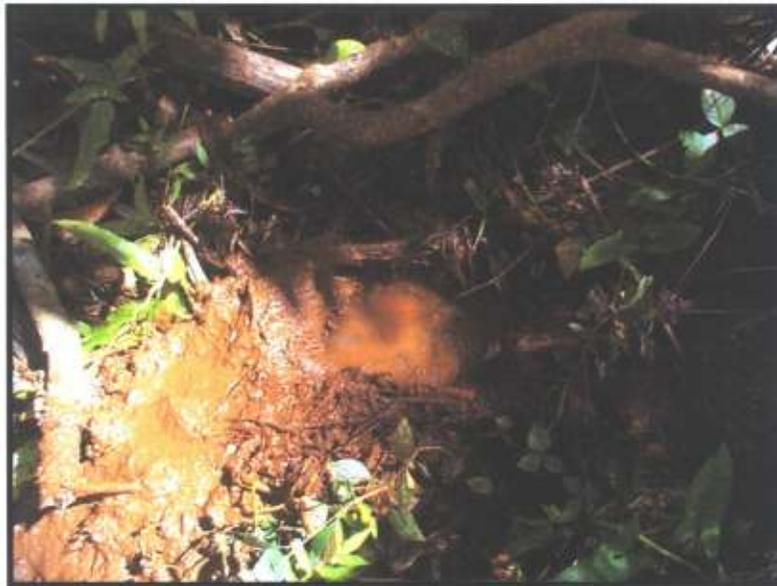
Photo 8: Sampling Point 4.

Profile Description:					
Depth (inches)	Horizon	Matrix Color (Munsell Moist)	Mottle Colors (Munsell Moist)	Mottle Abundance/ Size/Contrast	Texture, Concretions, Structure, etc.
0 - 16	AE	10R 4/2	No mottles	N/A	Silty clay loam
