June 8, 2007

RE: Preliminary Subsurface Utility Engineering Study for the Proposed Carolina Tranvía Stations, Carolina, Puerto Rico

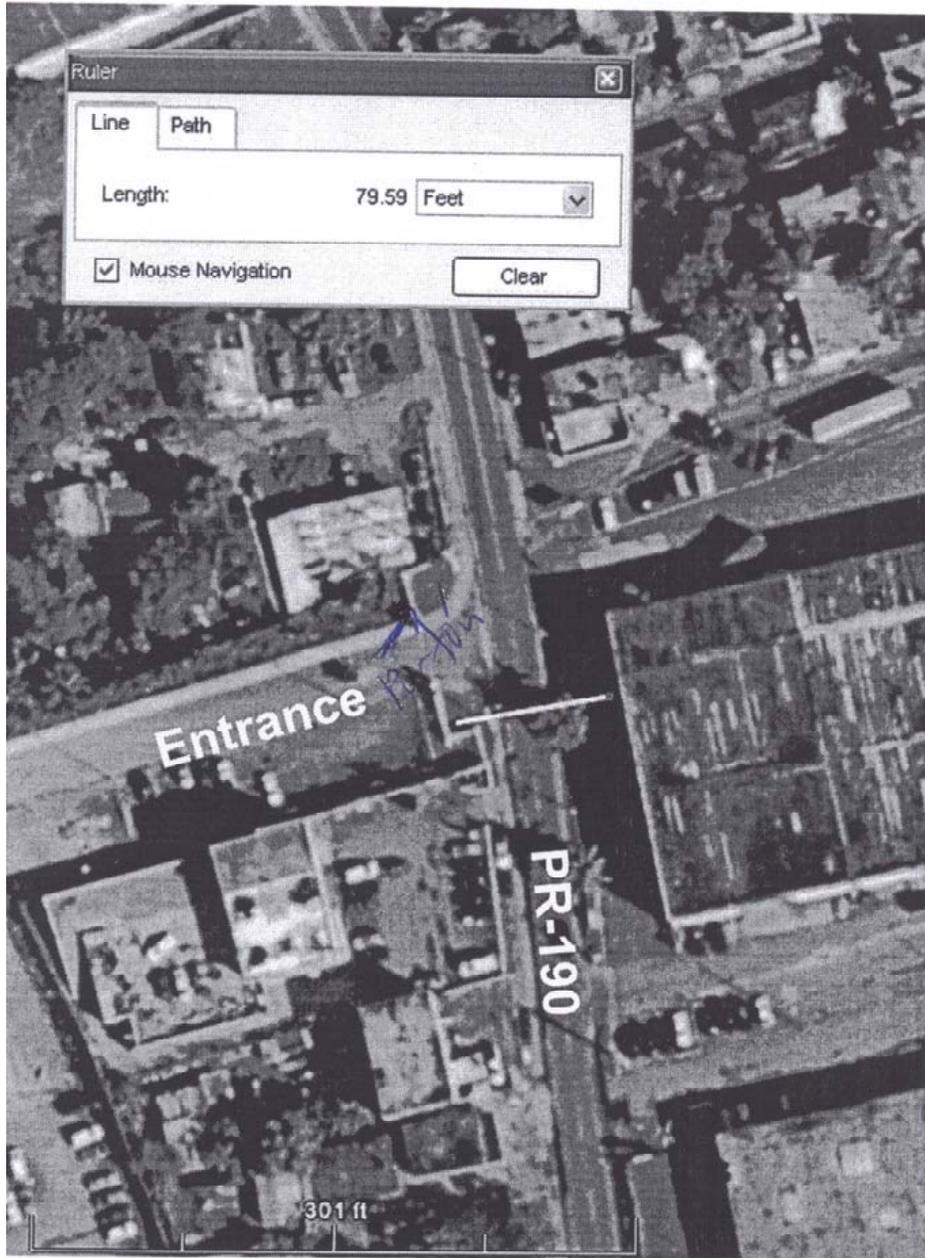
Location 4: PR-190 and entrance to
Universidad del Este
Subsurface Utility Survey, Tranvía, Carolina
Puerto Rico
Figure 3

At Location 4: **PR-190 and Entrance to Universidad del Este (Figure 13)** the following utilities were found:

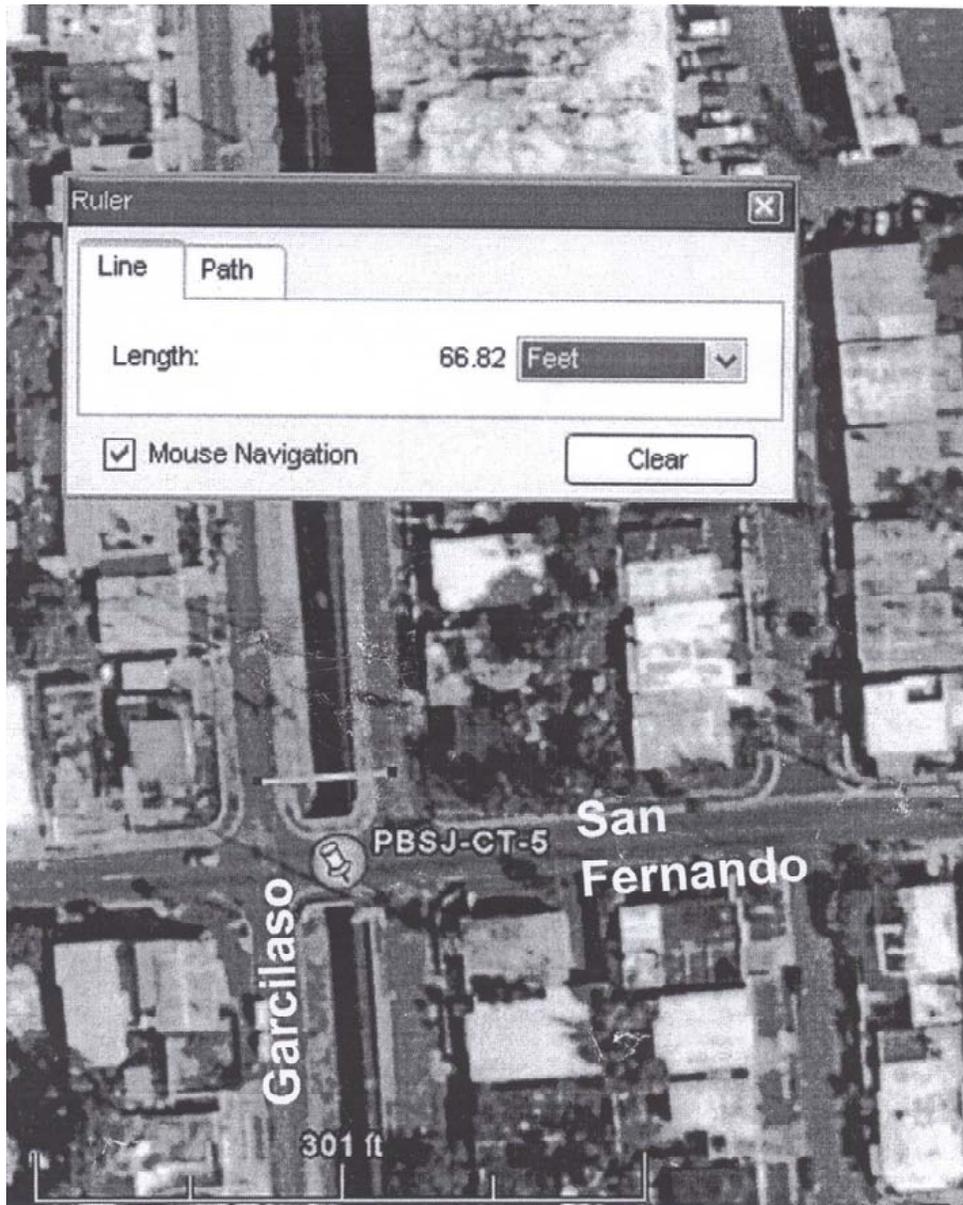
Location 5: At Garcilaso and Riviera St.
crossing San Fernando, thru Channel
Subsurface Utility Survey, Tranvía, Carolina
Puerto Rico
Figure 4

At Location 5: **Garcilaso and Riviera St. Crossing San Fernando**, just east of Channel (Figure 14) the following utilities were found:

At Location 5: **Garcilaso and Riviera St. Crossing San Fernando**, west of the Channel (Figure 15) the following utilities were found:

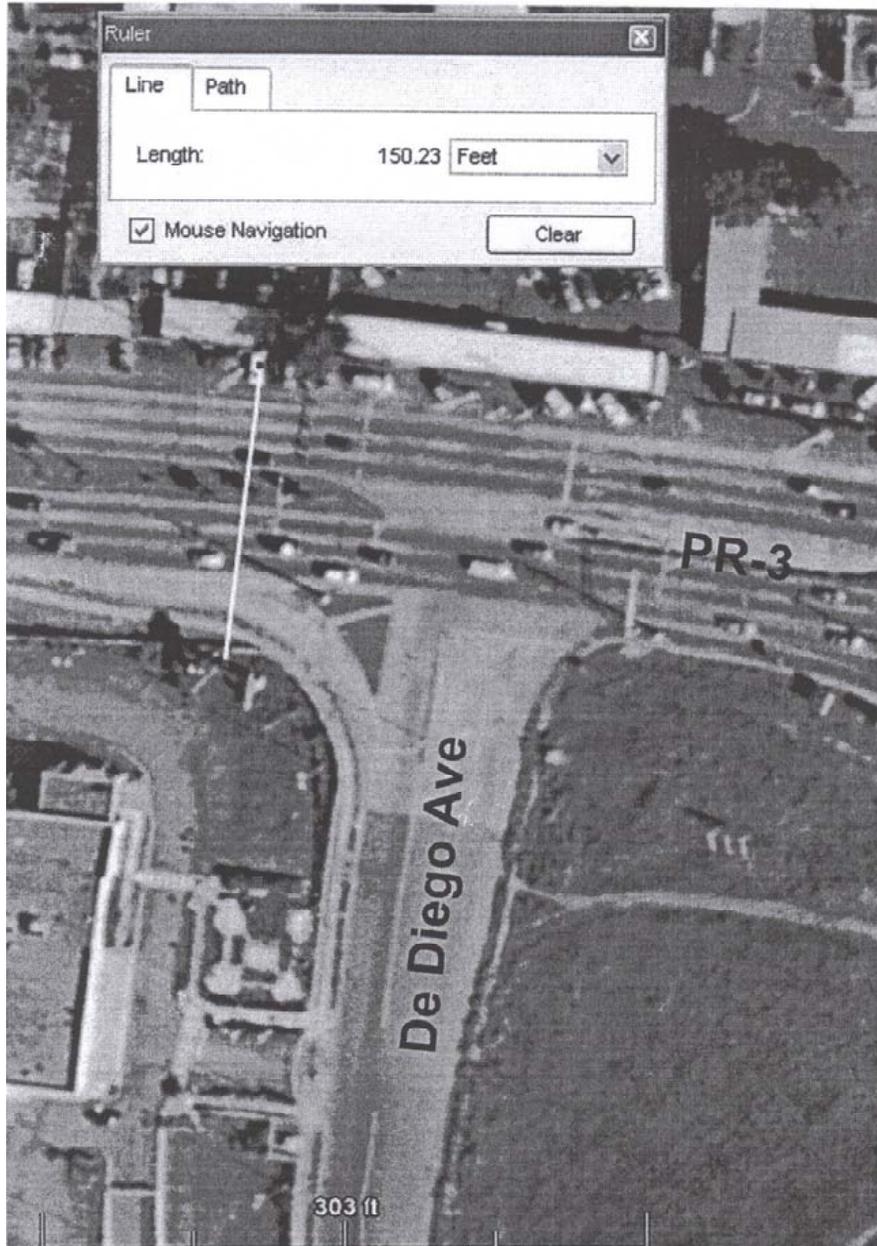
Location 6: PR-3 and De Diego Ave.
Subsurface Utility Survey, Tranvía, Carolina
Puerto Rico
Figure 5

At Location 6: **PR-3 and De Diego Ave. (Figure 16)**, the following utilities were found:

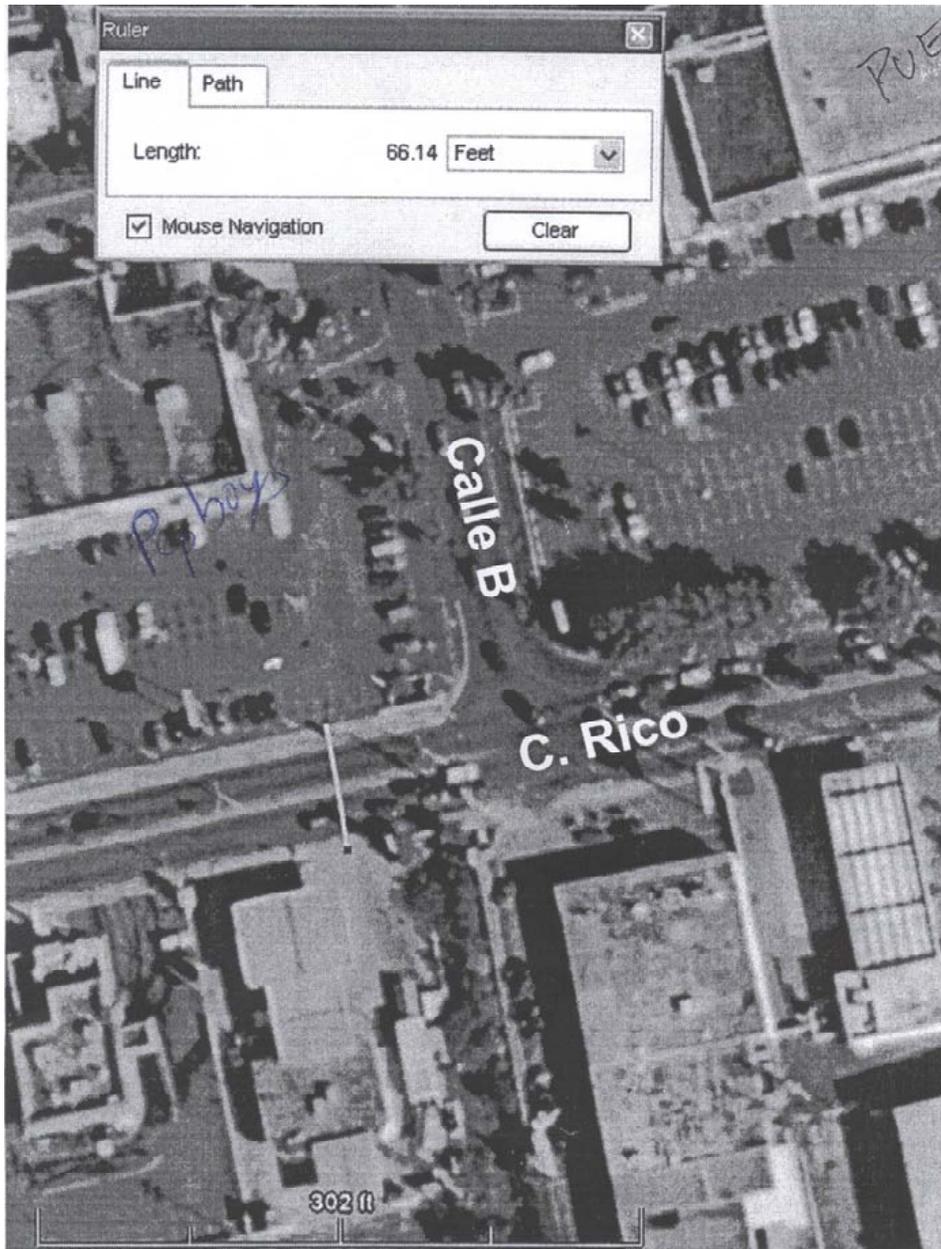
Location 7: Campo Rico Ave. and B St.
 Subsurface Utility Survey, Tranvía, Carolina
 Puerto Rico
 Figure 6

At Location 7: Campo Rico Ave. and B ST. (Figure 17), the following utilities were found:

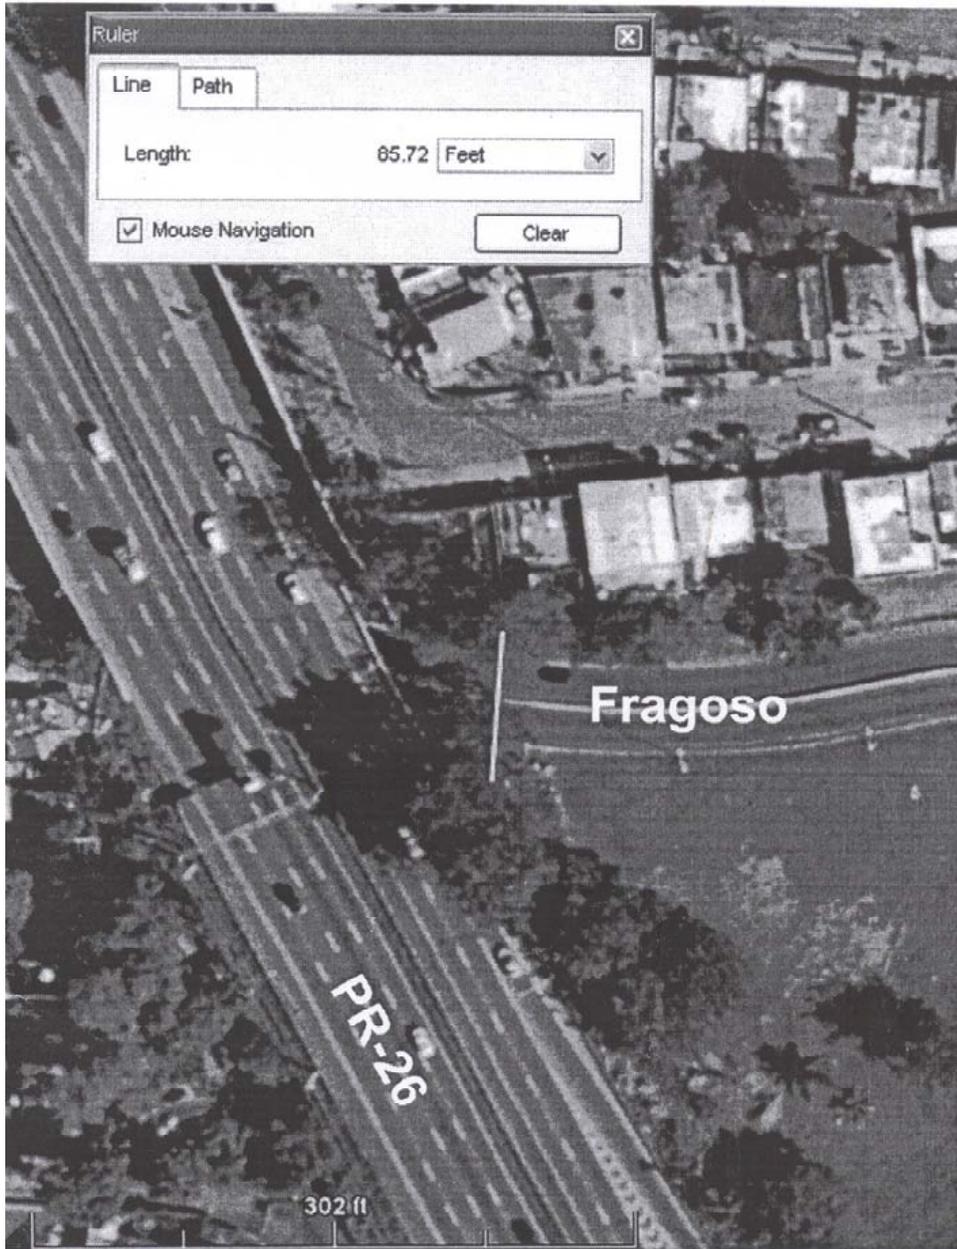
Location 8: PR-26 and Fragoso Ave.
Subsurface Utility Survey, Tranvía, Carolina
Puerto Rico
Figure 7

At Location 8: PR-26 and Fragoso Ave. (Figure 18), the following utilities were found:

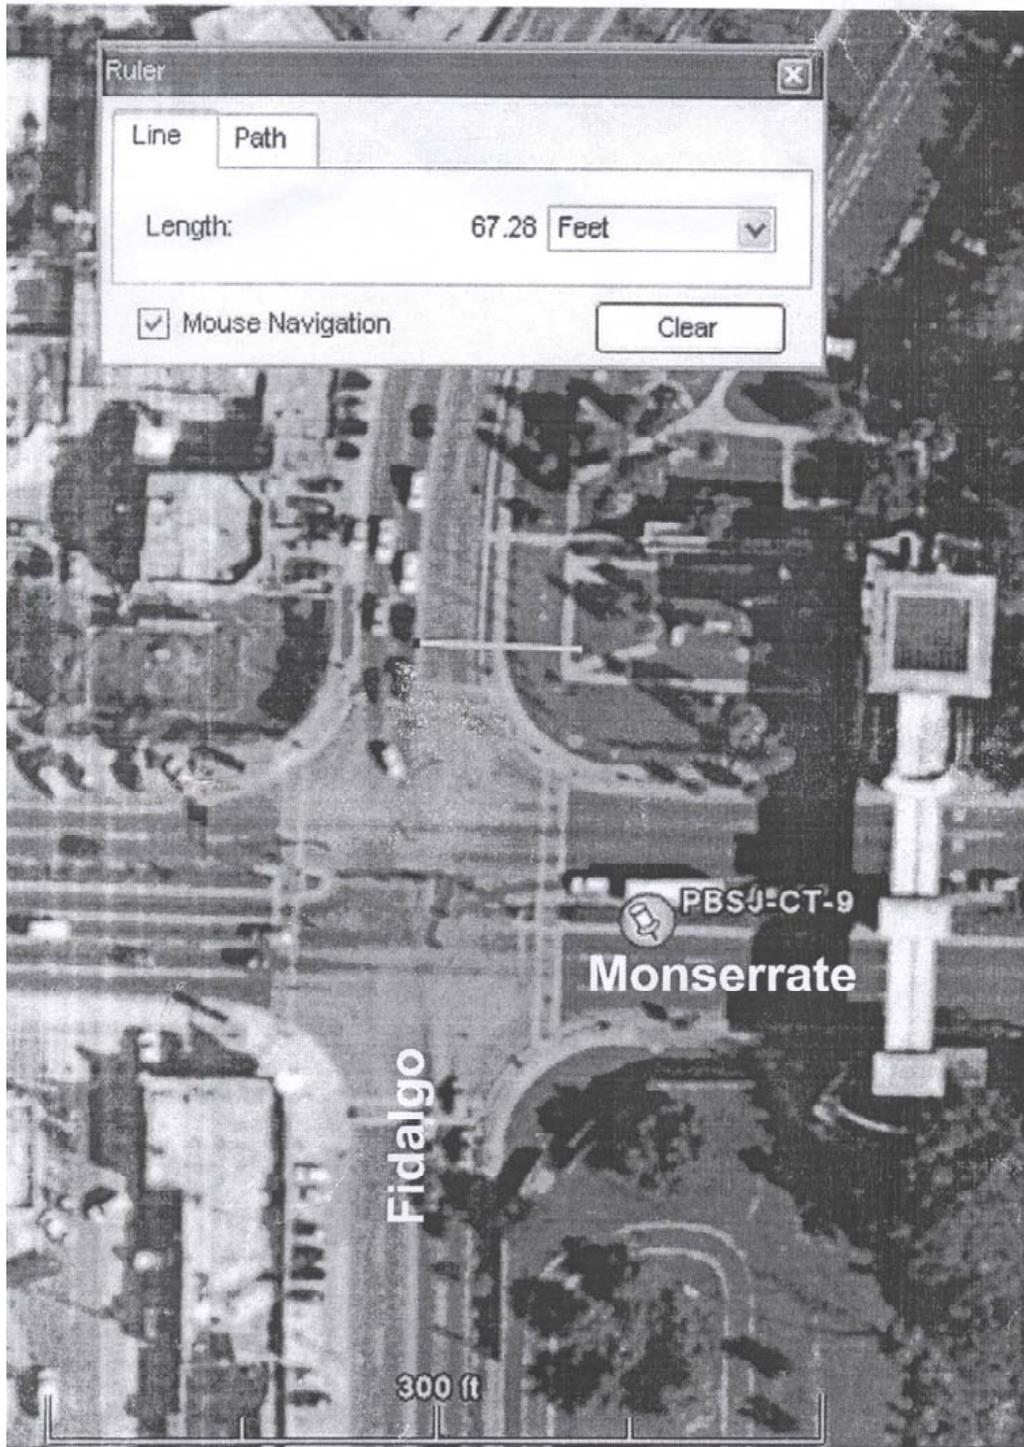
Location 9: Monserrate and Fidalgo Ave.
 Subsurface Utility Survey, Tranvía, Carolina
 Puerto Rico
 Figure 8

At Location 9: Monserrate and Fidalgo Ave. (Figure 19), the following utilities were found:

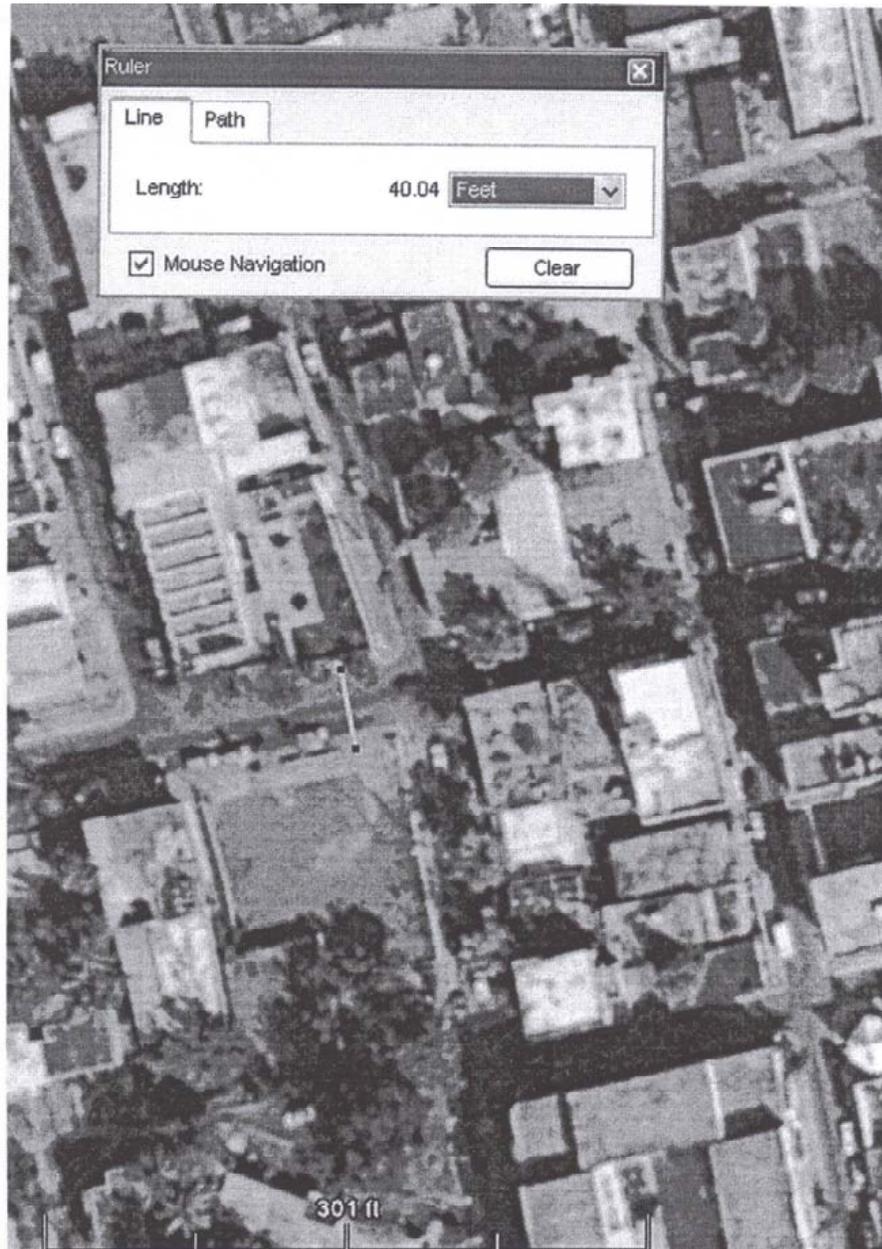
Location 10: Ignacio Arzuaga and Antonio Jimenez
Subsurface Utility Survey, Tranvía, Carolina
Puerto Rico
Figure 9

At Location 10: Ignazio Arzuaga and Antonio Jimenez Landrau St. (Figure 20), the following utilities were found:
