**RIO VALENCIANO DAM PROJECT: SITE
GEOLOGY AND GEOLOGIC STRUCTURE ANALYSIS
-DR. JAMES JOYCE-**

Rio Valenciano Dam Project Site Geology and Geologic Structure Analysis

Prepared for the CSA Group
on behalf of
The Puerto Rico Aqueduct and Sewer Authority

Prepared by James Joyce PhD, PG
Professor of Geology - Department of Geology
Mayagüez Campus - University of Puerto Rico

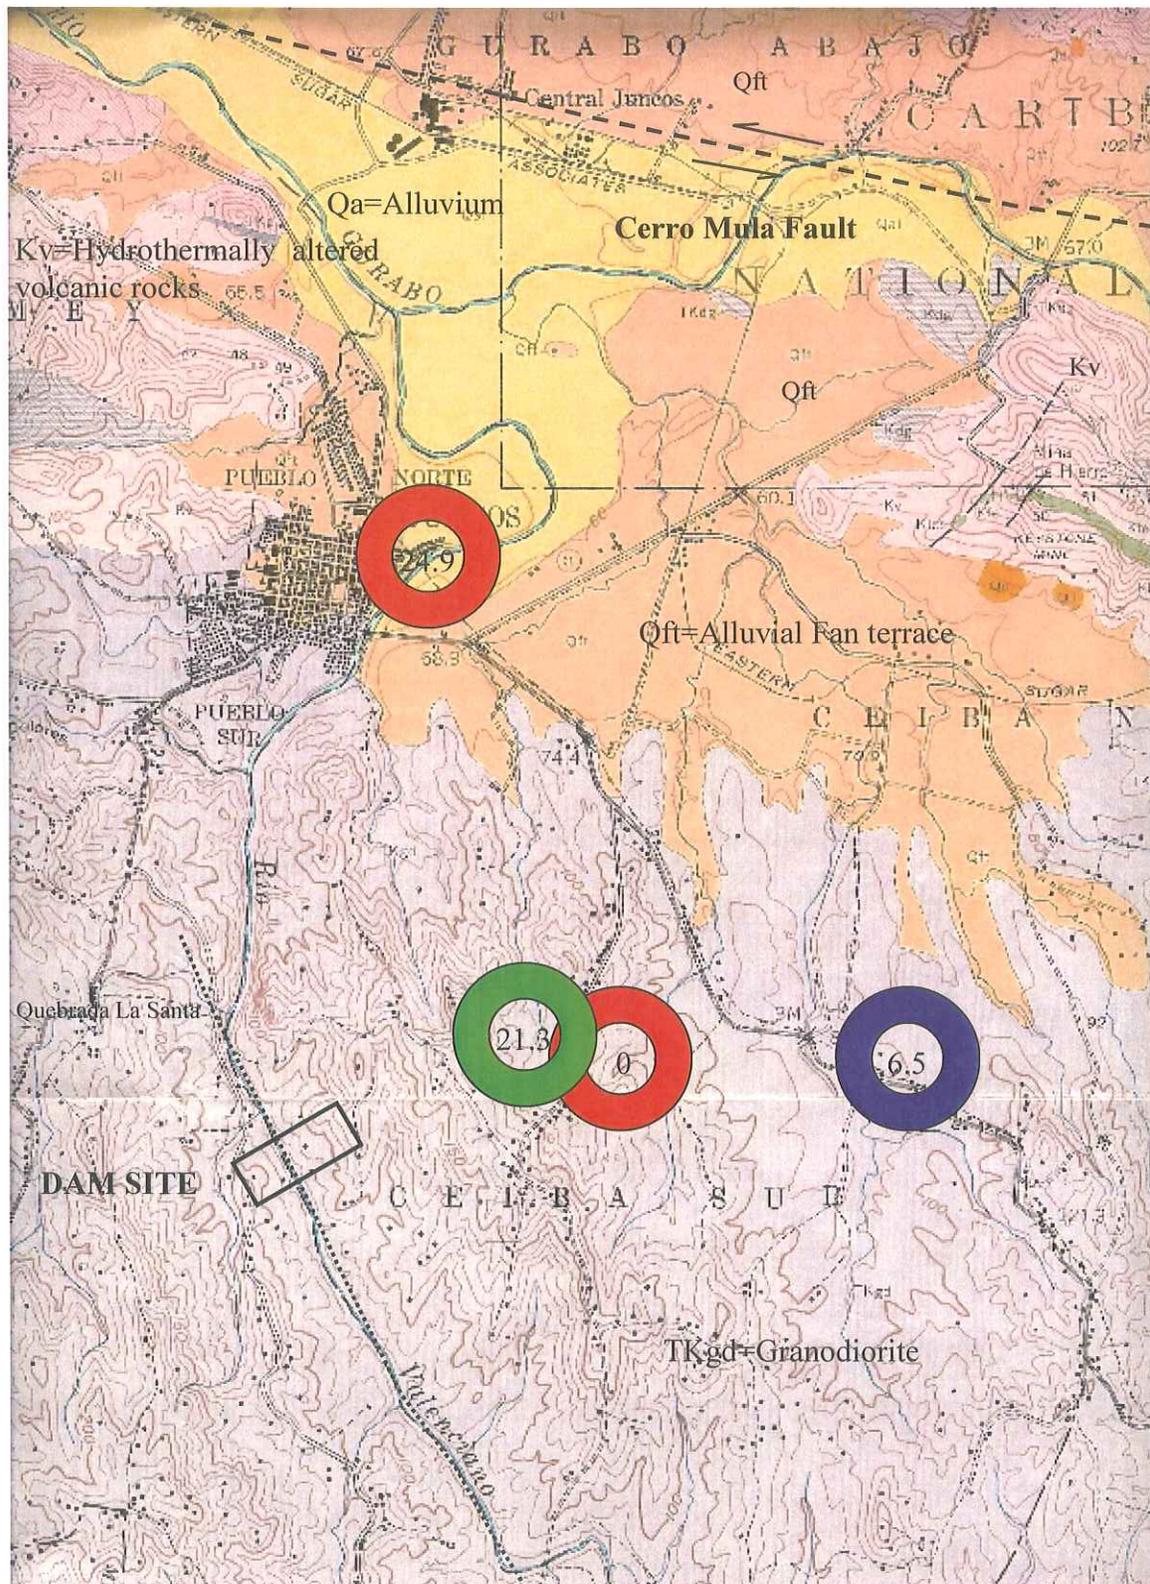
Figure 2a Portion of the Preliminary Geologic Map of the Juncos Quadrangle (Broedel, 1961). The dashed line is the extension of the Rio Humacao fault. Circles are earthquake epicenters with depths. Magnitudes; 1-2 = blue; 2-3 green; 3-4 red.

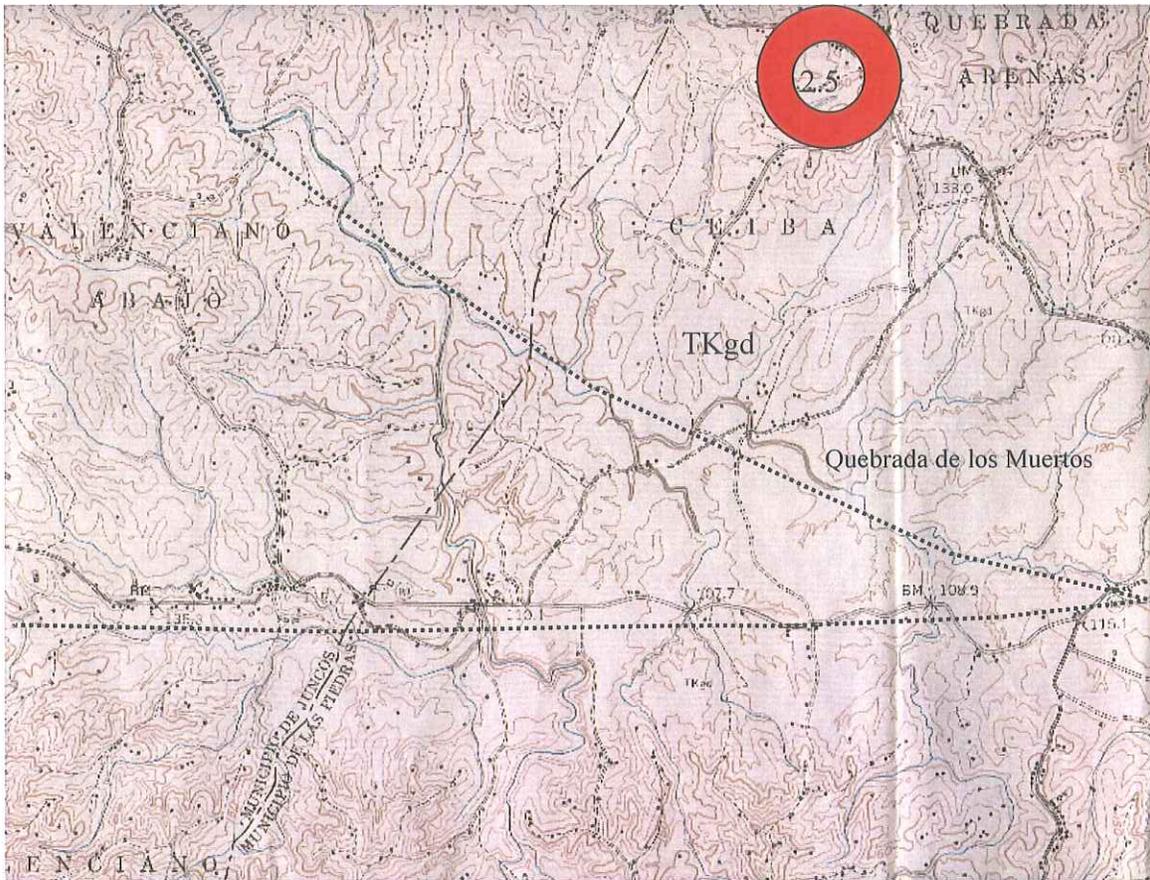
Figure 2b Southern portion of the Preliminary Geologic Map of the Juncos Quadrangle (Broedel, 1961) along Rio Valenciano. Symbols same as 2a.

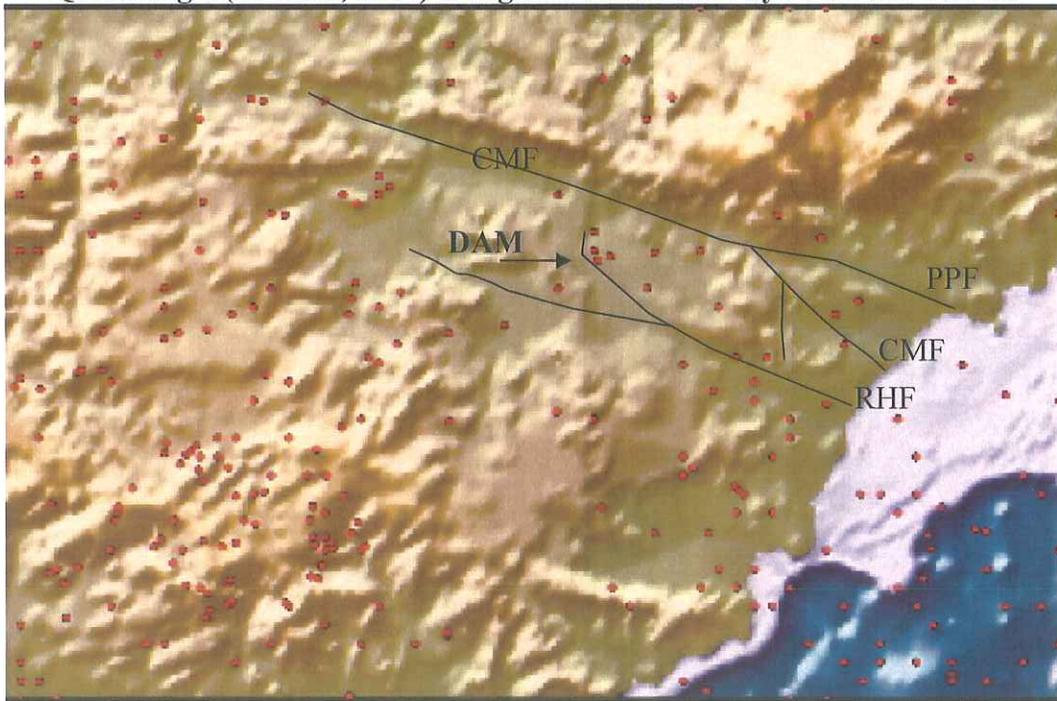
Figure 3 Shallow earthquake epicenters from PRSN data 1995-present. Faults: HF = Rio Humacao Fault, CMF = Cerro Mula Fault, PPF = Peña Pobre Fault.

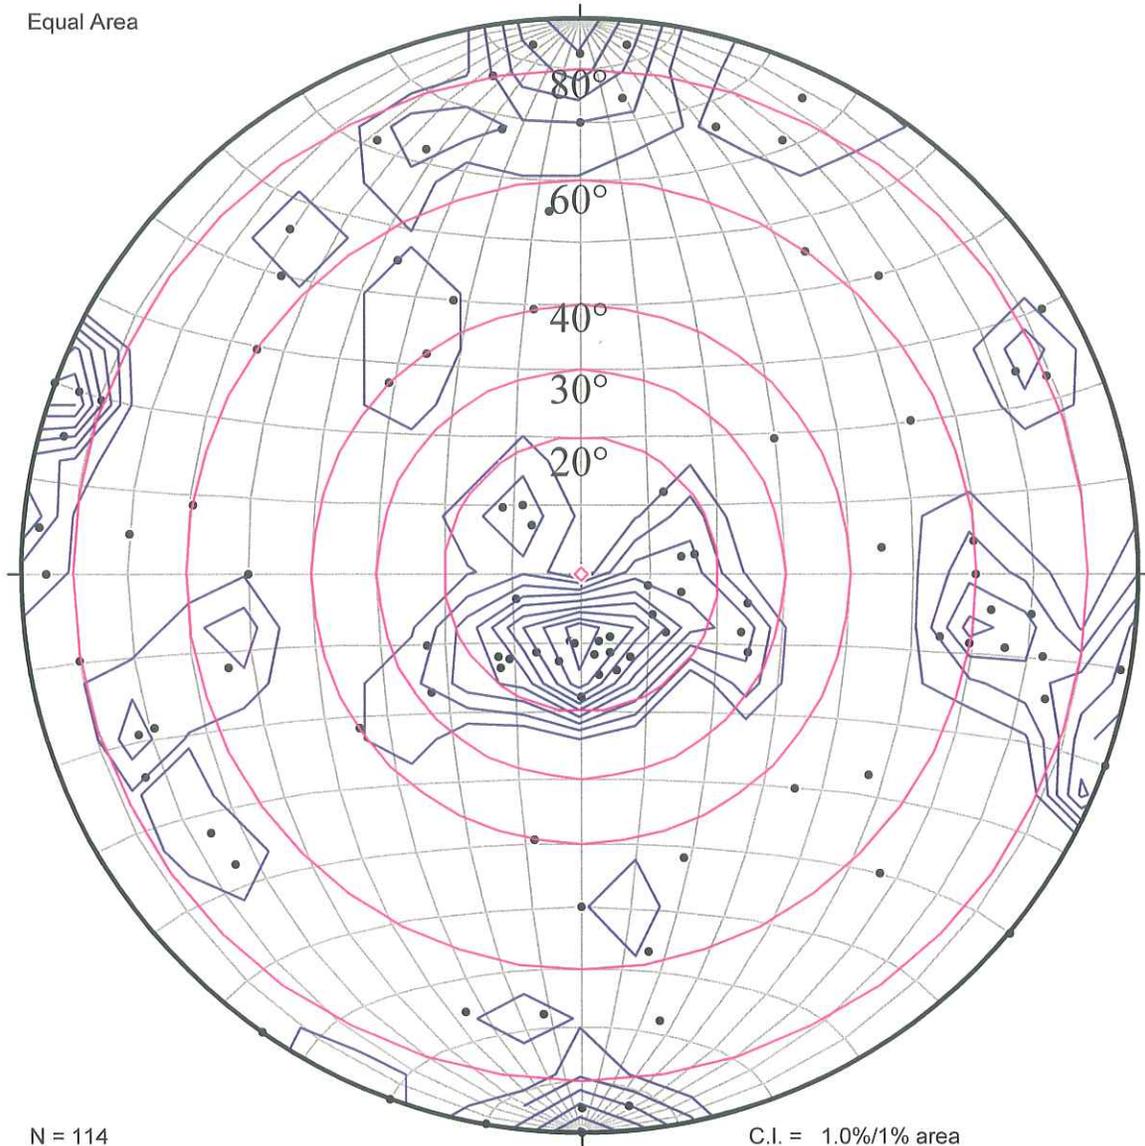
Figure 6 Stereographic projection of poles to joint set planes.

sub-horizontal joint poles is largely due to multiple measurements at one or two localities. The contoured pole densities do not represent a true statistical analysis as sampling was not statistical. The contour data does however, delineate well the dominant and subsidiary joint sets that were observed in the field area (Photos 1-2, 4-6, 7-10). The dominant orthogonal joint sets 1-3 define the boundaries of spheroidal weathering corestones throughout the observation area. The massive corestones are often cut by inclined, conjugate joints. When seen in extended outcrops the 2 vertical sets are generally continuous with spacing of 1-5 meters and sometimes greater. Intervals between the continuous joints are sometimes characterized by discontinuous and semi-continuous parallel joints with spacing about 0.5-1.0 meters lending a thicker and thinner “bedded” appearance to the massive igneous rock. Joints in surface exposures tend to be open from 2mm to 2cm (*moderately wide to wide*) and some are filled with clayey soil or grus residuum. Their surfaces tend to be planar and rough to slightly rough.

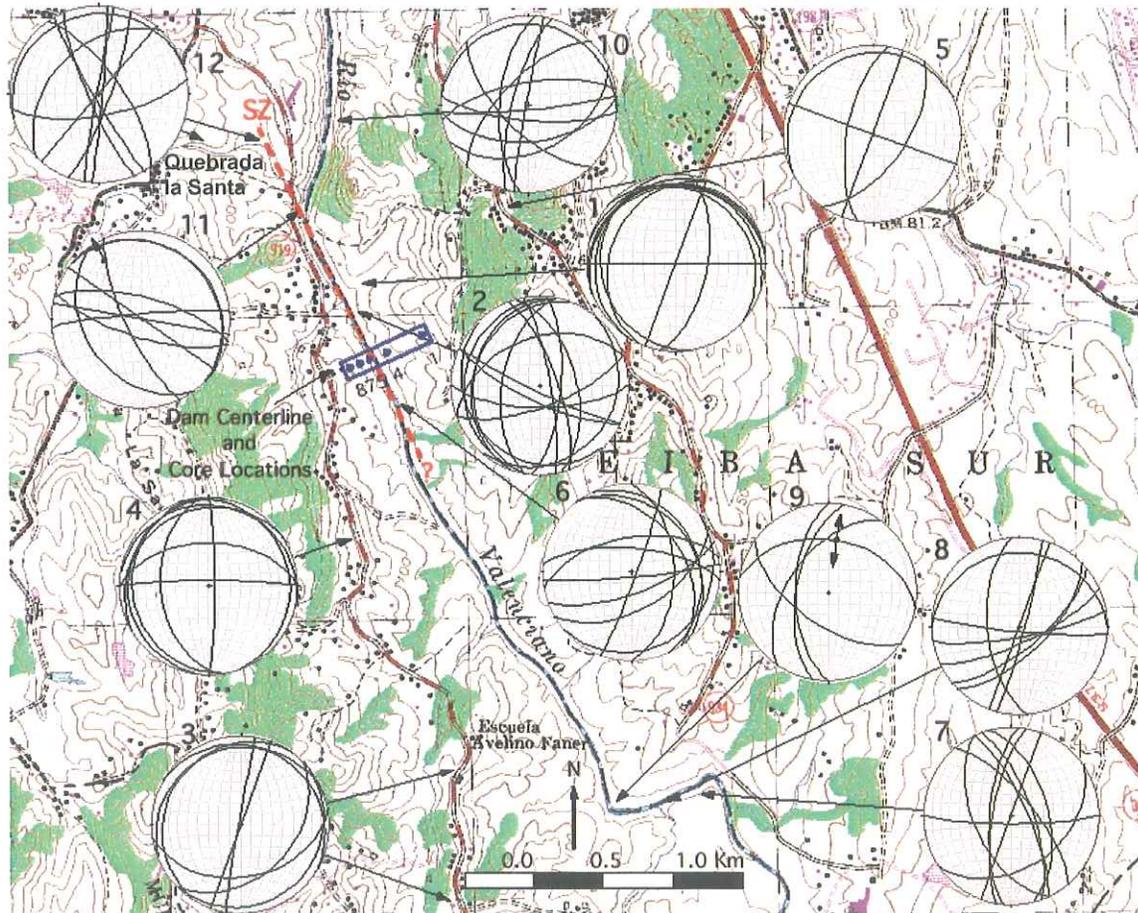
Figure 7 Topographic map showing the locations of the dam centerline, Black and Veatch cores and present study sites with stereographic plots of joint measurements.

rock exposures along the channel are dominated by NNW and WNW trending steeply inclined and NW trending shallow to moderately inclined joints (Figure 7 #11). Joint spacing ranges from 10-50 cm for continuous joints down to 2-5 cm for discontinuous

component. That is, the west side of the fault is moving to the north-northwest and down whereas the east side of the fault is moving to the south-southeast and up. The measured strike of the shear plane and parallel joint set is exactly parallel and aligned with the river channel (Figure 7). It is likely that these exposures are then representative of the structural conditions of the rock below the river channel at the dam site. Extending this fracture-shear zone parallel to the strike of the shear plane places it along a NNW trending stretch of the Quebrada la Santa, the quebrada that flows into the river just north of the fracture-shear zone exposures Figure 7. Although the main channel of the quebrada bends off to the west at the end of this stretch, an extensive and topographically pronounced NNW trending drainage gully confluent the quebrada at that point (Figure 7). A relatively flat exposure of intensely fractured and sheared rock occurs on the inside of the bend at the confluence point (Photo 12). Notably, the east side of the channel at the bend is confined by a vertical NNW trending joint face in massive granodiorite. The fracture-shear zone is dominated by continuous a NNE trending joint-fracture set with a more closely spaced discontinuous NE trending fracture within the NNE joint intervals (Photo 12). The NE discontinuous joints tend to curve counterclockwise into the continuous NNE joints at their terminations. Intersection of the two fractures produces rhomboid to elliptical rock phacoids. The counter clockwise rotation and orientation of the phacoids are compatible with NNE left lateral shear (Photo 12). Despite being aligned with the right lateral shear-fracture zone observed in the river

2. Perforation of 3-4 borings and cores in the river channel along the dam centerline to precisely define the geologic structure below the river bed, in order to determine both the existence and character of the fracture shear zone and the continuity of the sub-horizontal joints below the river.

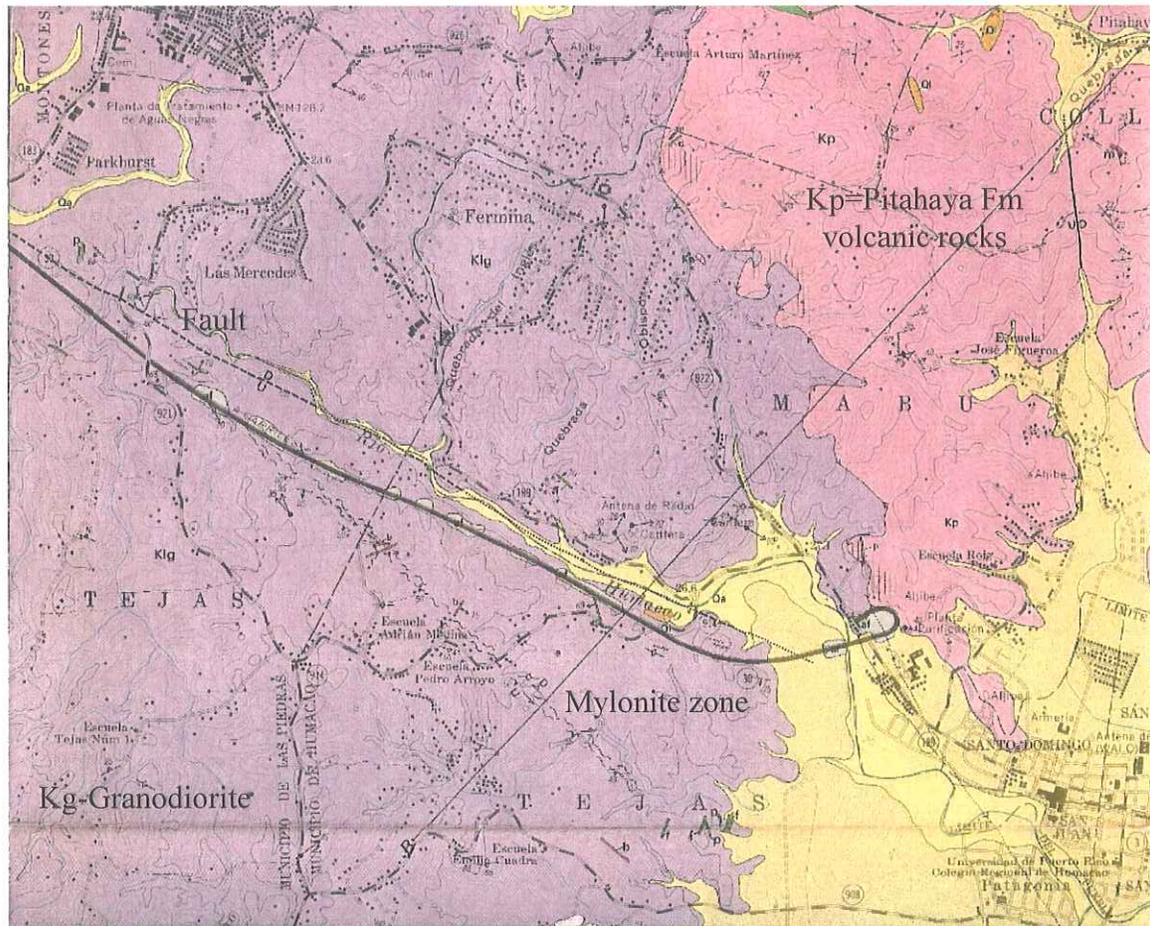
Figure 8 Rio Humacao portion of the Geologic Map of the Humacao Quadrangle (M'Gonigle, 1978) showing the mylonite zone and the inferred fault in the river.
