## Executive Summary

## Introduction

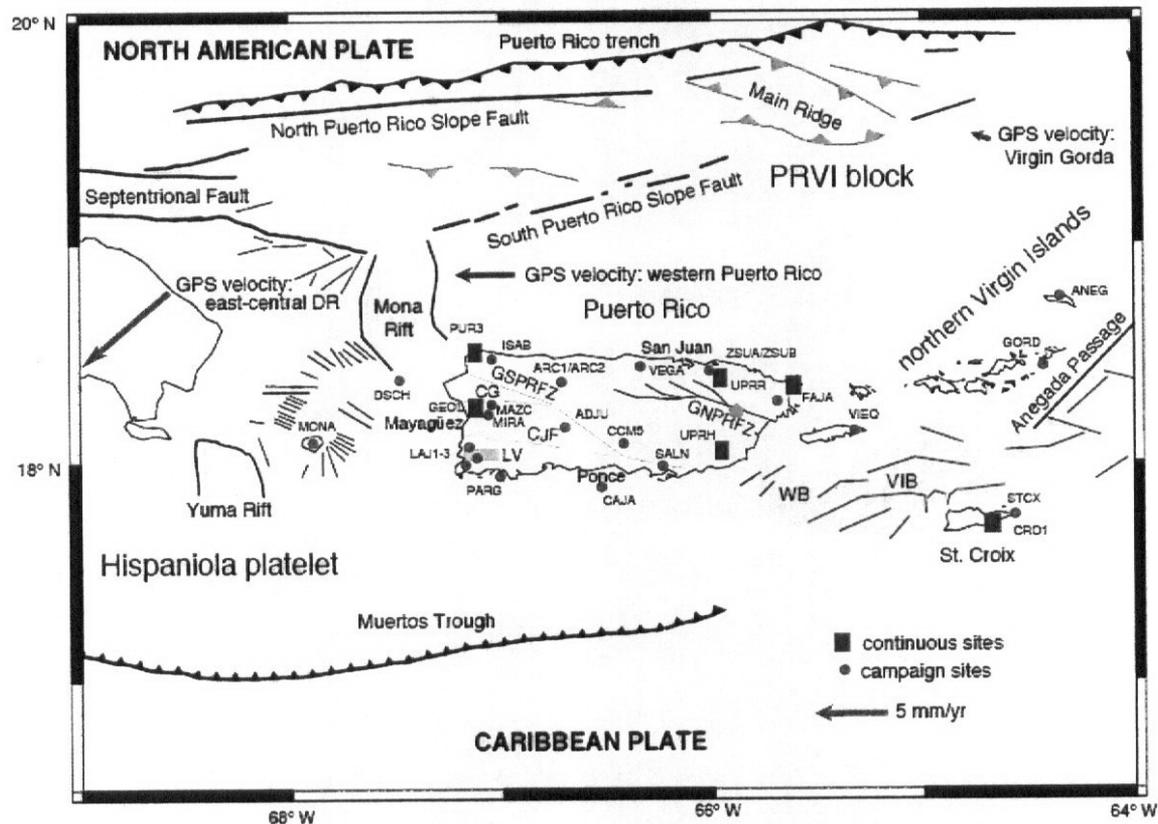
**Figure 1** Regional map showing geography and major faults (From Jansma and Mattioli, NEHRP report, 2005). Proposed Valenciano Dam is located at green dot near the top of “F” in GSNPRFZ. Blue squares are locations of continuous GPS stations placed to measure differential motion across faults within the Puerto Rico - Virgin Islands block (PRVI). Red dots are benchmark monuments that have been occupied temporarily in “campaign” surveys. Figure 2 shows GPS results to the end of 2005. Grey outlines areas of inferred active extension from fault styles and earthquake geometries. Faults with sawtooth pattern are reverse faults. The flags are located on the hanging wall (overriding) block. Sense of motion on other faults is believed to be lateral or extensional. Mann and others (2005) suggest that the geometry of the GSNPRFZ is consistent with right-lateral motion. Jansma et al., indicate that motion between St Croix and eastern Puerto Rico (Anegada Passage fault zone) is less than 2 mm/yr.

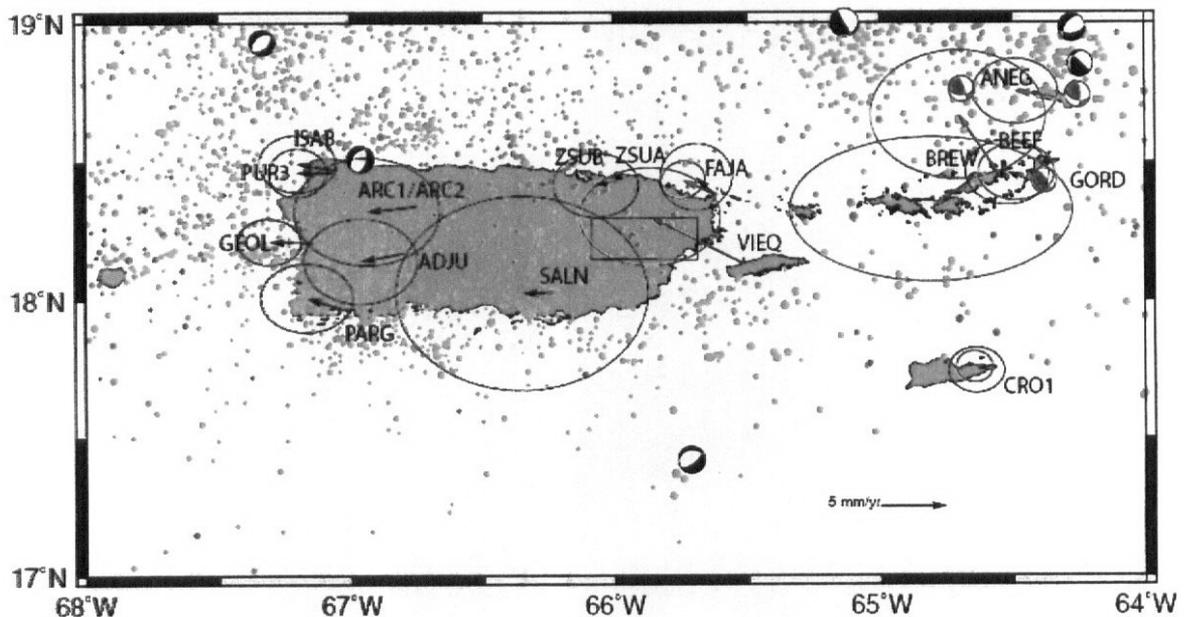
**Figure 2.** Map of Puerto Rico and Virgin Islands. Study area in rectangle (area of Figure 3) (From Jansma and Mattioli, NEHRP report, 2005).. Epicenters (blue dots) and GPS-derived velocity as of November 2005. Ellipses show uncertainty in GPS vector solution. Velocity scaled to arrow at lower right. Note that motions are relative to St. Croix. Red arrow at FAJA (3mm/yr-NW) is a preliminary solution based on short time series, but appears similar to earlier solution (in black). Comparing FAJA and ZSUB to the best western Puerto Rico vectors, PUR3, GEOL, and PARG indicates 1-2 mm/yr differential motion between these locations

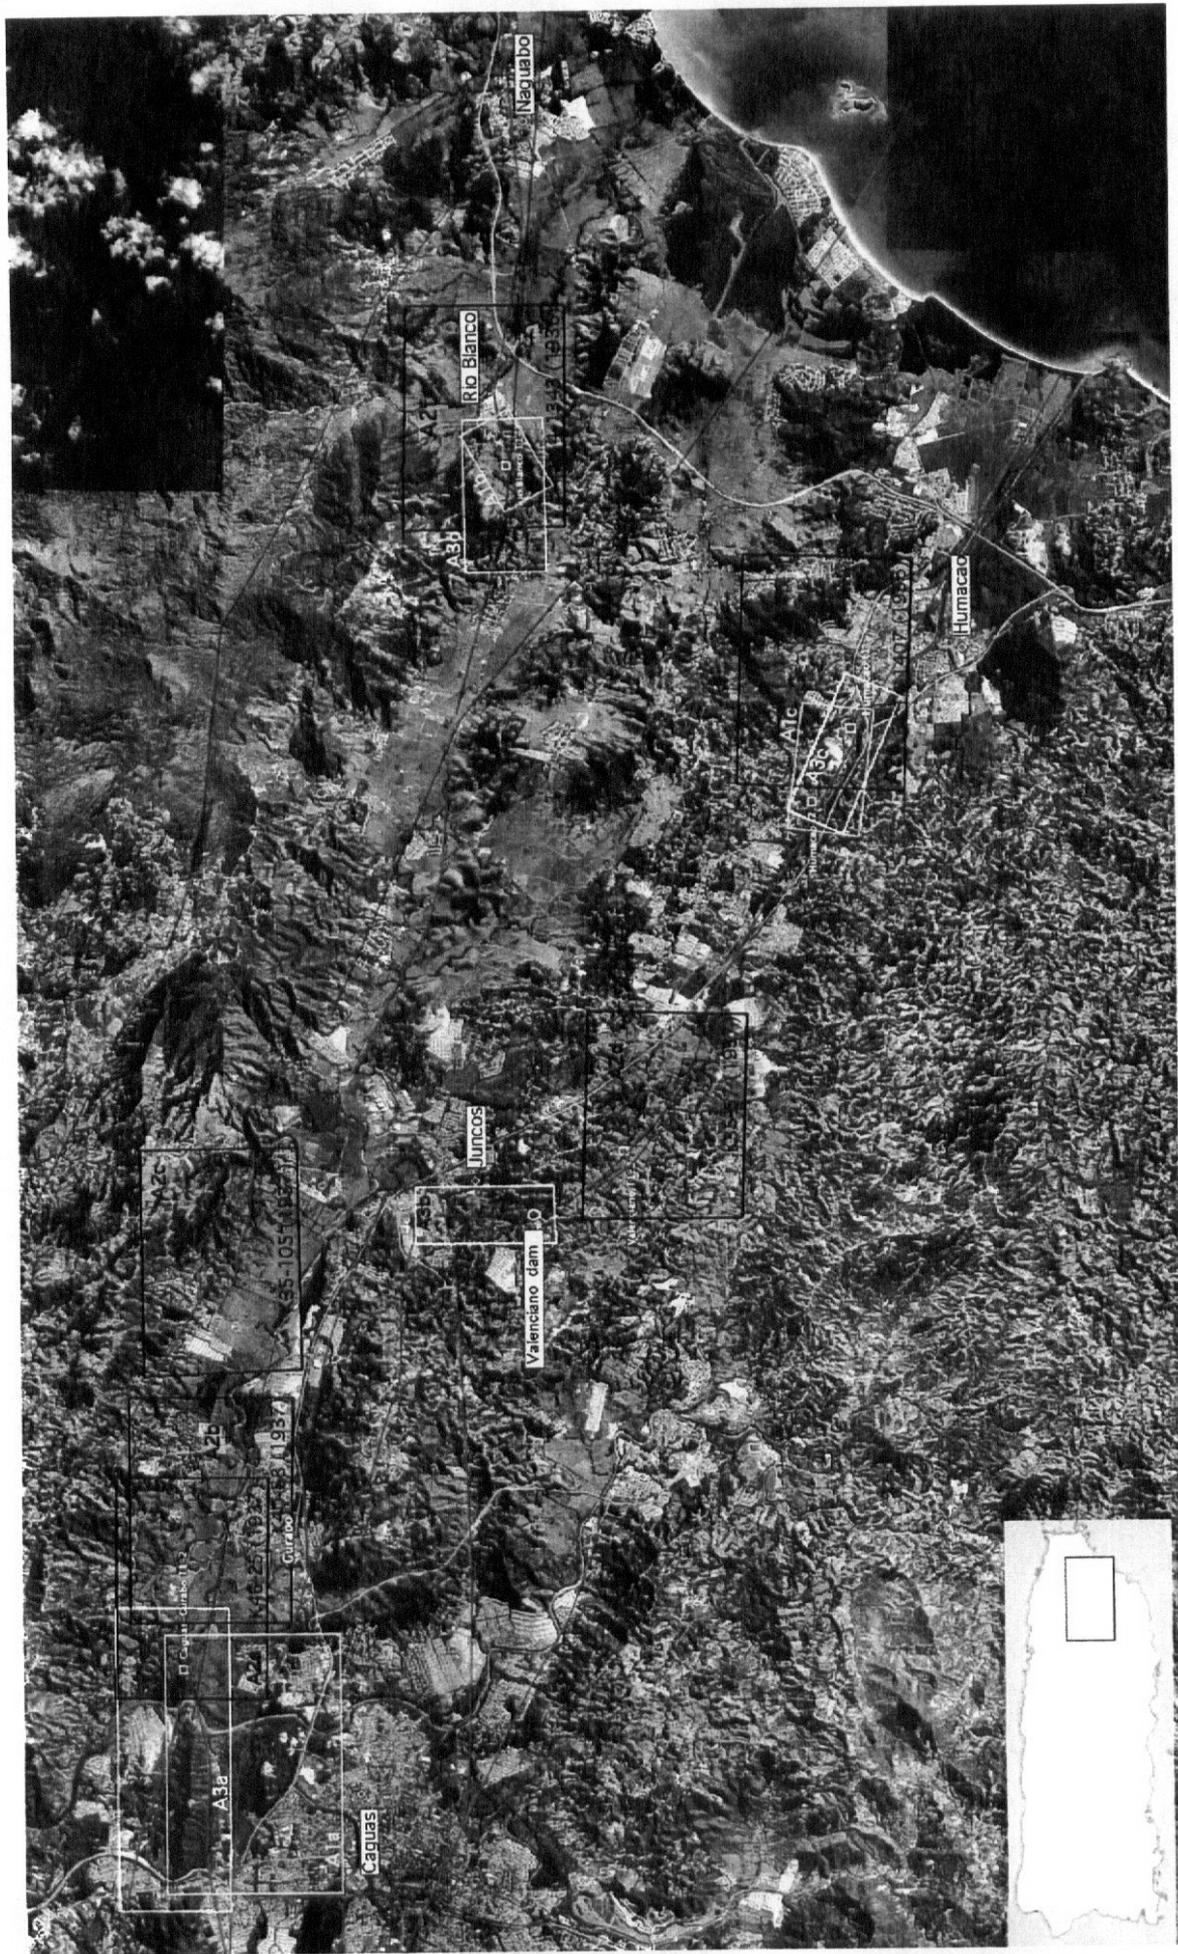
Figure 3. General extent of study area. Map area is 35 by 20 kilometers. Most prominent bedrock faults, colored blue, are derived from USGS mapping. Prominent lineaments (permissive faults) interpreted in this study from landform features viewed in published digital elevation models and Lidar data compiled in this study are denoted by red lines. Possible active fault features selected for continuing investigation in Phase 2 are colored pink. Yellow rectangles are detailed planning maps of candidate trench sites (Williams Appendix 1). Black rectangles are some of the 1936-1937 air photos with suggestive fault or fault-like features (Williams Appendix 2). White rectangles are selected Lidar images in areas proposed for further study (Williams Appendix 3).

The principal bedrock faults delineate zones of crustal weakness, and are thereby the most likely locations for reactivation or continuing fault activity. Our approach to detection of late Quaternary and Holocene activity of the NPRFZ has been to focus on the most prominent bedrock fault intersections with valley deposits, and the projection of those fault trends within Quaternary and Recent valley deposits, particularly river terraces and alluvial fans. The presence of faults was also investigated within prominent valley and ridge lineaments and linear valley margins. We searched for evidence of active faulting within sediments of the most prominent linear valleys and along linear valley margins. We also searched for mid valley active fault features in valleys with prominent bedrock faults projecting into the mid valley area. The area of study extends from the east coast of Puerto Rico between Naguabo and Humacao, to the western extent of the Gurabo-Loiza valleys near Caguas (Figure 3).
