Culebrinas River Flood Control Project

**Prepared by Beverly Yoshioka
U.S. Fish and Wildlife Service
Boqueron Field Office**

November 1999

Executive Summary

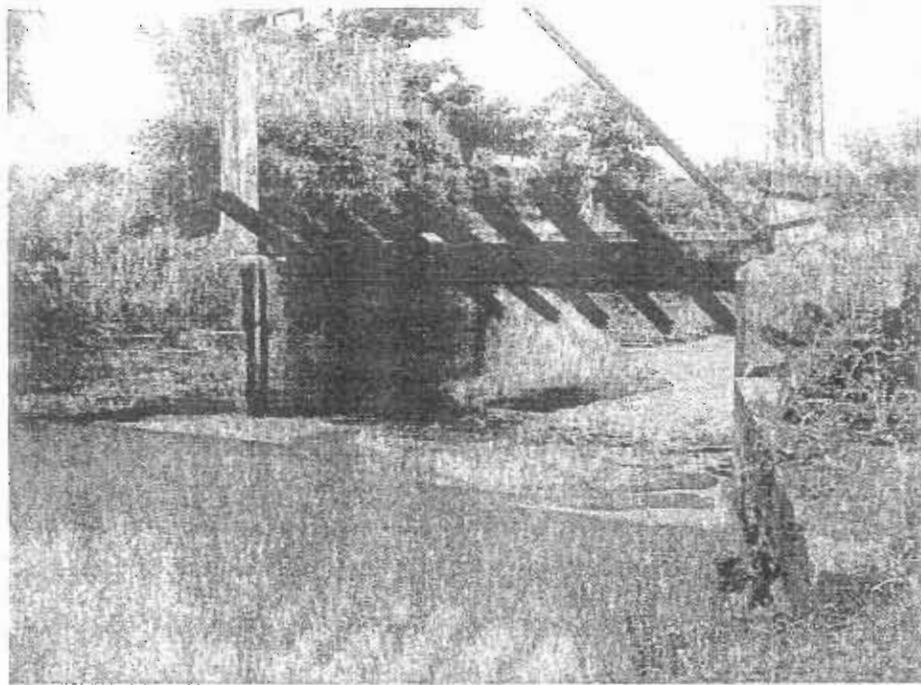
Photo 1. Coloso diversion dam from the upstream side. Note that the opening is very narrow and topped by a road.

The river has no major impoundments, but does have a small low head dam (Photos 1 and 2) built in the early part of the century to provide a water diversion for the Coloso Sugar Mill. This diversion is still used to provide process water for the mill. In 1998, the Puerto Rico Aqueducts and Sewers Authority (PRASA) along with the Commonwealth Infrastructure Agency (AFI) developed a surface water intake for potable water using the impoundment from this dam. The dam is located several hundred meters upstream of PR-2, and the pump house is located on an elevated stand next to the diversion dam (presumably above the 100 year flood stage). The raw water is currently pumped up to the Aguadilla treatment plant, but AFI is considering the creation of an off-river reservoir/ sedimentation lake near the damsite to supply additional firm yield and reduce the very high sediment load in the raw water extracted from the river. Because of its narrow design, it is likely that the existing dam serves as a constriction creating overflow into the floodplain above PR-2 during flood stage.

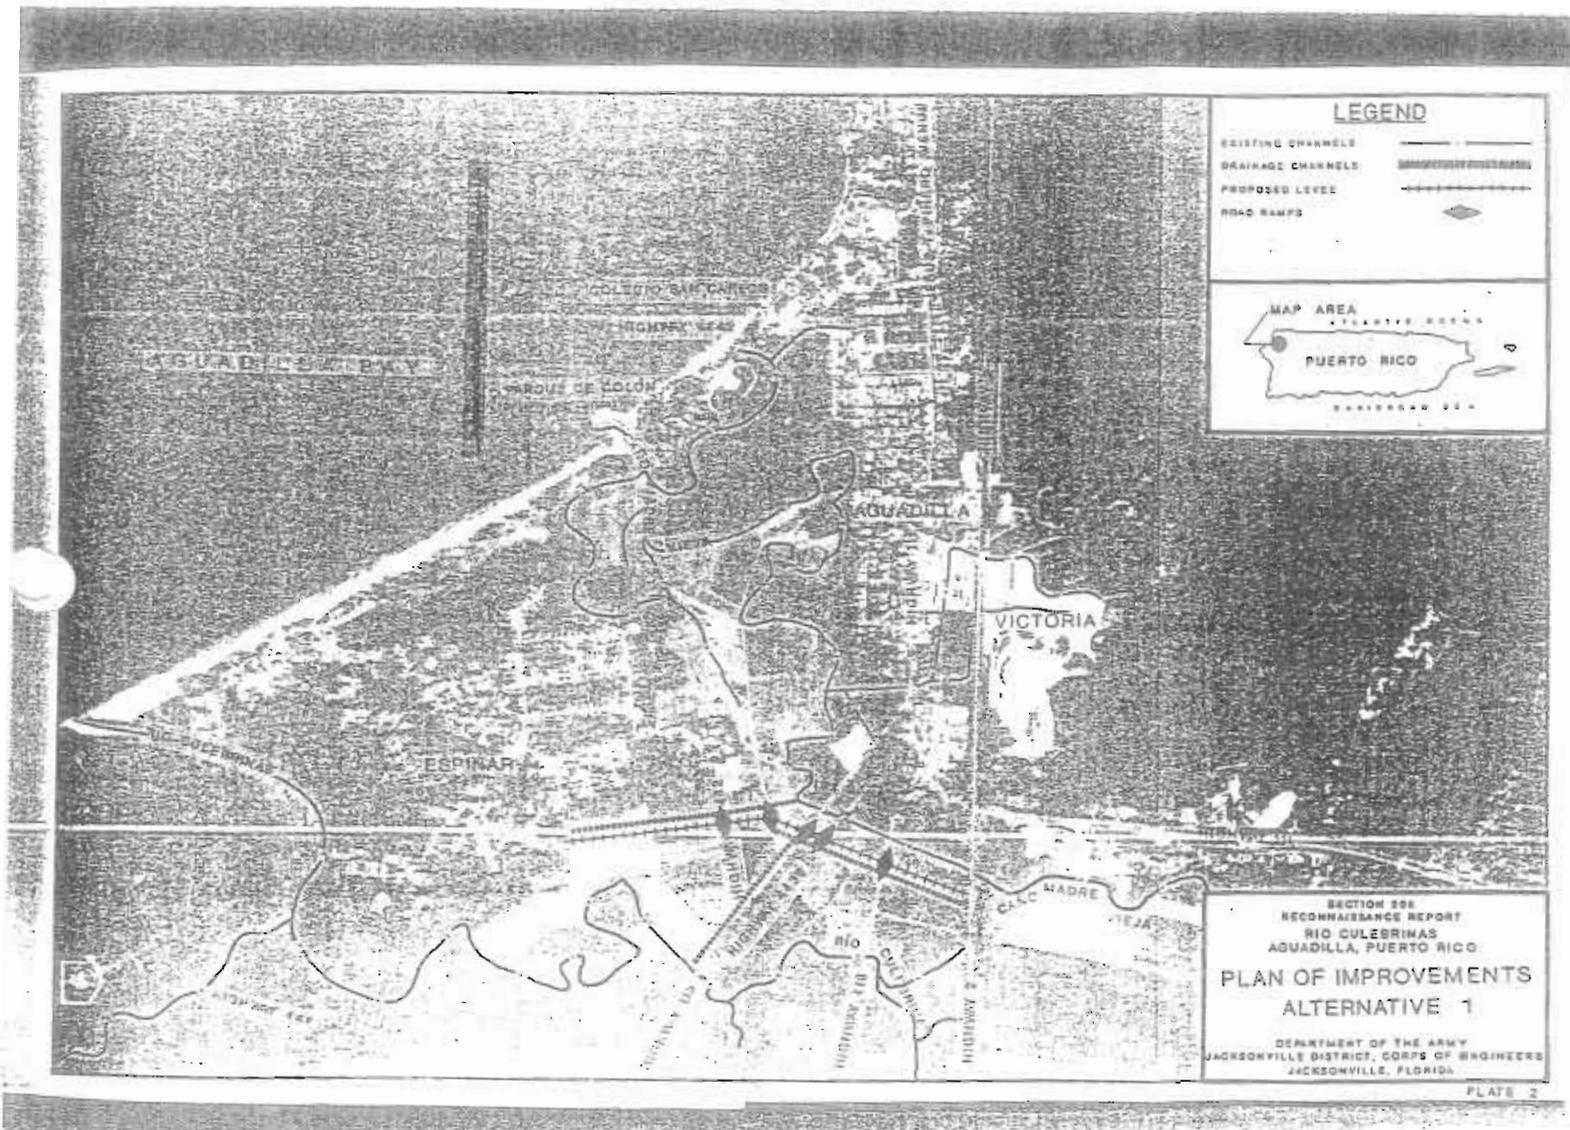
Figure 2. Original alternative 1 from Section 205 Reconnaissance Report, 1992.

From documents provided by the Corps, we understand that a number of alternatives have been considered to provide some Flood Hazard Mitigation for already developed portions of the community of Espinar and the southwestern communities of Aguadilla. The first alternative proposed was to construct a single flood levee from PR-2, just southwest of Caño Madre Vieja extending along the south side of Espinar, tying into a hill to the west to isolate the Caño from the floodwaters of the Culebrinas River (Figure 2). This would have provided flood protection for the western communities of Aguadilla, greatly reduced the floodplain of Caño Madre Vieja, and protected portions of the Espinar community. It would have raised flood levels in the Culebrinas River, however, thus affecting other portions of the Espinar community along the Culebrinas River. It also would have reduced the frequency of high flows that help maintain the channel and mouth of Caño Madre Vieja and encouraged development in much of the currently uninhabited floodplain along the Caño, violating E.O. 11888 for the protection of floodplains. To be effective, this plan would have to include channelization of the lower Culebrinas River to minimize the flood levels on its course, eliminating the river meanders and associated wetlands, and increasing maintenance costs for the floodway channel. Channelization of the lower Culebrinas River would have been likely to affect hydrology in the neighboring associated Cayures marsh. Our understanding is that this alternative has been discarded due to high costs and environmental considerations.

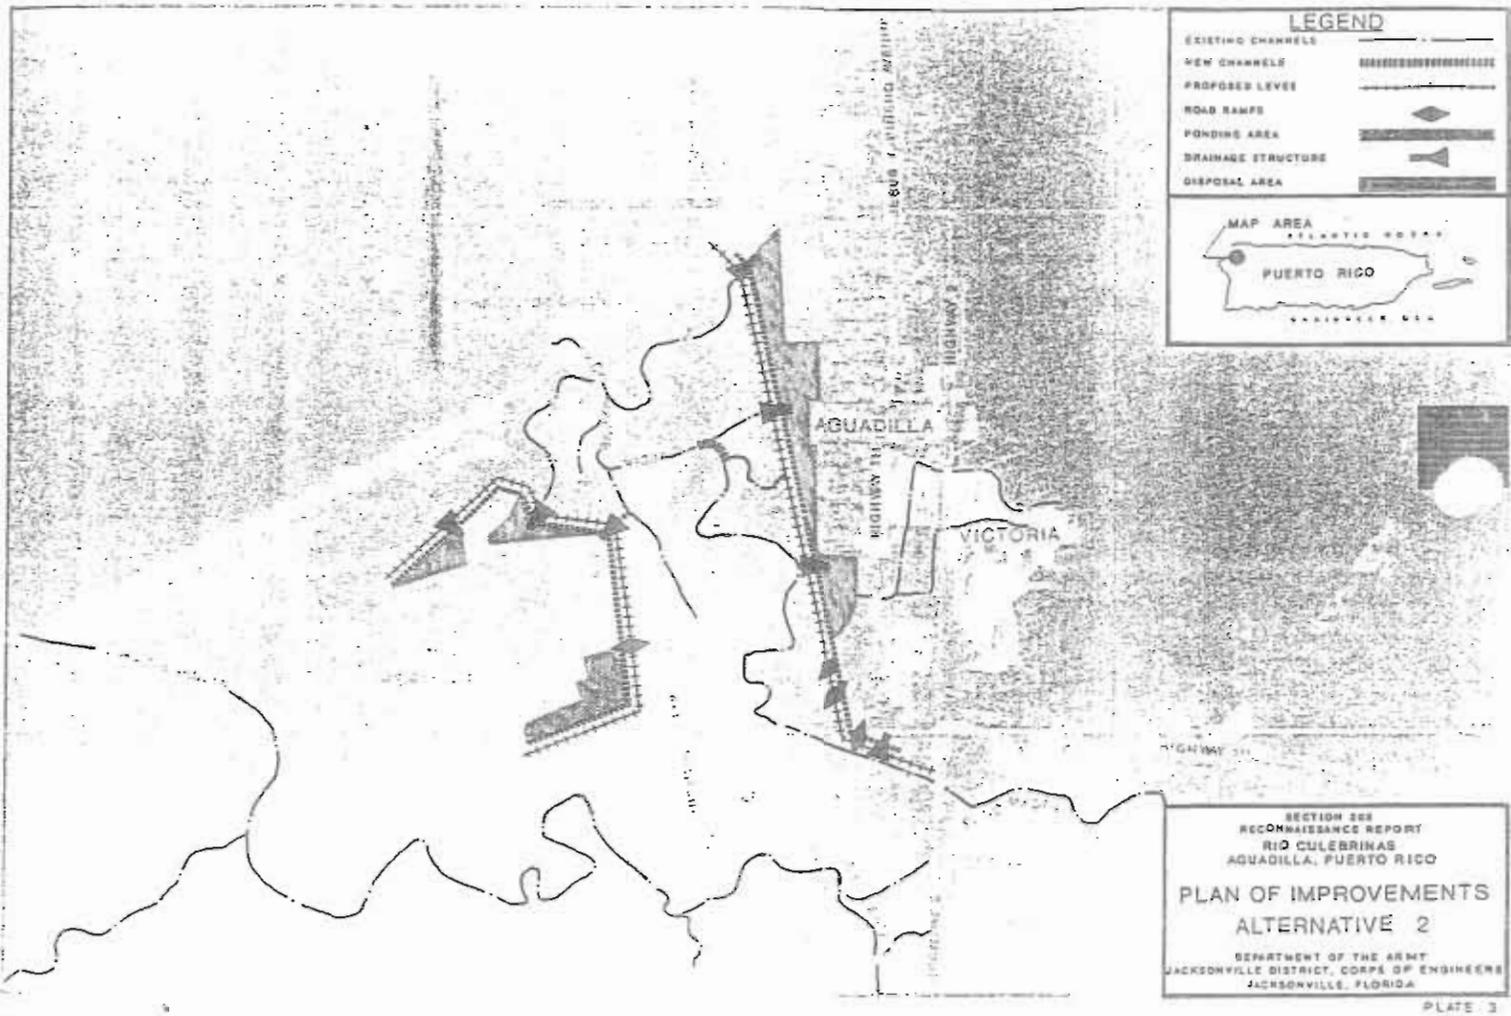
Figure 3. Original Alternative 2 from Section 205 Reconnaissance Report, 1992.

Alternative 2 from the original Reconnaissance Report (Figure 3) would provide two flood levees: one along the eastern side of Caño Madre Vieja north of PR-2 to protect southern Aguadilla, and a flood ring levee on the west side of the Caño. The original design would also have included a continuation of this levee on the north side of Espinar. Various permutations of Alternative 2 have been considered by the Corps as additional alternatives, mostly as variations to the western levee. In addition to the levees, the various permutations of this alternative also require the elimination of a double meander of Caño Madre Vieja via a short cut-off channel to accommodate the eastern levee. A modified version of Alternative 2 is the currently preferred alternative described as "Plan 1" in the Detailed Project Report (Figure 4). The western levee of this plan was altered to include the Iglesia de Espinar, a historic church for that community, in the protected area. The portion of the levee behind the beach berm and just north of Espinar community was eliminated, and the end of the levee was tied into the beach berm on the west side of the mouth of the Caño. One-way drainage structures are to be incorporated into the levee at strategic points. This last alternative has been further modified to include a two-way culvert

The original version of the two-levee alternative (Figure 3) included a flood ring levee immediately adjacent to the south, east and north sides of Espinar community. The variation to include the church could still be used within this alternative. That alternative would have impinged on the mangrove channel immediately adjacent to the northeast part of Espinar community, but would have remained south of the back-berm herbaceous and forested wetlands and Coastal Barrier Unit PR-75 and it would have avoided impacts to the sedge dominated wetlands south of the mangroves. The mangroves that would be impacted could be mitigated by relocating the portion of the channel to be impacted slightly eastward and replanting mangroves.

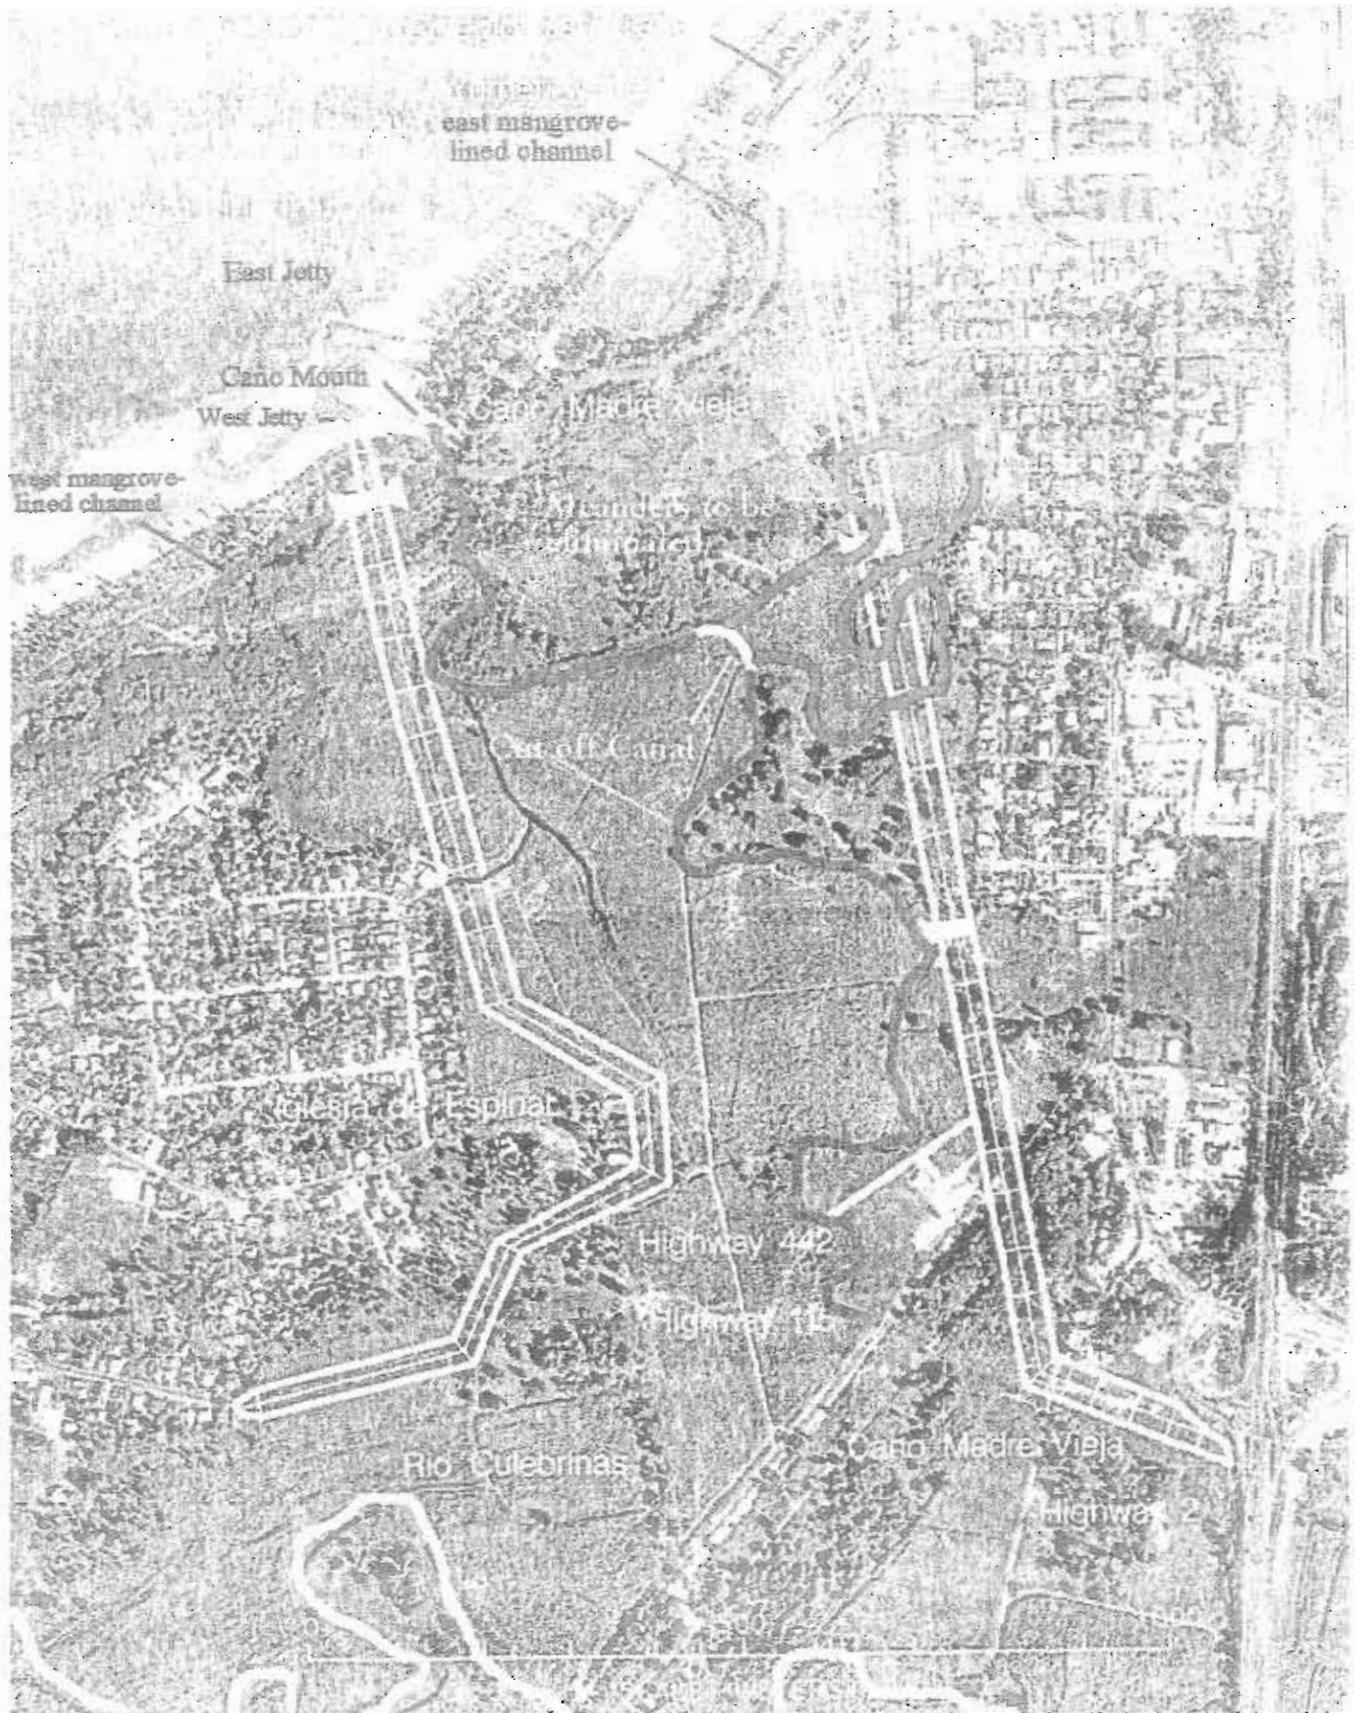
Figure 4. Currently favored alternative with the modified west levee.

Further upstream, to the southeast, the eastern dike would pass through a forested area and over two roads (Figure 4). The forest in this area has some mature mango trees, but is heavily dominated by *Albizia procera*, an introduced legume that colonizes old cane fields and disturbed areas. *Albizia* tends to form monocultures and provides little wildlife habitat value. While this species is often found in relatively wet soils on the edges of wetlands, it is considered to be an upland species.

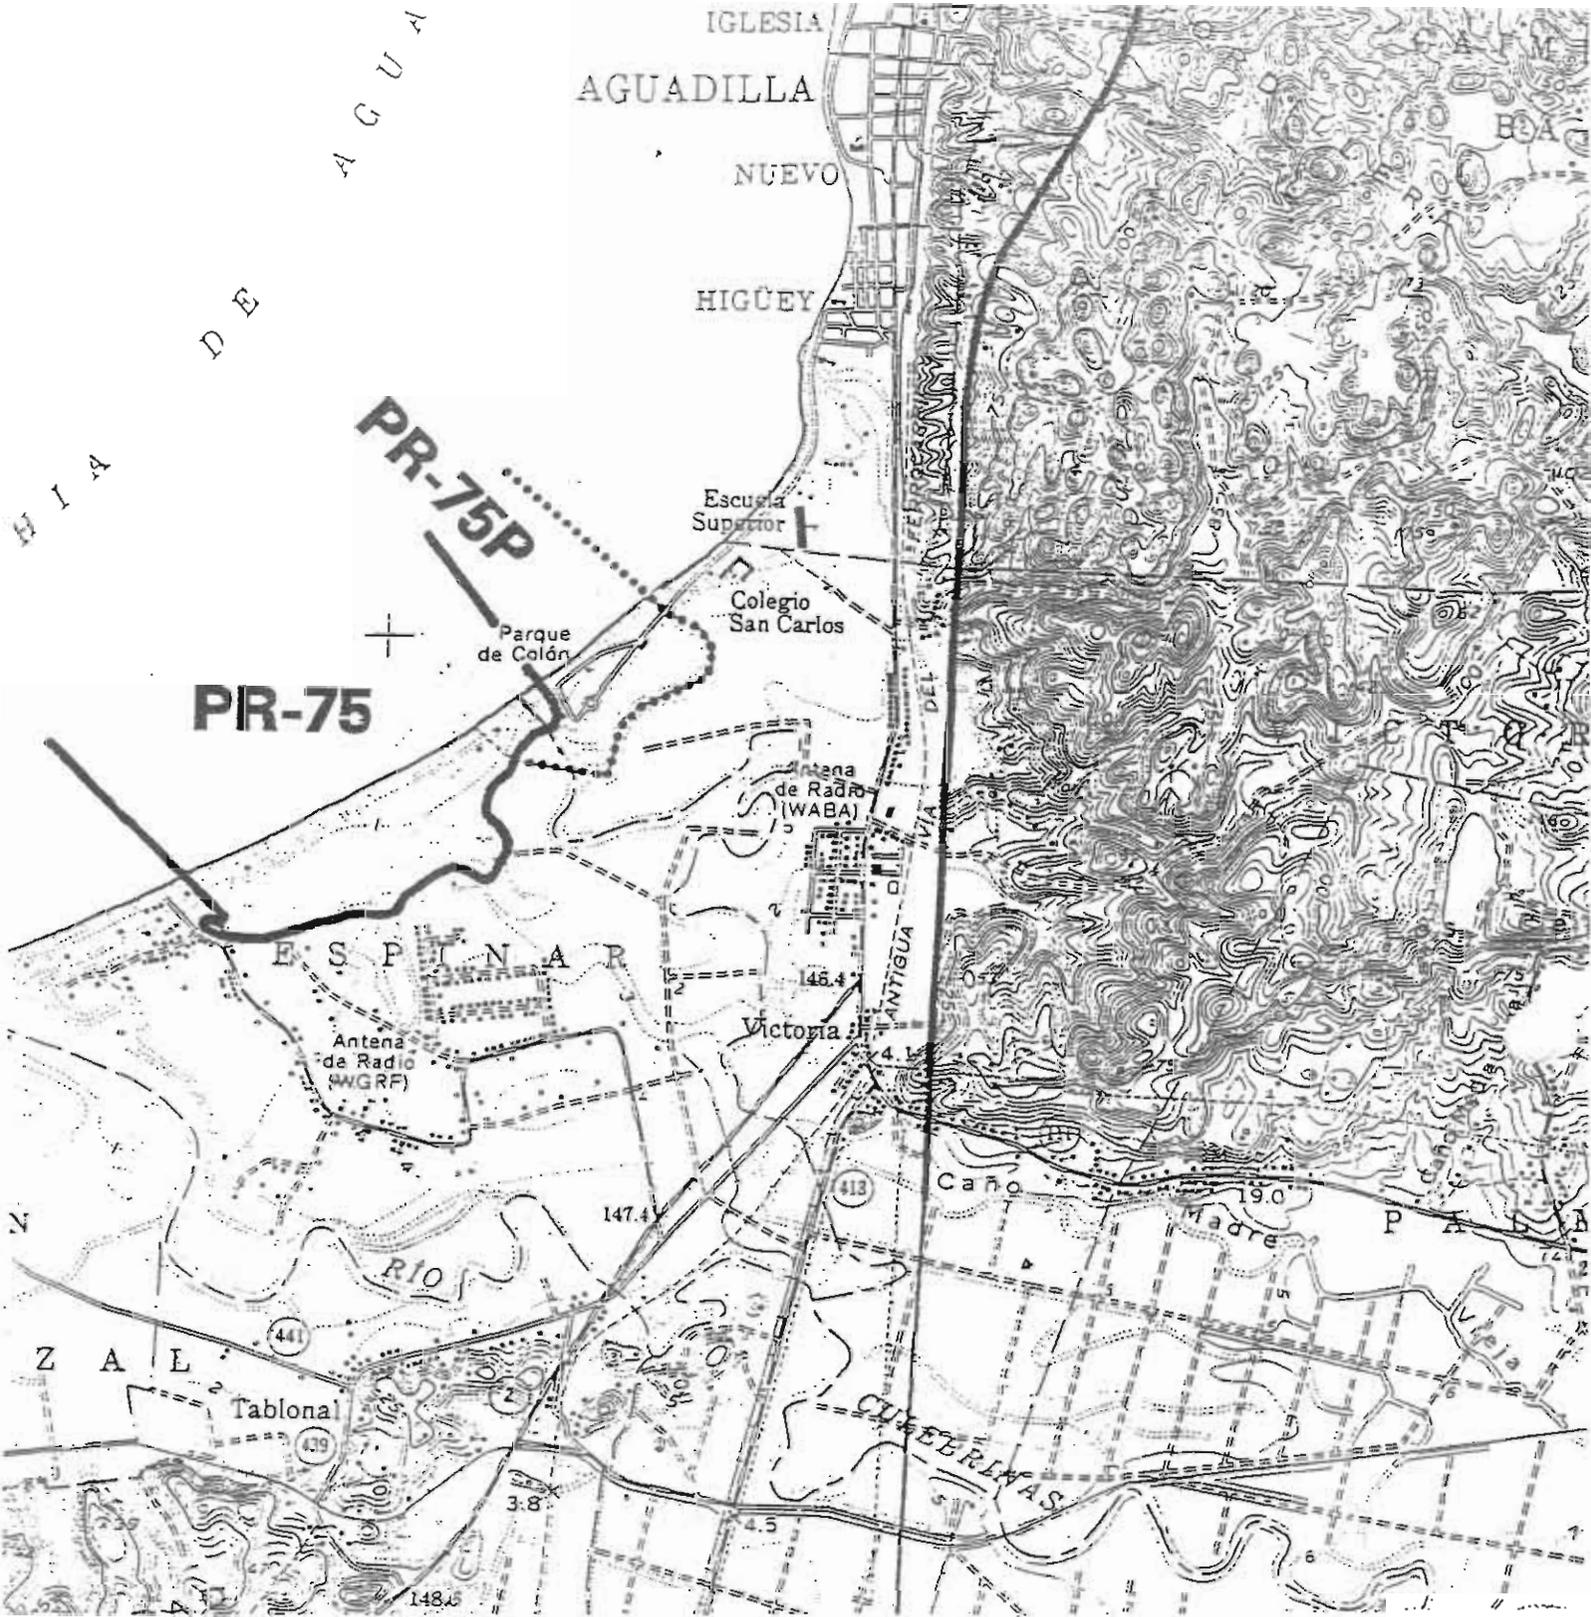
Figure 5. Showing Coastal Barrier Resource Units PR-75 and PR-75P.

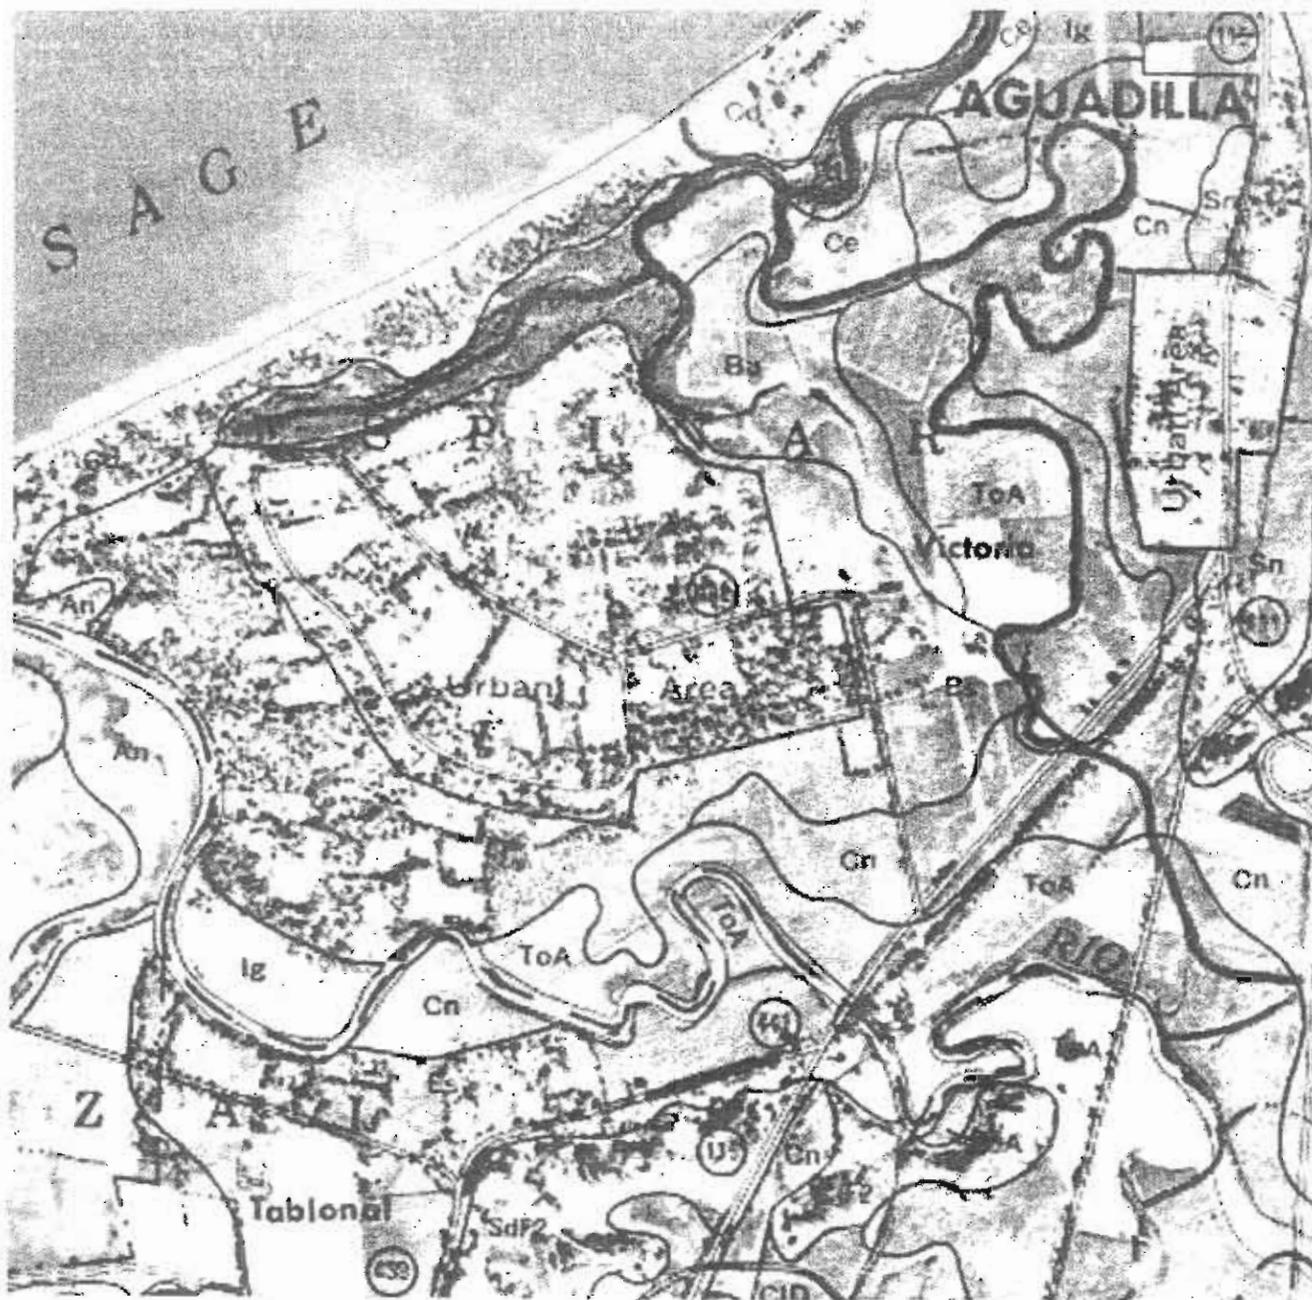
Figure 6. Enlarged soil map showing Caño Madre Vieja.

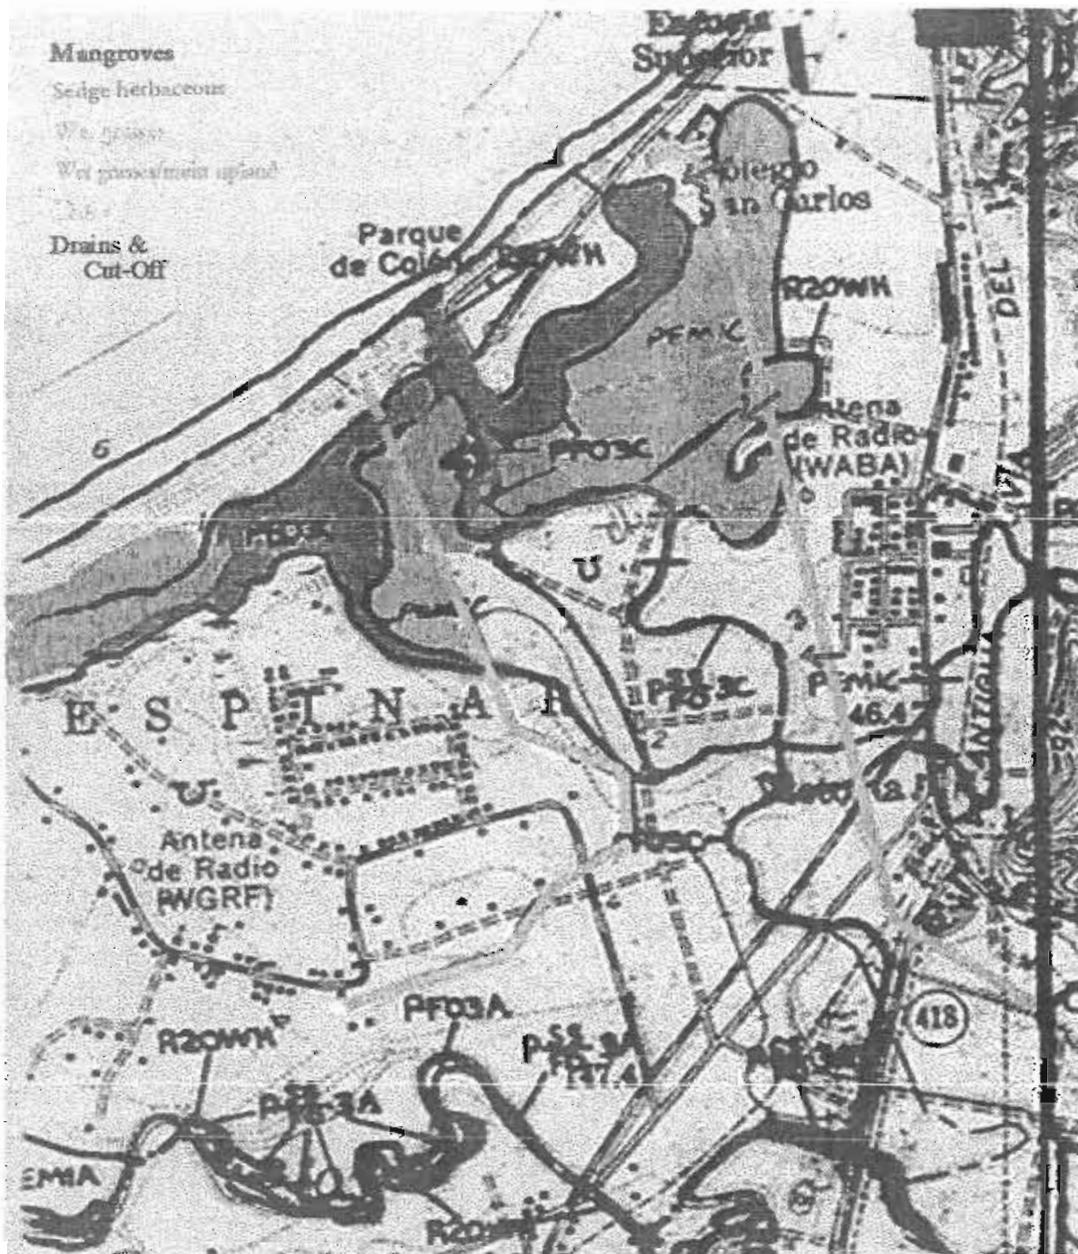
Figure 7. NW1 map of the project with the dike layout and rough approximation of wetland types

The National Wetland Inventory Map (Figure 7) of the area indicates relatively extensive wetlands in the Caño Madre Vieja area. While wetlands east of Caño Madre Vieja may be over-estimated in the maps, some areas marked as uplands within the proposed levees may be in the process of reverting to wetlands. The mouth of Caño Madre Vieja is mapped as Cd on the soil map, and is a classic small stream opening on a dynamic beach. The beach berms, while considered to be uplands are relatively narrow. On the eastern side of the Caño, as mentioned above, the beach berm has been elevated for the coastal road and further altered with groins and rip-rap to protect the park development, the public road, and the school. The beach berm on the western side of the Caño mouth has retained more natural characteristics with some forest of coconut palms and portia tree (*Thespesia populnea*), and West-Indian almond (*Terminalia catappa*).

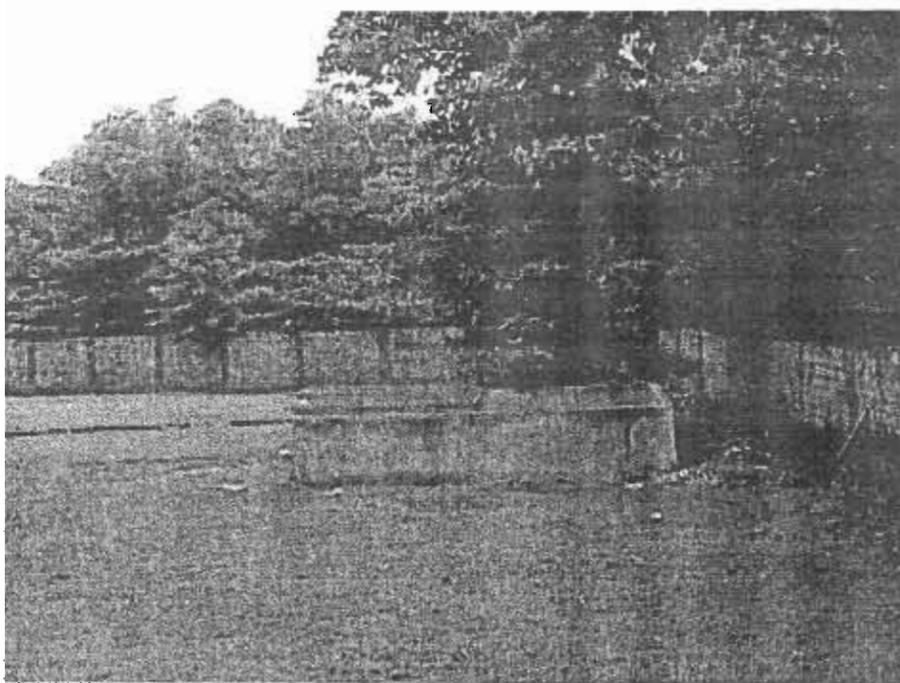
Photo 7. Colegio San Carlos school yard with the forested drainage behind it. The eastern levee would pass through part of the school yard and forest.

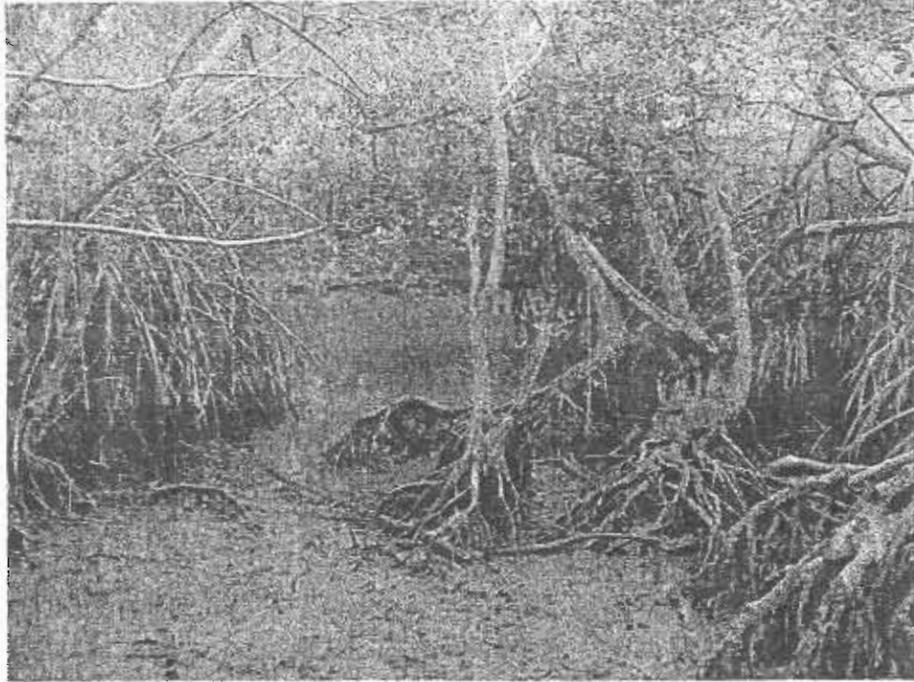
Photo 11. Predominantly red mangrove forest in the area where the western dike would cross and near the narrow point of the channel. The tide was moving out and at low stage.
