National Register of Historic Places Registration Form

historic name Eugenio María de Hostos School
other names/site number Escuela Eugenio María de Hostos

street& number Matías Brugman Avenue not for publication
city or town Las Marías vicinity
state Puerto Rico code PR county Las Marías code 083 zip code 00670

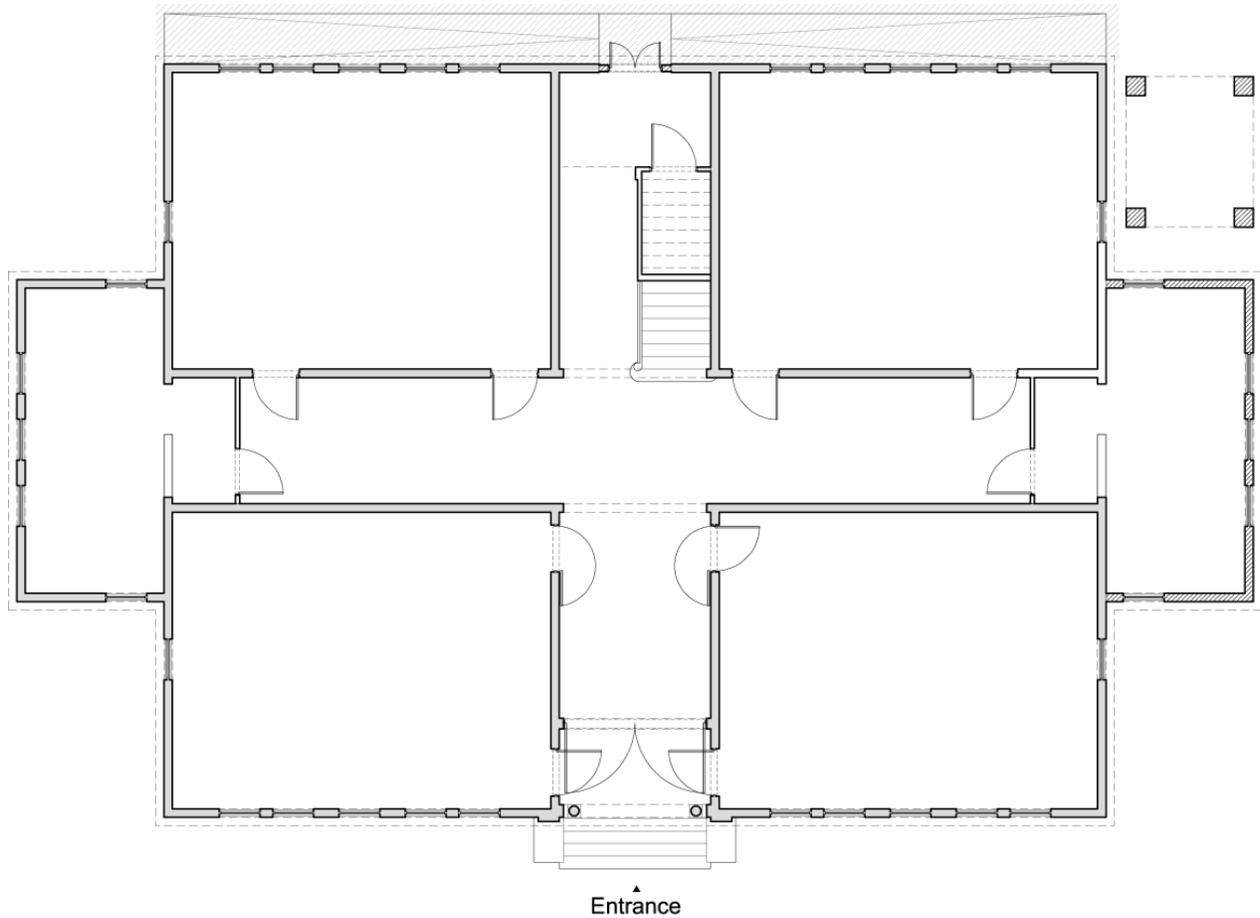
FIG. 1: Eugenio María de Hostos School Ground Level Floor Plan. Classroom spaces are housed within the main volume, and reached by a cross-shaped, double-loaded, corridor; restrooms flank the main volume. Drawing: Eduardo Miranda, September 19, 2012.

Originally, the *Eugenio María de Hostos School* accommodated eight classrooms: four at each floor, distributed symmetrically at either side of a central axis. On the second level, the principal's office was provided at center. Restrooms and storage spaces flank the sides of the main volume, which is higher (**FIG. 1**). The school's main façade is situated on a northeast orientation and on axis with an access road from PR-120, one of Las Marías' main arteries that lead into the "pueblo" [downtown]. *Escuela Hostos* is bordered on the north, east and south by the aforementioned PR-120

A cross-shaped, double-loaded corridor on the first floor level and a T-shaped hallway on the second floor level lead to the classroom spaces housed within the main volume. At ground level, said hallway includes a 12'-0" wide vestibule that extends from the main entrance to the rear facade and runs northeast/southwest, providing direct access to classrooms, the main stairs, and a secondary back entrance, partially hidden behind these. To the left side of the vestibule, a mural painted by students fills portions of the wall below the stair's landing. The stairway itself is built in concrete, located on axis with the main entrance, and prominently featured within a double height space. The dogleg stair⁸ is wide but plain, and features a round post where the center balustrade ends at the curtail step (**FIG. 7**). Steps are finished in polished concrete and include stair nosings. The space underneath the stairs is used as storage. The first level has an interior height of 14'-0". The hallway

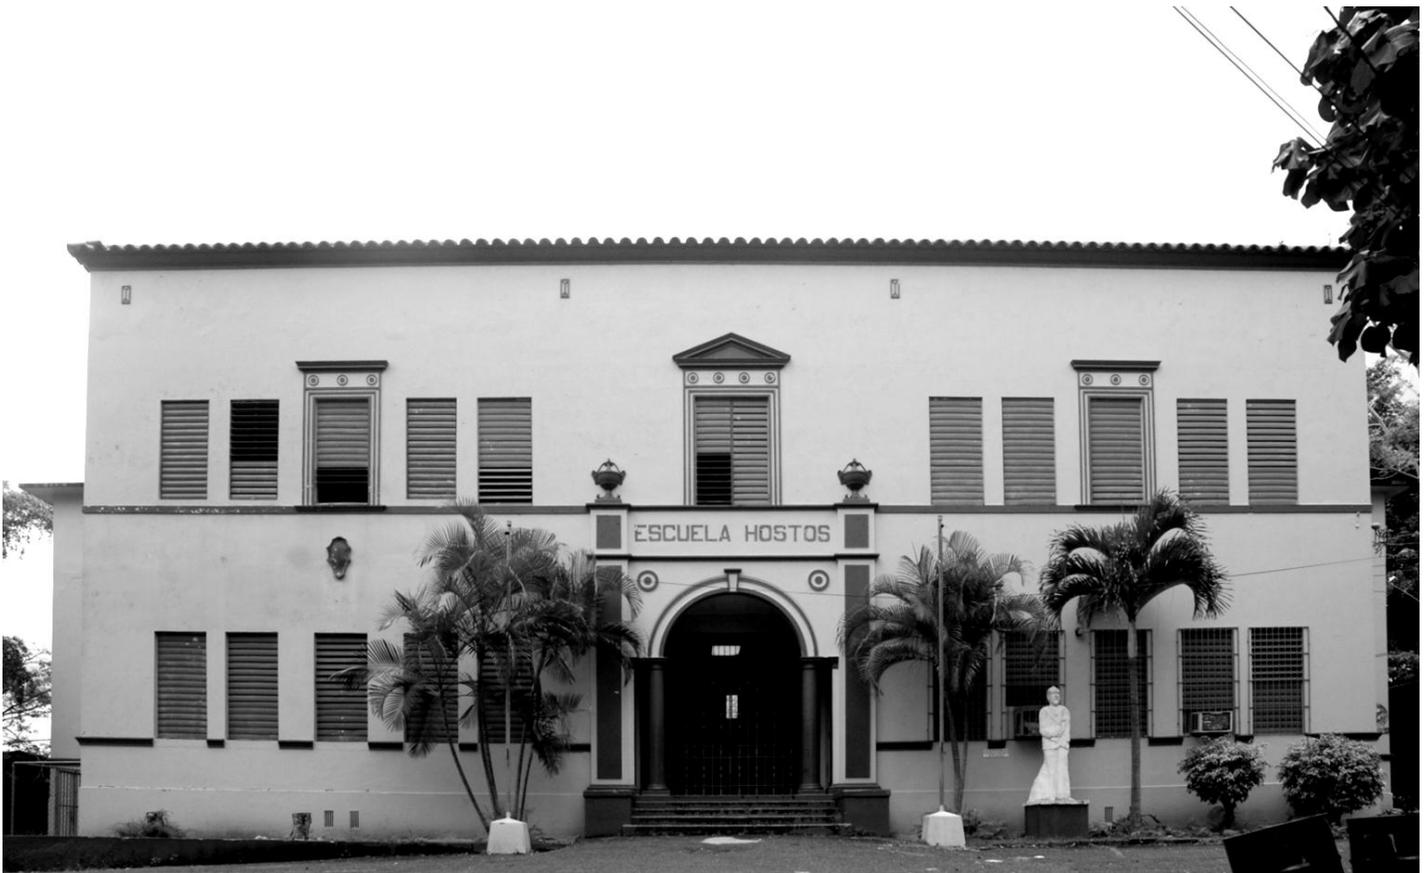
FIG. 2: Eugenio María de Hostos School northeast elevation, looking southwest. Main facade existing conditions in the town of Las Marías, Puerto Rico. Original reversed hipped roof and wood louvers windows has been substituted but the fenestrations retain their original proportions. The frontispiece on center is a predominant feature in otherwise bare façade. Windows in group of five, featuring interrupted cornice on ground floor, highlighted center window on second floor level and cartouche underneath central window. A cornice on ground floor level breaks with each window's opening at window sill height. Portions of the openings have been filled adroitly in cement, corresponding with the top of the cornice, to accommodate smaller window units. At roof level height one of four lantern shape, low-relief, coarse finish inlay, concrete motif are distributed along the front façade below a cornice. Photo: Mariana Morales, May 28, 2012.

Through the manipulation of myriad architectural elements characteristic of the Beaux Arts Period (cornices, moldings, and other trims raised from wall surfaces for emphasis) the designer provided the school's main volume with abundant horizontal lines that emphasize its importance (**FIG. 2**). Ornamentation is concentrated around the main entrance of the building and three windows on the second floor. A rather elaborated frontispiece adds monumental scale to the otherwise bare façade. Two low piers flank a five-step stoop lacking any handrails (**FIG. 3**). It acts as a pedestal for the one and one-half level pilasters that rise to reach a slightly protruding flat cornice that "wraps around" the main volume at "waist height", underneath the sill of the upper level windows. This grants an over slung scale to the school building, and is partly responsible for the monumental presence it exerts in town.

6. **Northeast elevation, looking southwest. Main facade existing conditions in the town of Las Marías, Puerto Rico. Original reversed hipped roof and wood louvers windows have been substituted but the fenestrations retain their original proportions. The frontispiece on center is a predominant feature in otherwise bare façade. Windows in group of five, featuring interrupted cornice on ground floor, highlighted center window on second floor level and cartouche underneath central window. A cornice on ground floor level breaks with each window's opening at window sill height. Portions of the openings have been filled adroitly in cement, corresponding with the top of the cornice, to accommodate smaller window units. At roof level height one of four lantern shape, low-relief, coarse finish inlay, concrete motif are distributed along the front façade below a cornice.**

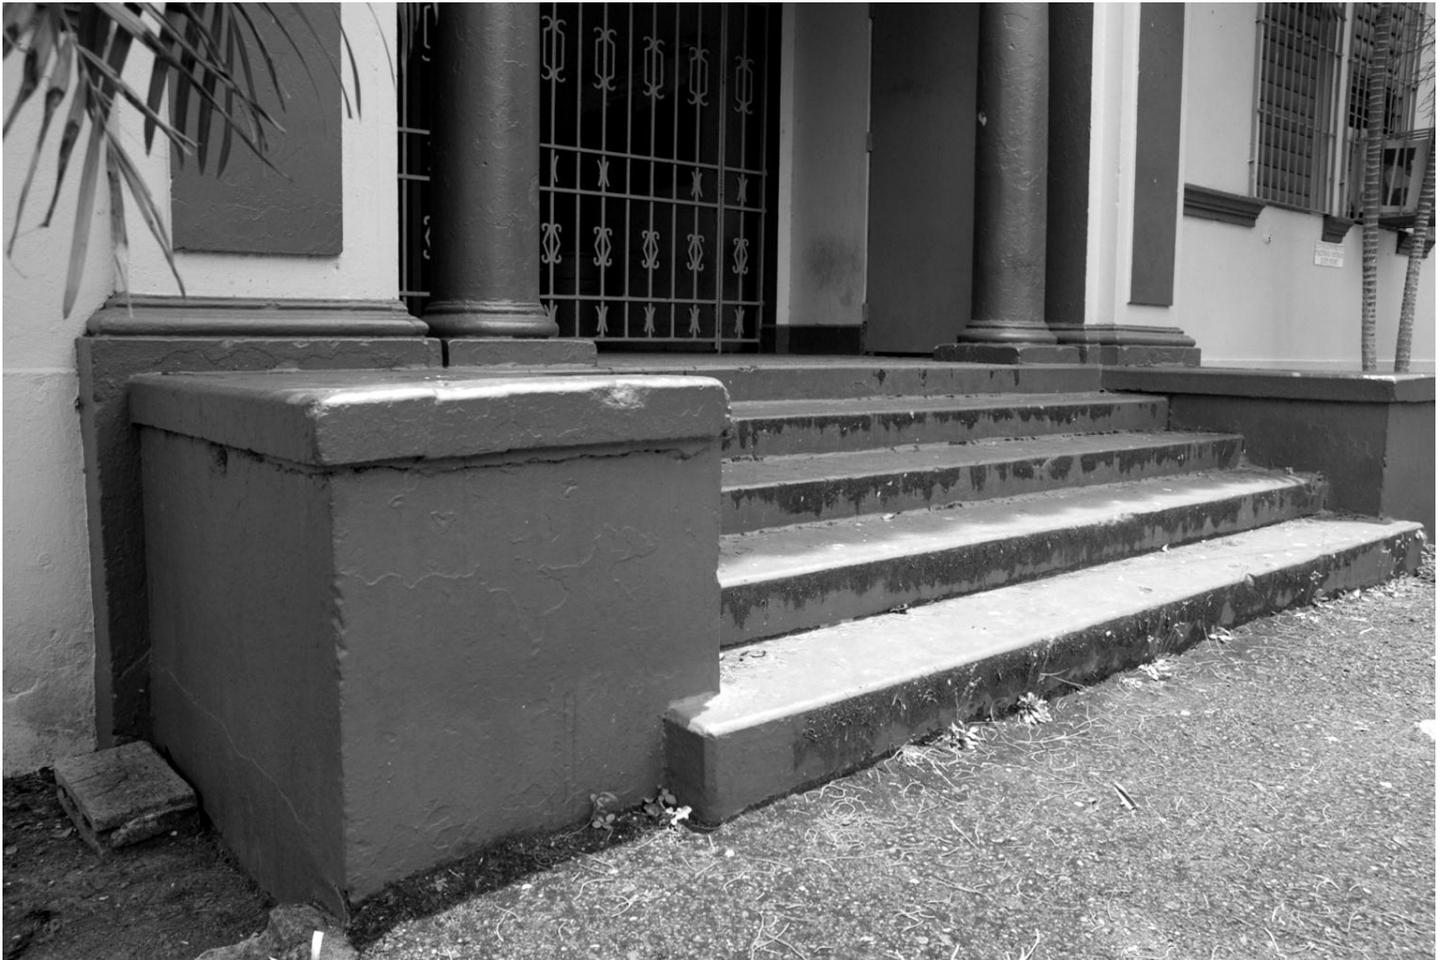
FIG. 3: Eugenio María de Hostos School northeast elevation, looking southwest. A five stepped stoop with no handrails flanked by a low pier at each side; acts like a pedestal for the pilasters. Photo: Mariana Morales, May 28, 2012.

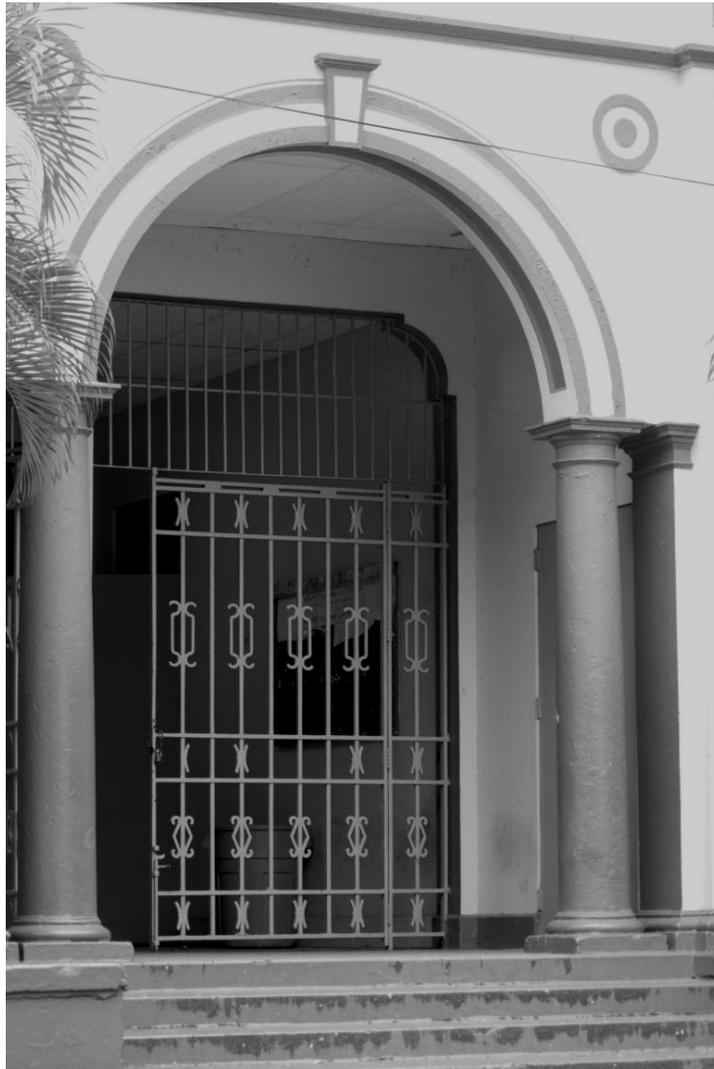
FIG. 4: Eugenio María de Hostos School northeast elevation, looking southwest. Main entrance arch part of an elaborate frontispiece. Photo: Mariana Morales, May 28, 2012.

To further underscore the arched entry, the portico displays two Tuscan order columns between *antae* (pilasters). In terms of architectural composition, said arrangement is formally referred to as *distyle-in-antis*⁴. Column shafts are unfluted and tapered. The base is plain and simple; only a single torus molding⁵ sits above the plinth of the base. The capital consists of a plain astragal⁶ ring on top of the column beneath its plain cap (**FIG. 4**). The entrance arch is in Roman style, sporting a double frame architrave⁷. On top, a protruding keystone includes coarse finish inlay and crown top molding. A paneled soffit underscores the underside of the arch.

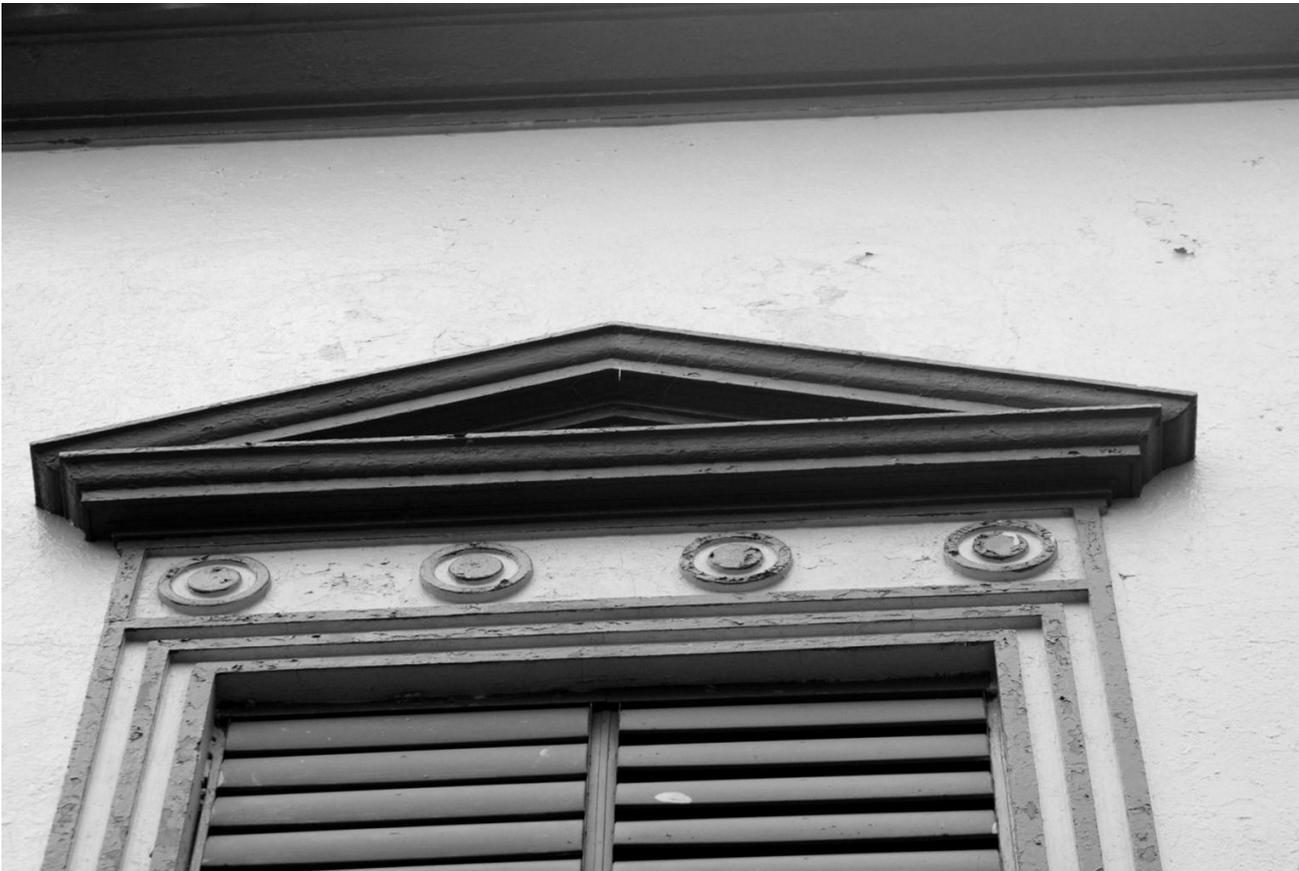
FIG.5: Eugenio María de Hostos School exterior detail, looking southwest. Highlighting the window at center, where the principal's office used to be located. Three flat (fillet) moldings surrounds the 4'-3" wide opening. Above, a small entablature framed by a single fillet molding encases four "bull's-eye" round medallions laid-out horizontally. On top a pediment crowns on axis the second floor window. Photo: Mariana Morales, May 28, 2012.

In the front façade, windows appear in sets of five (5), each group corresponding to a single classroom. Thin, rectangular, concrete columns separate one window from the other, mullion-like, far from being perceived as full wall segments. The sets of five windows are closely spaced and “read” as a horizontal field in the overall building composition. Window openings are rectangular and vertical; all of them now house aluminum, operable jalousies. The symmetrical composition of the entrance frontispiece is further emphasized at these window groupings by highlighting the window at center, on the upper level, where the principal’s office used to be located. Three flat (fillet) moldings surround the 4’-3” wide, window opening. Above, a small entablature framed by a single fillet molding encases four “bull’s-eye” round medallions lined-up horizontally. A pediment crowns the window (**FIG. 5**). On the same façade - at window groupings corresponding to flanking classrooms right and left of the entrance - the center window [part of a group of five] is also highlighted with similar trimmings. These openings (3’-3” wide) incorporate the three flat (fillet) molding surrounds and a small entablature. The latter is framed by a single fillet molding that encases three “bull’s-eye” round medallions also laid-out horizontally and capped-off by a flat cornice, instead of a pediment. Their compositional importance is further underlined by a three-dimensional cartouche placed on axis beneath them.

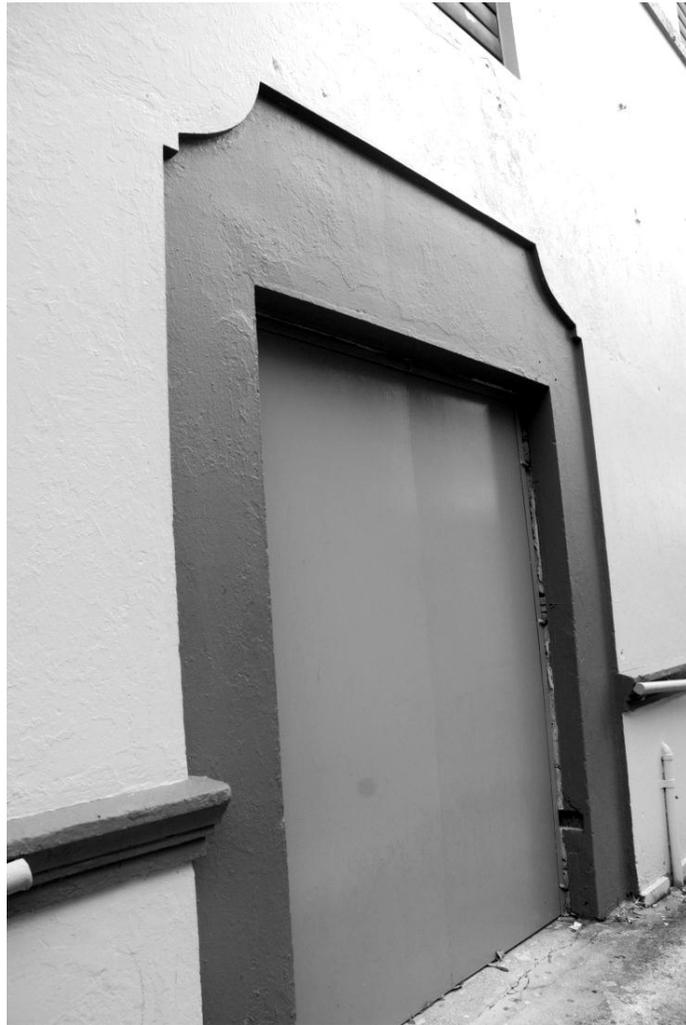
FIG. 6: Eugenio María de Hostos School exterior detail, looking northeast. A rear entrance/exit mixtilinear arch filled in to accommodate a 5'-0" wide solid metal double doors. Photo: Mariana Morales, May 28, 2012.

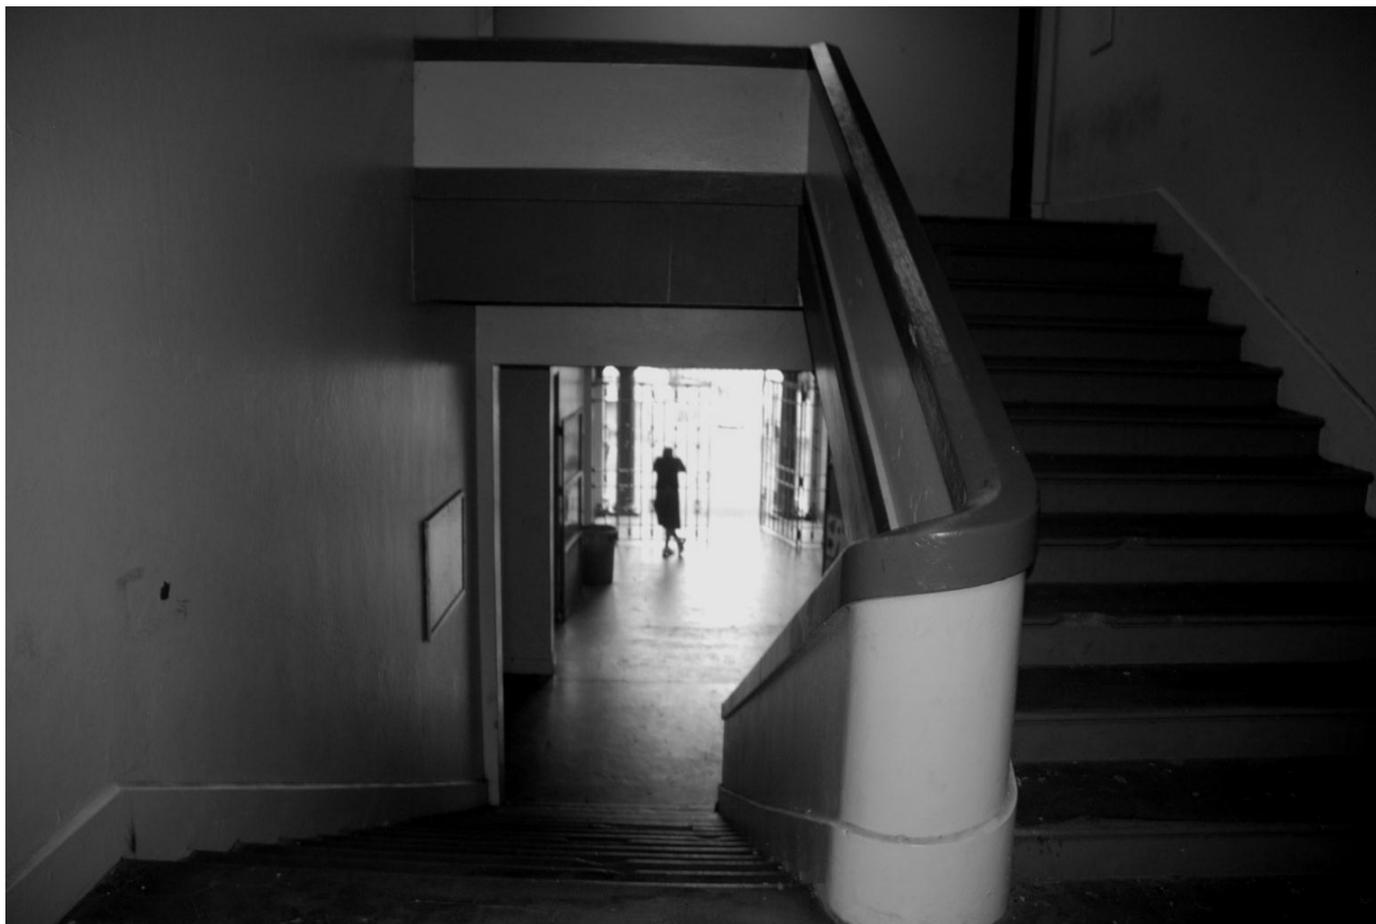
FIG.7: Eugenio María de Hostos School interior view, looking northeast. The stairway is built in concrete and is located on axis with the main entrance prominently featured with a double height space. The dog-leg stair is plain and wide, they feature a round post where the center balustrade ends at the curtail step. Steps are finished in polished concrete and include stair nosings. Photo: Mariana Morales, May 28, 2012.

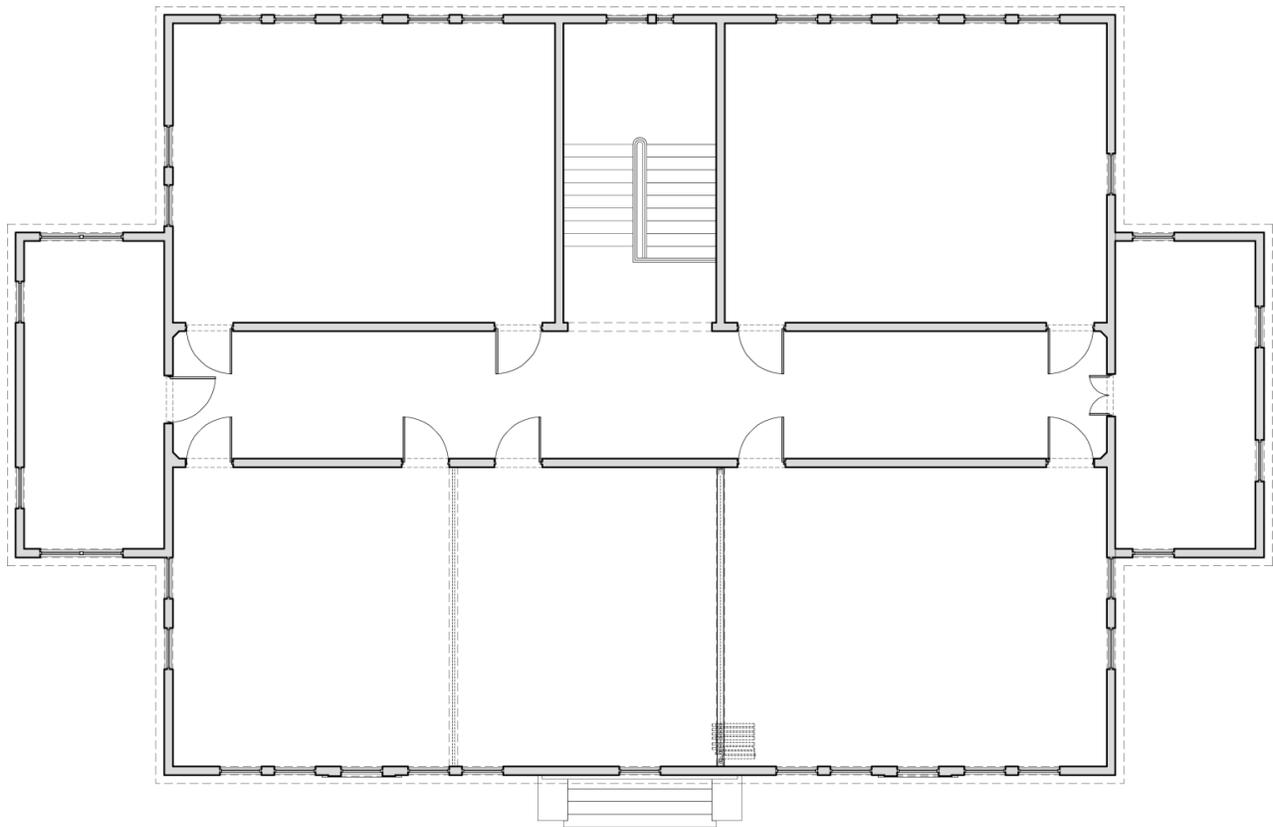
FIG. 84: Eugenio María de Hostos School Second Level Floor Plan. Classroom spaces are housed within the main volume, and reached by a T-shaped, double-loaded, corridor; storage space flank the main volume. Facing northeast, two classrooms and principal's office on the second floor were provided with folding door partitions, so that they could easily be converted into a large assembly room. Drawing: Eduardo Miranda, September 19, 2012.

Inside, the spatial flexibility originally granted by the retractable accordion doors in the second floor has been temporarily lost. The walls that now replace them impede the joint use of classroom spaces. Wooden floors at classrooms were oiled; wooden fenestration was stained. Doors were paneled and included ventilation transoms. Paneled shutters complemented casement windows with glass panes. Cement floors have been repaired nostalgic haphazardly and in some areas painted over. The original stairs remain, but several steps need repair. Stair railings are not ADA compliant. Through the decades, however, most changes have been related to the substitution of all wood components of the building, including the roof, classroom floors, and most fenestration.
