**National Register of Historic Places
Inventory—Nomination Form**

historic Church Nuestra Señora del Rosario of Naguabo *(Historic Churches of*
Puerto Rico)
and or common same

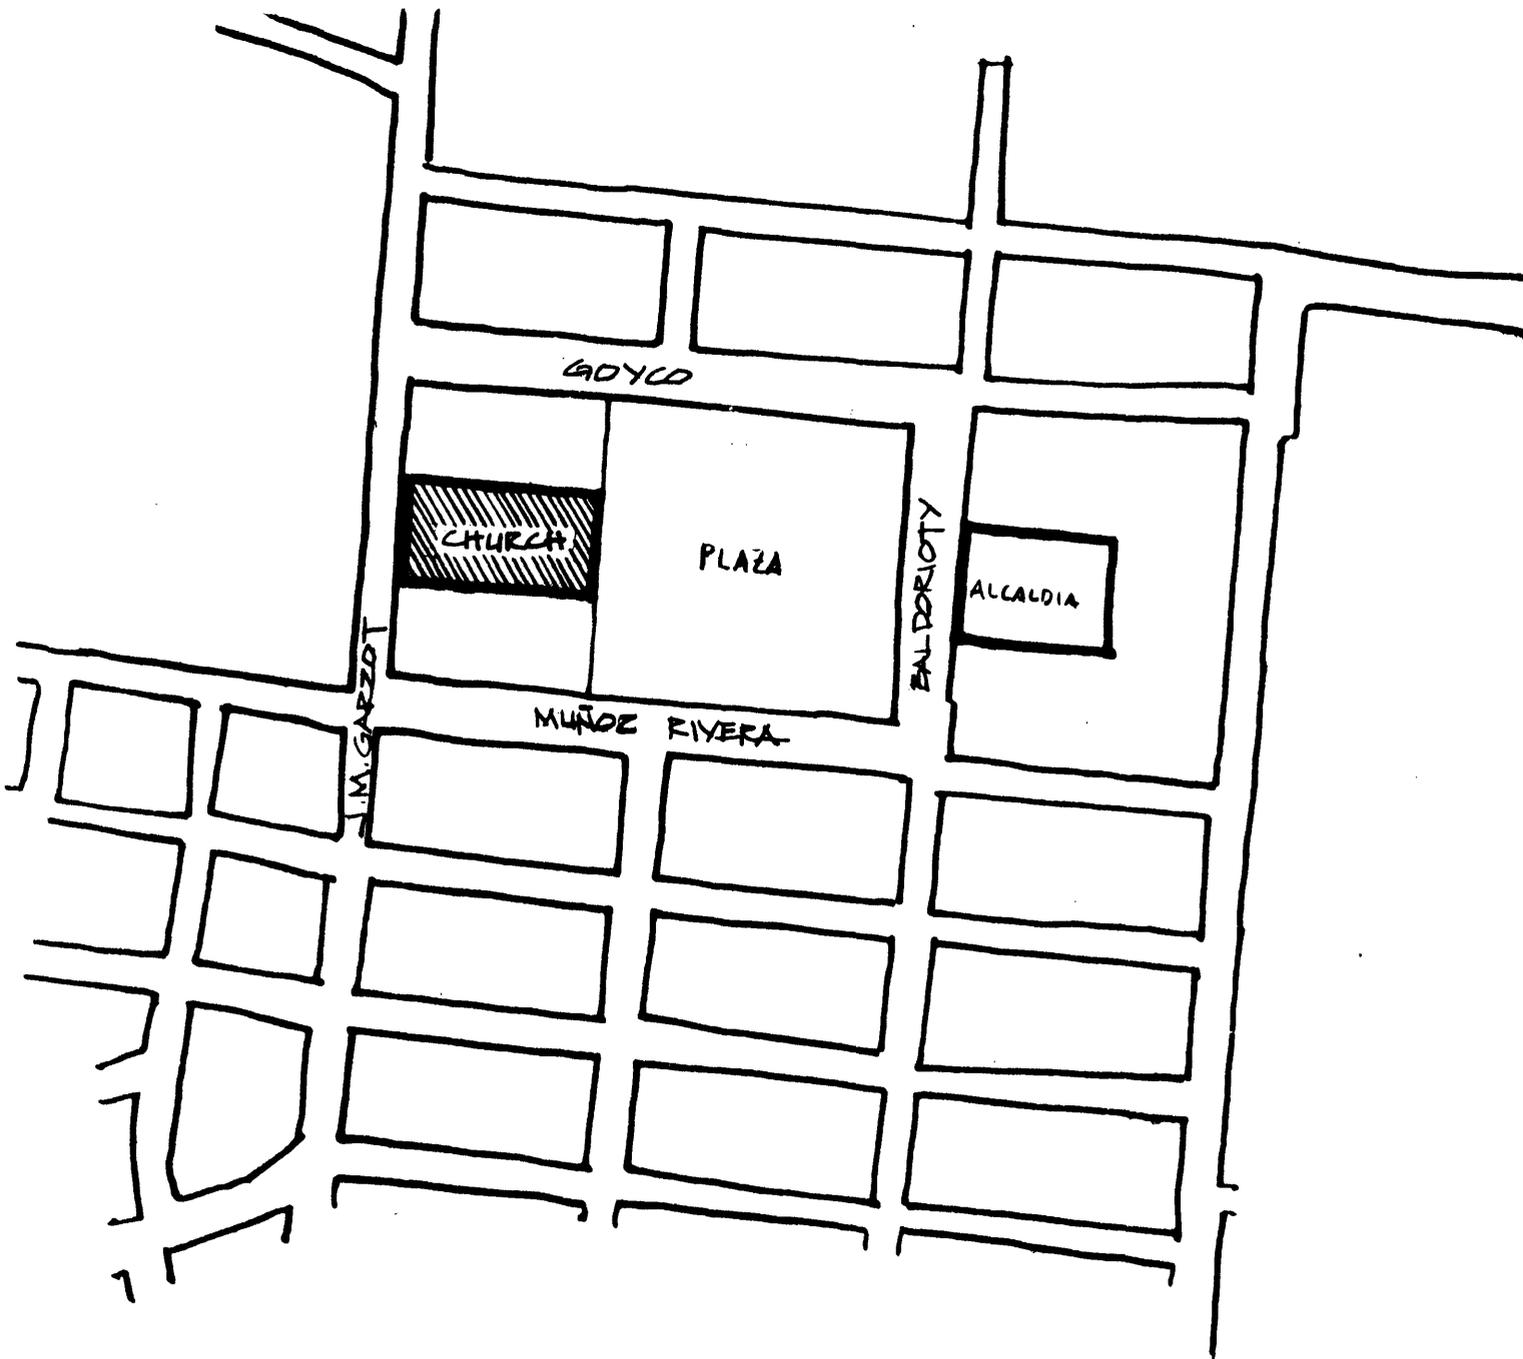
town: **HAGUABO**

scale: 1:2000
