National Register of Historic Places Registration Form

Historic name: Observation Tower

Other names/site number: Torre de Piedra, Santa Ana Tower

New Deal Era Constructions in the Forest Reserves of Puerto Rico, 1931-1942 (Amendment)

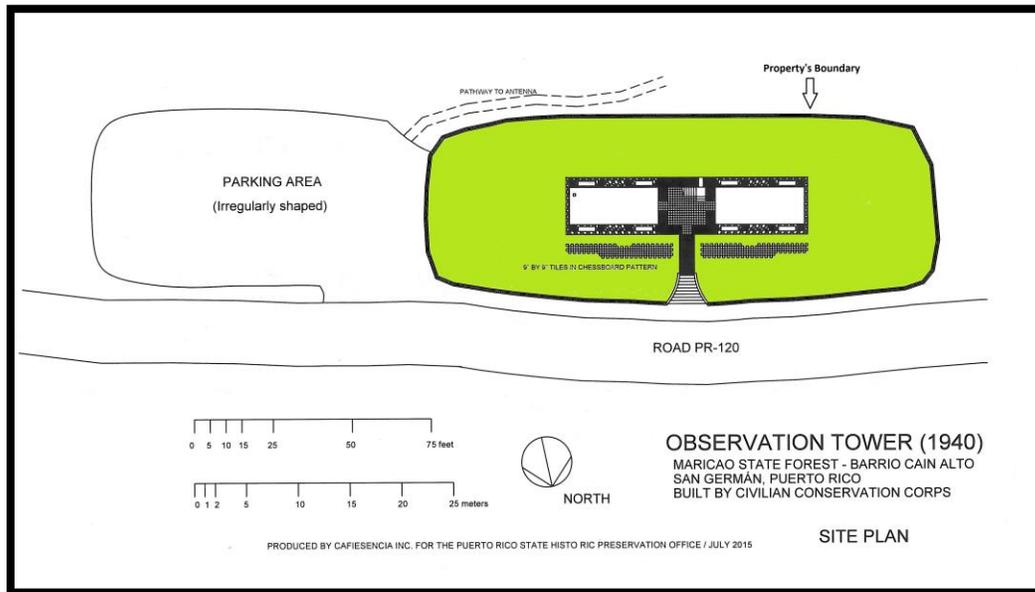
Figure 1. General plan of the Observation Tower prepared by Cafiesencia, Inc., 2015.

The Observation Tower, is a stone and concrete two volume rectangular building 76.5 feet (23.3 m) long and 18 feet (5.5 m) wide that rest on a manmade six feet high grassy knoll south of SR-120 at kilometer 14.0. The tower is located at the highest point of the Maricao Forest Reserve in the Cain Alto Ward of the Municipality of San German. The tower is divided in two volumes: a central observation tower and two lateral picnic shelters. With a height of some six feet over the neighboring road; the tower itself is about 30 feet (9.1 m) high with a height difference of the lower level and the observation platform of 24.75 feet (7.5 m).

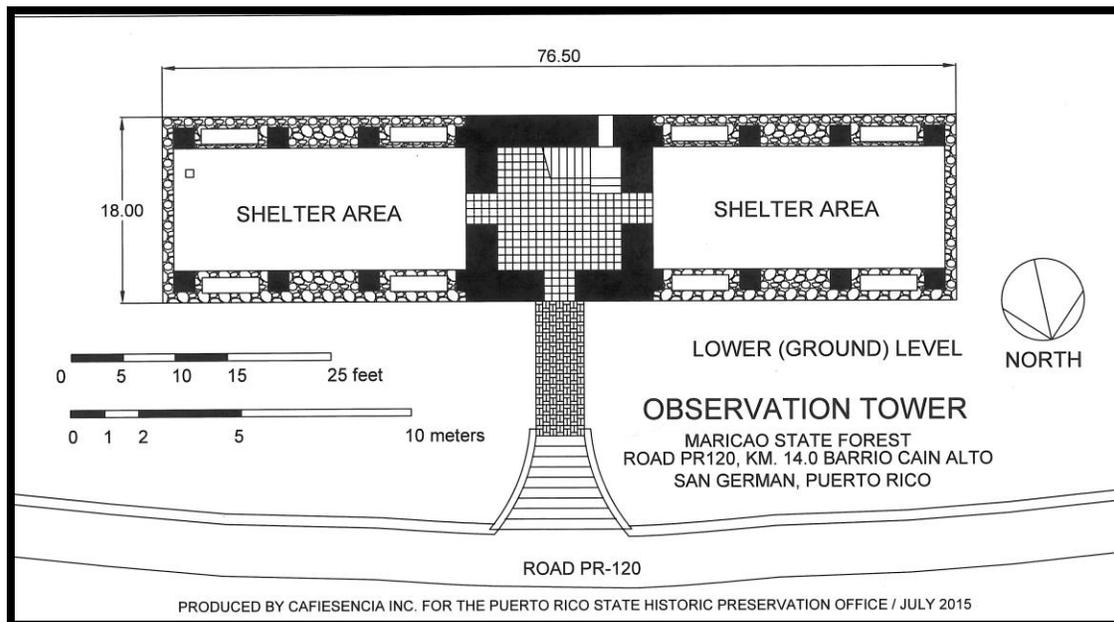
Figure 2. Plan of Observation Tower prepared by Cafiesencia, Inc., 2015.

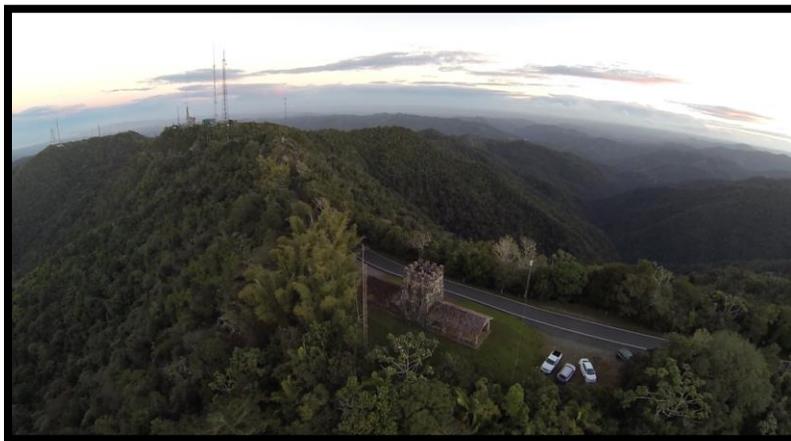
Photo 1. Aerial View of the Observation Tower taken from film *JIBA, el Bosque de Maricao*.

- Aerial View of the Observation Tower from the film *JIBA, el Bosque de Maricao* facing approximately north 1 of 12.
- View of the brick and stone stairway facing approximately southwest, 2 of 12.

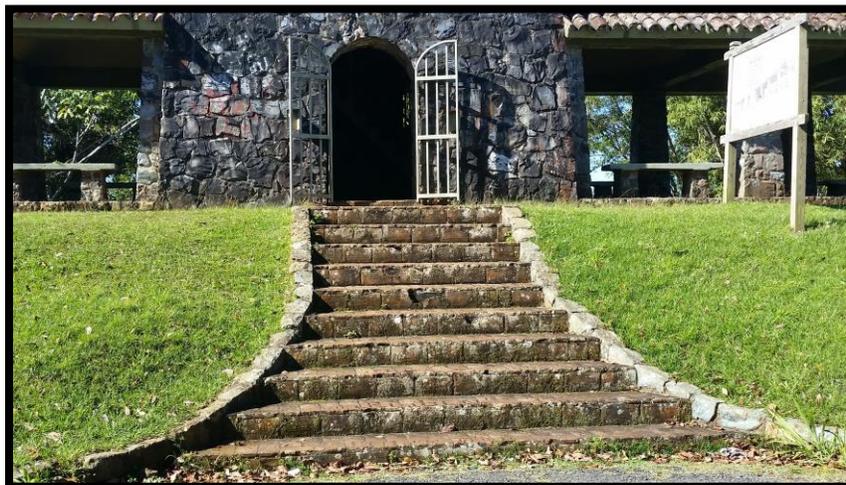
The tower's main entrance is reached from the roadway by way of a ten brick and stone stairway cut into the knoll. The stairway is broader at the base and shorter at the top. At the top of the stairs a brick path leads into the building's entrance. West of this brick path there is one historic marker prepared by the *Compañía de Parques Nacionales* (National Parks Company) that identifies the property and provides background information on the Civilian Conservation Corps. Also, square clay pavers (9"X 9") were dispersed to both sides of the path, in a chessboard pattern in the grass.

Photo 2. View of the brick and stone stairway facing approximately southwest.

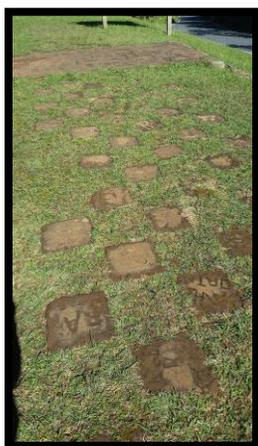
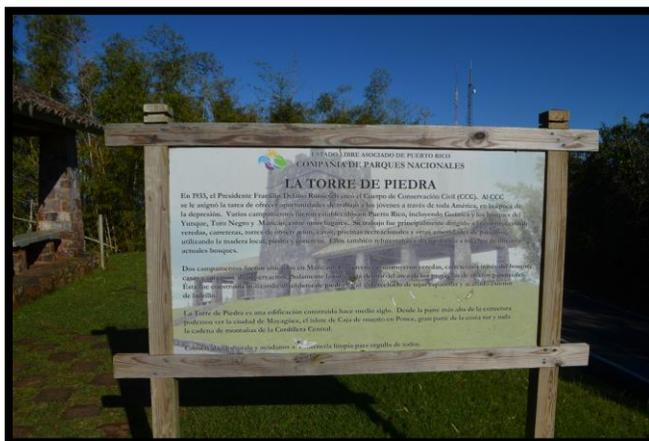
Photos 3 and 4. Pavers on the knoll and marker.

- Brick pavers on the knoll, facing approximately west, 3 of 12.
- Marker placed by the National Parks Company, facing approximately west, 4 of 12.
- View of Observation Tower facing approximately southwest, 5 of 12.

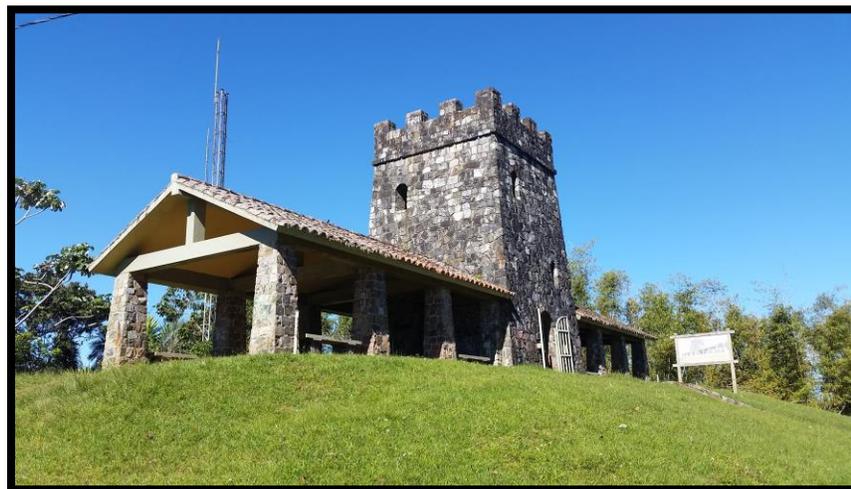
The central volume is solid-looking and a closed volume which has a footprint of 18 X 18 feet (5.5 m X 5.5 m). The building's exterior surface has irregular stones having one face dressed for outside exposure and using predominantly hard volcanic rock. The north (main façade) has an arched doorway opening with a louvered steel bar gate and above it two window openings. Both the east and west facades, which provide access to the picnic shelters, have one arched door opening with one window. The southern façade does not have a doorway, but has a three window openings. Steel bars have been placed in the window closest to the ground level.

Photo 5. View of the Observation Tower facing southwest.

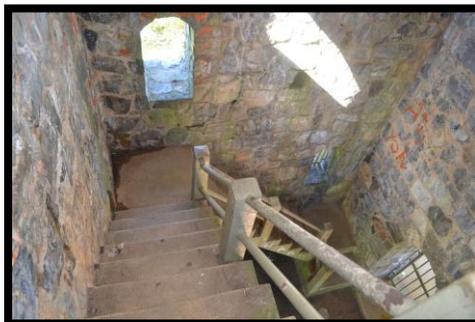
The flooring of the tower is made of a mix of brick and concrete slabs. Access to the observation terrace is made by way of a three quarter turn surfaced polished cement stair attached to the walls. The stair's railing consists of two parallel 1.5 inch pipes, with a 1 feet of separation, held by symmetrically spaced 2.5 feet high cement posts.

Photos 6 and 7. View of the window opening northern with iron grill work in southern façade and interior stairway looking west.

After 1960, due to safety reasons, three iron gates were installed on the tower's central volume openings and iron bars placed at the two lowest arched window openings. The side gates (opening to the picnic shelters) are kept closed while the main gate is kept unlocked all year round as informed by the management official of the Maricao State Forest.

- View of opening in the southern façade with iron grill work looking approximately southwest, 6 of 12.
- View of interior stairways, looking approximately west, 7 of 12.

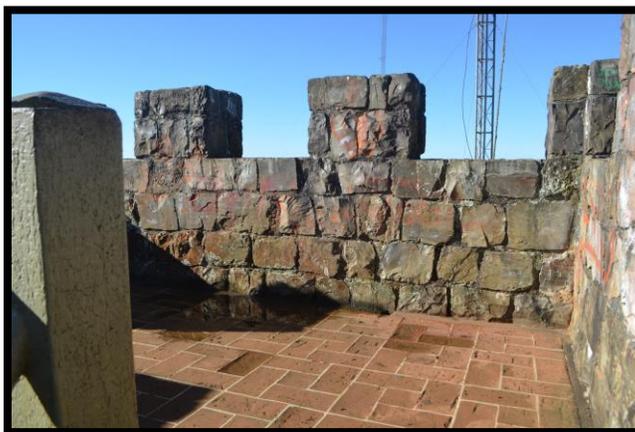
Photo 8. Observation area at the top of the tower.

- Observation area at the top of the tower, looking approximately south, 8 of 12.
- View of eastern picnic shelter taken from the roadway facing approximately southwest, 9 of 12.

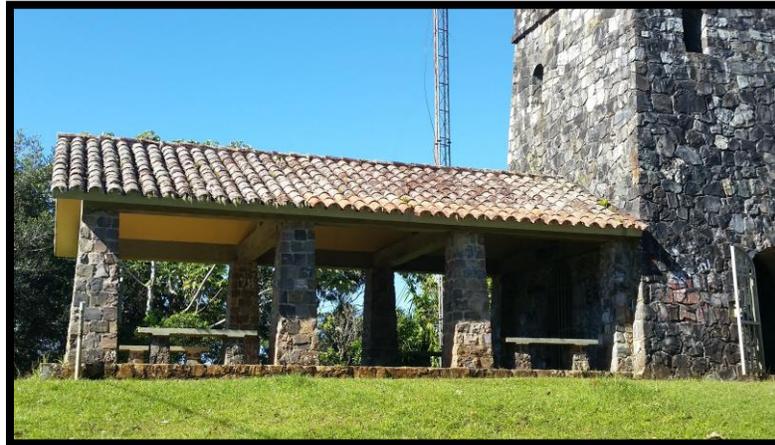
Each picnic shelter wing has gabled I-beam roof supported by eight stone squared columns. Flooring in the picnic shelters consists of polished cement at the center surrounded by pressed stone of about 1 foot wide. Four concrete benches were placed between the columns at the eastern and western end of the wings. The two picnic shelter wings have a footprint each of 29.5 X 18 feet (8.9 m X 5.5 m). The original roofs were initially made out of wood and but by 1955 they had been substituted with reinforced concrete trusses by the Insular Forest Service.

Photo 9. View of the four columns and two of the benches in the eastern picnic shelter taken from the roadway facing southwest.

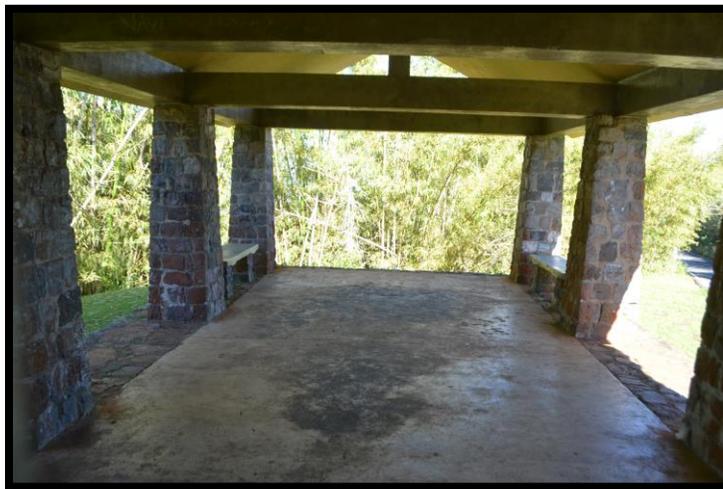
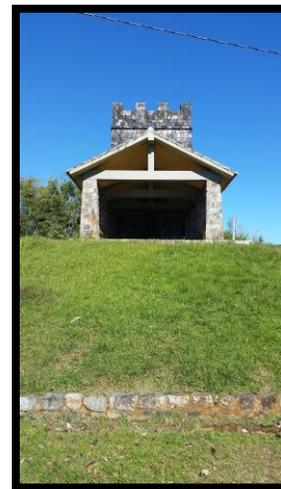
Photos 10 and 11. View of the picnic shelter as seen from the tower (facing northwest) and close-up of the kingpost with tie beams.

- View of western picnic shelter, facing approximately east, 10 of 12.
- View of the curb and the eastern picnic shelter taken from the parking area facing approximately west, 11 of 12.

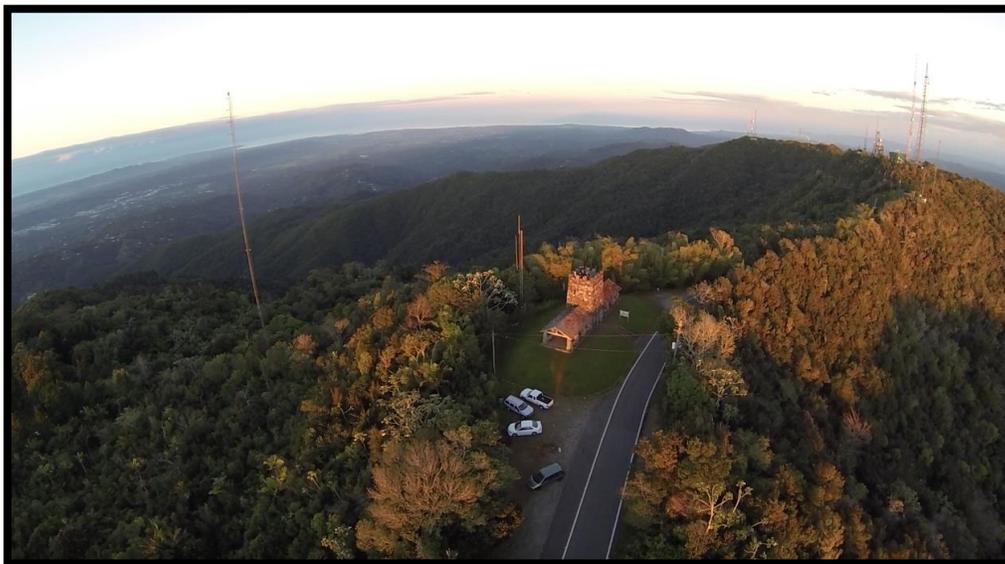
Facing the southern façade a communication antenna was placed at approximately 20 feet of distance, with a small reinforced concrete shed. The shed and antenna are outside the property's boundaries.

Photo 12. View of the antenna in the forest areas behind the Observation Tower taken from film *JIBA, el Bosque de Maricao*.

- View of the observation tower, its nearby antenna, the surrounded forested area and mountain ranges, looking approximately west, 12 of 12.
